Champion Mine CERCLA Removal Action

Dustin G. Wasley, PE, Principal
Cascade Earth Sciences – Spokane

Champion Mine Removal Action
May 5, 2010

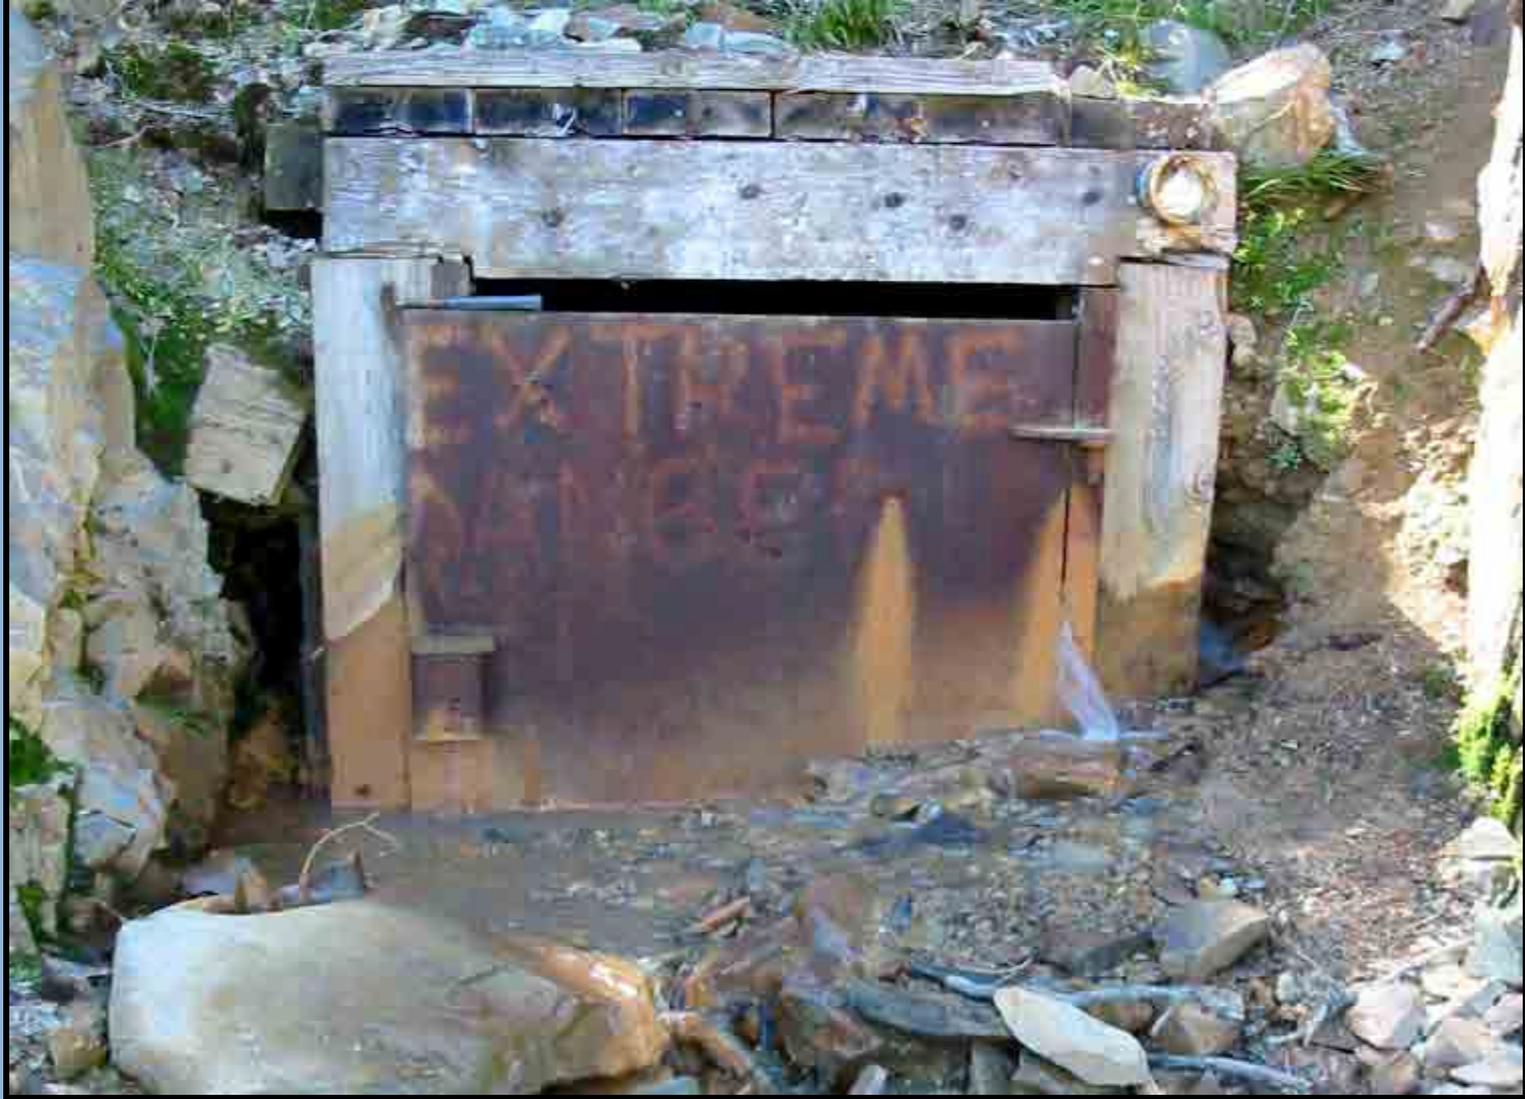
Main Haulage (1,200-Level) Adit – Before

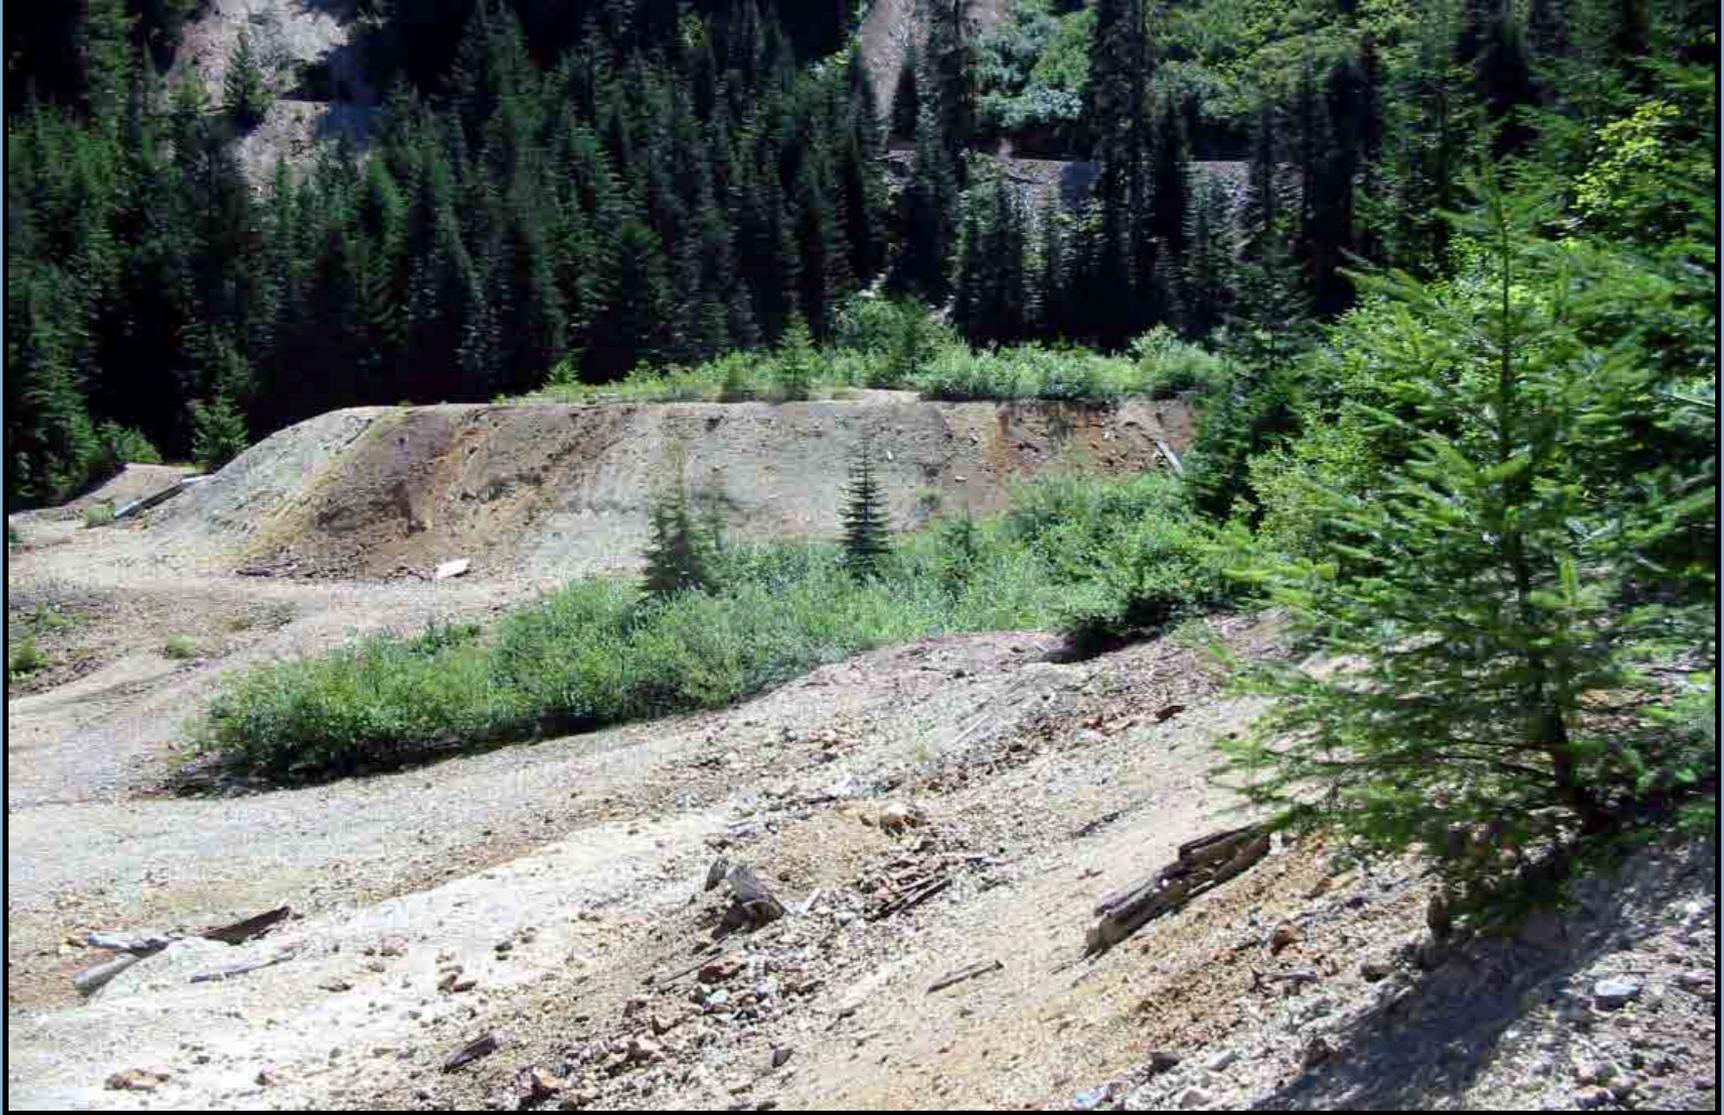
Waste Rock Piles and Ponds - Before

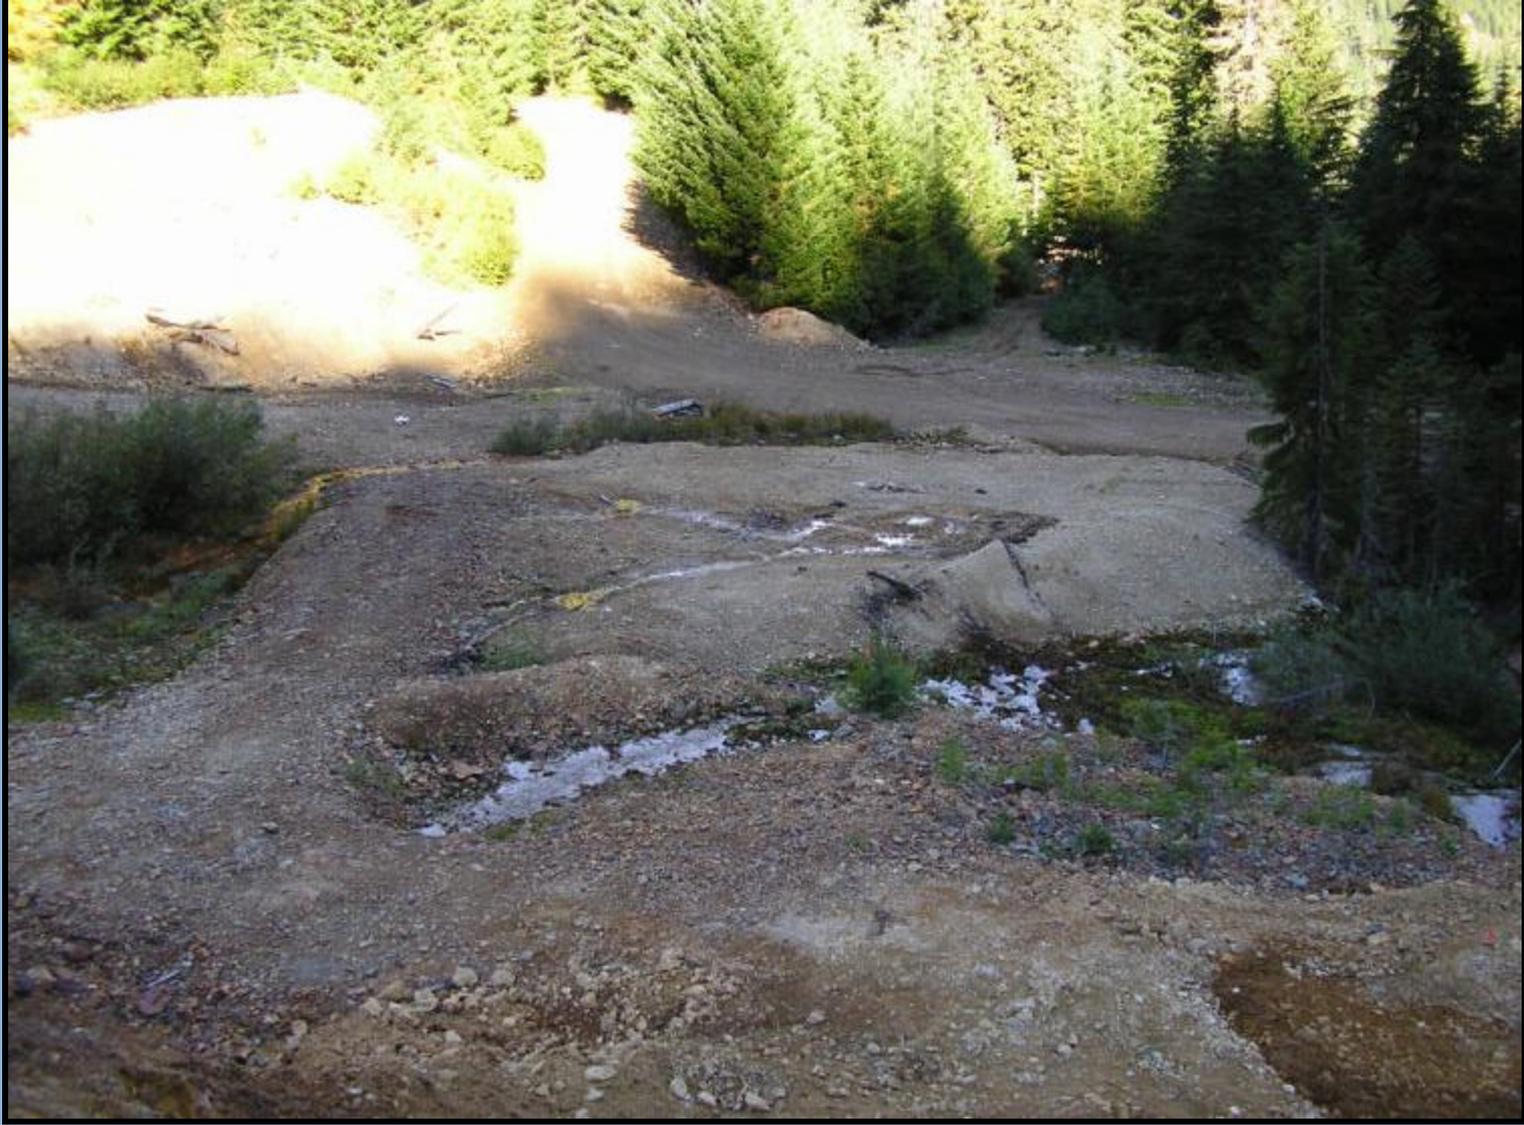
Waste Rock and Seeps Below Ponds - Before

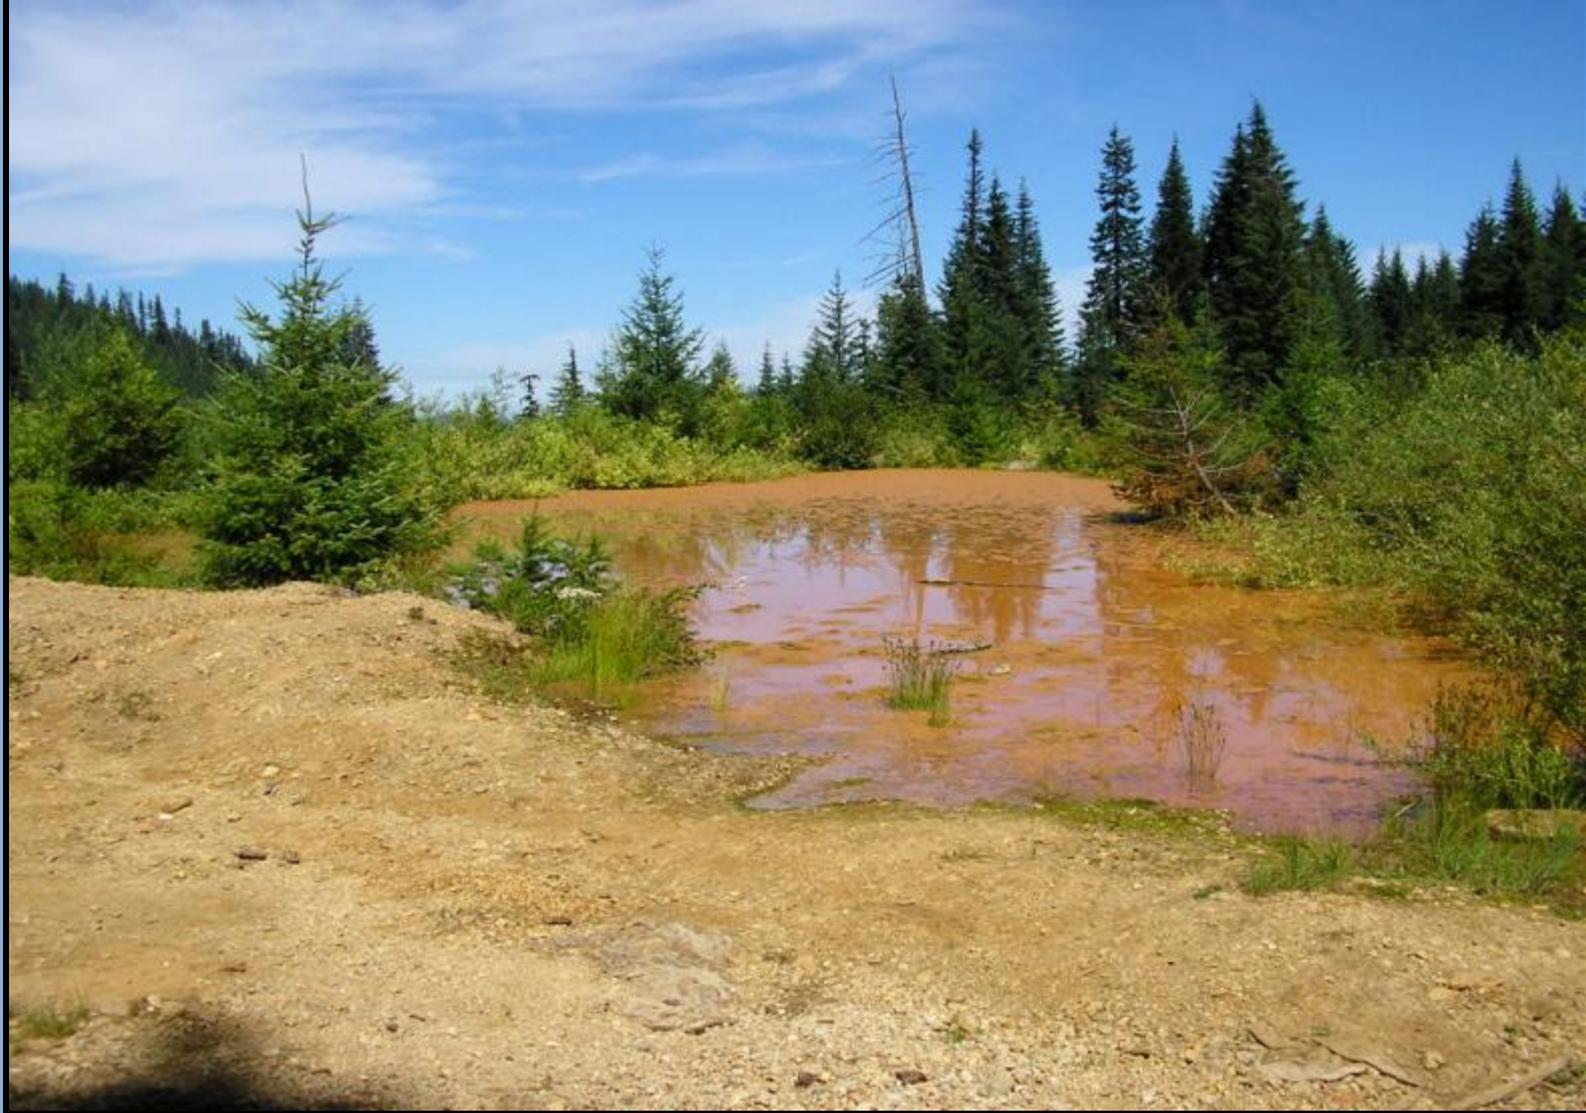
Upper Pond - Before

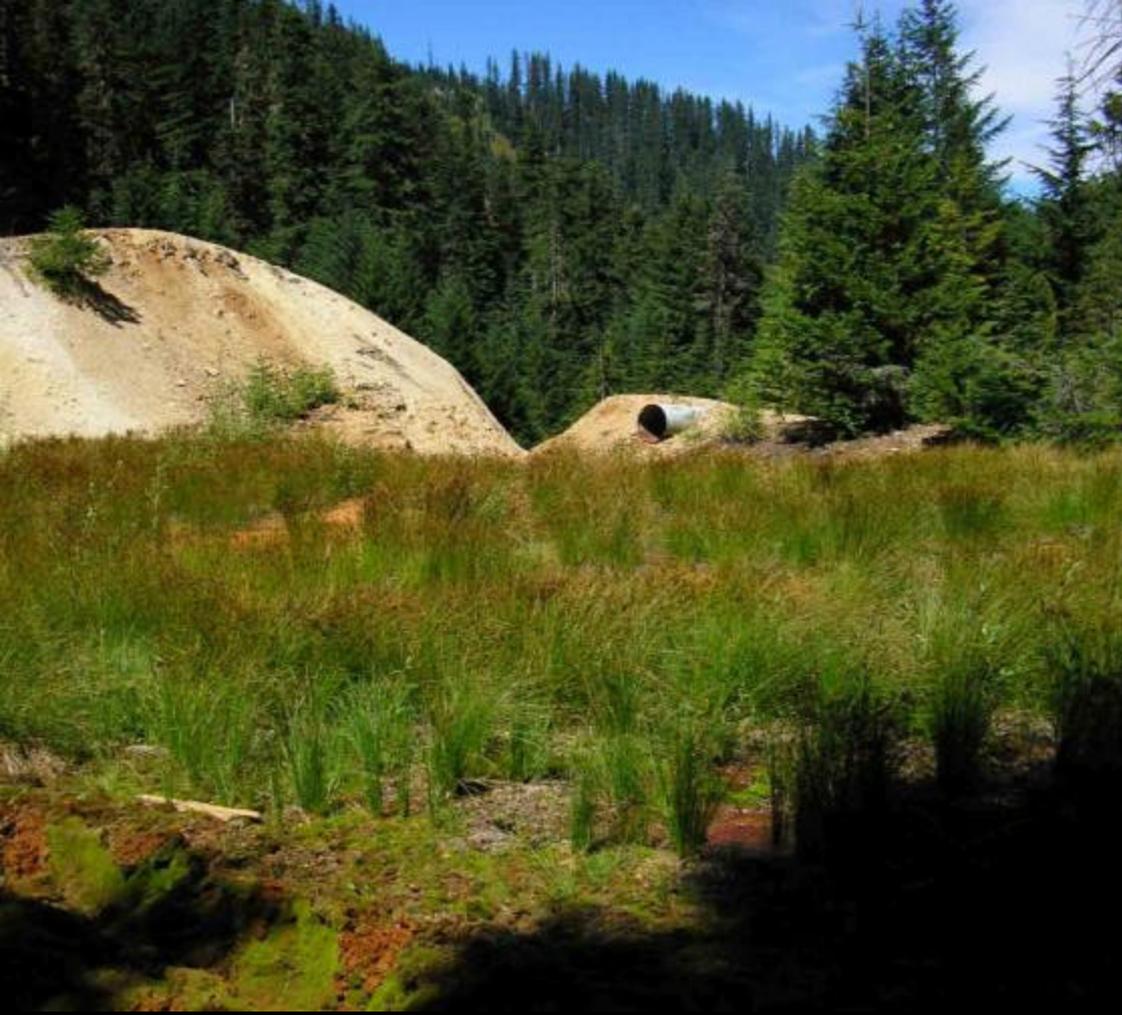
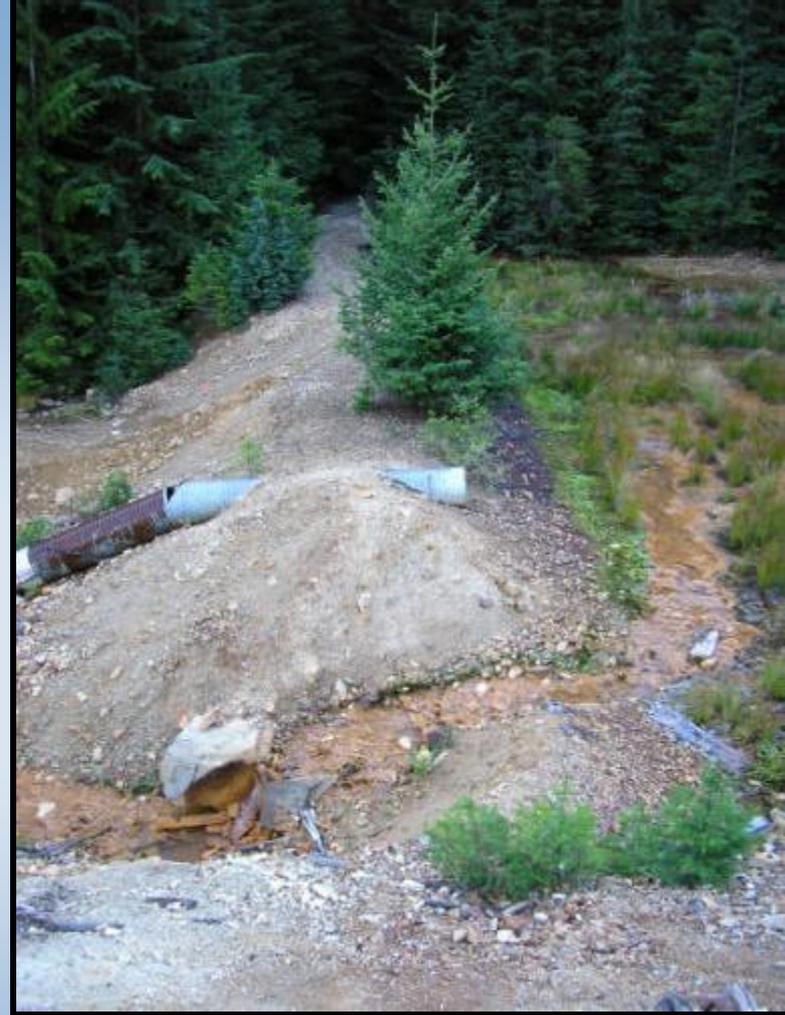
Lower Pond - Before

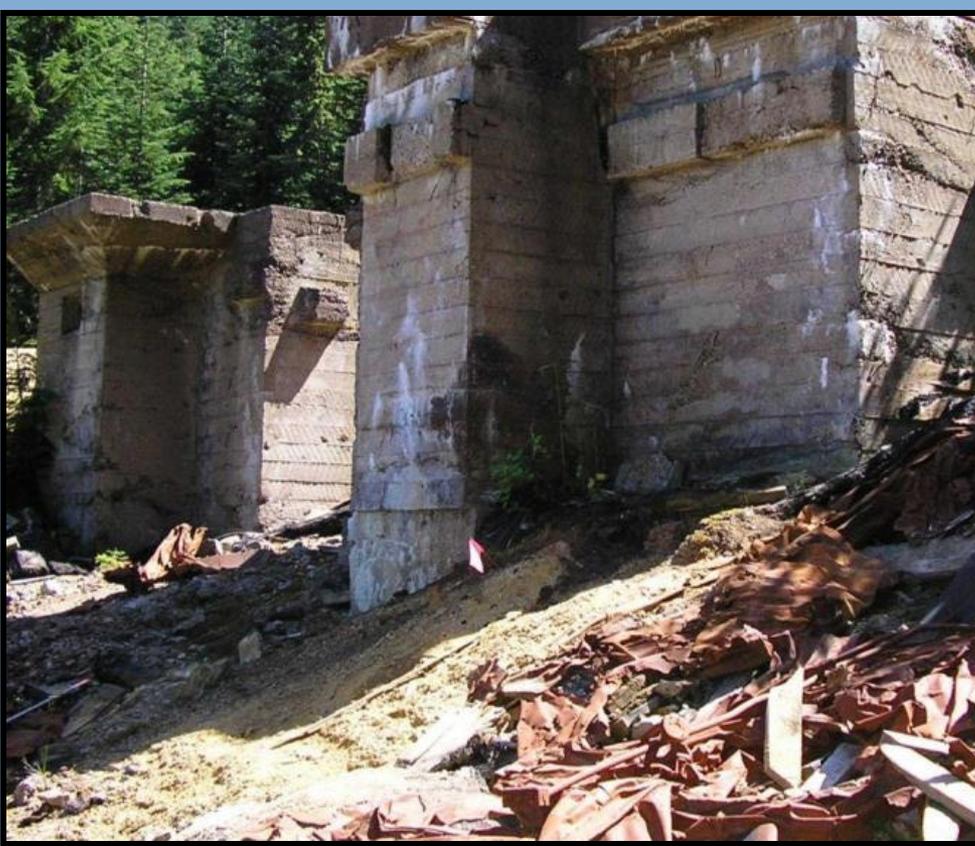
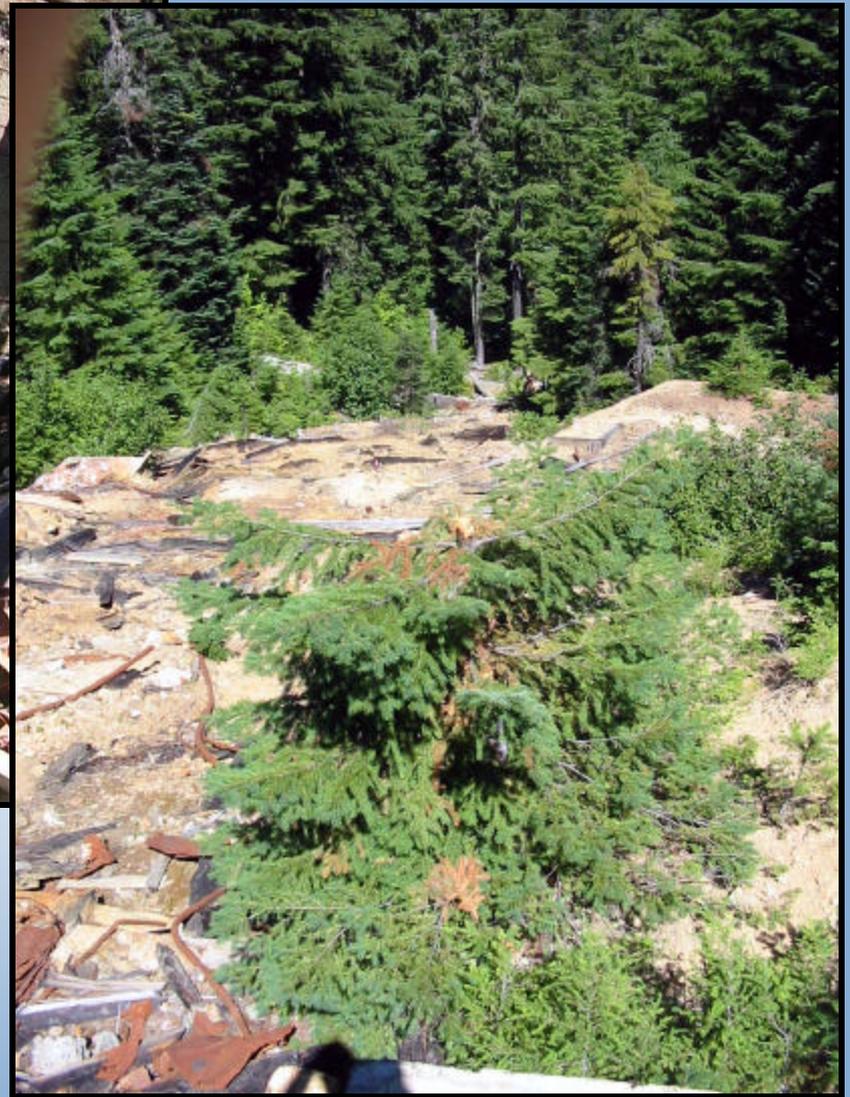
Champion Mill Foundations - Before
