Fontenelle Dam Incident, Wyoming, USA

Michael J. Gobla, P.E.

U.S. Department of the Interior
Bureau of Reclamation

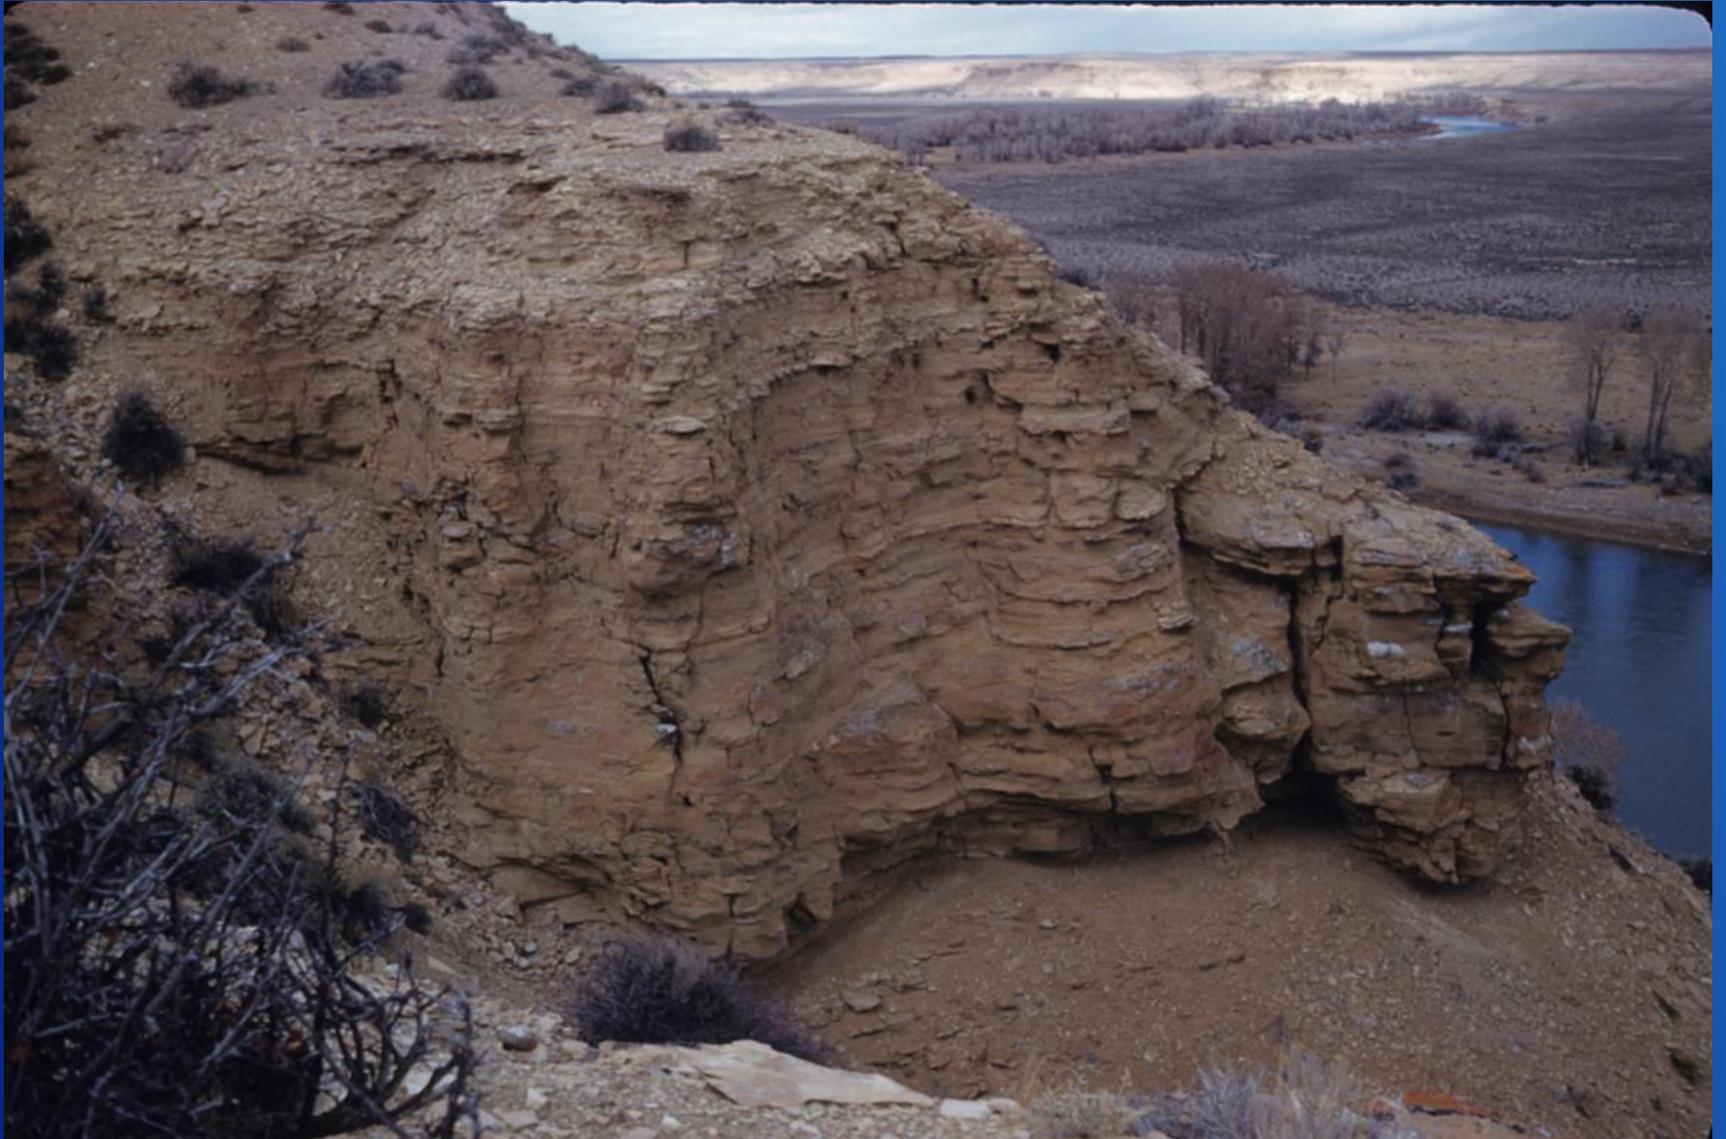
Stress Relief Joints

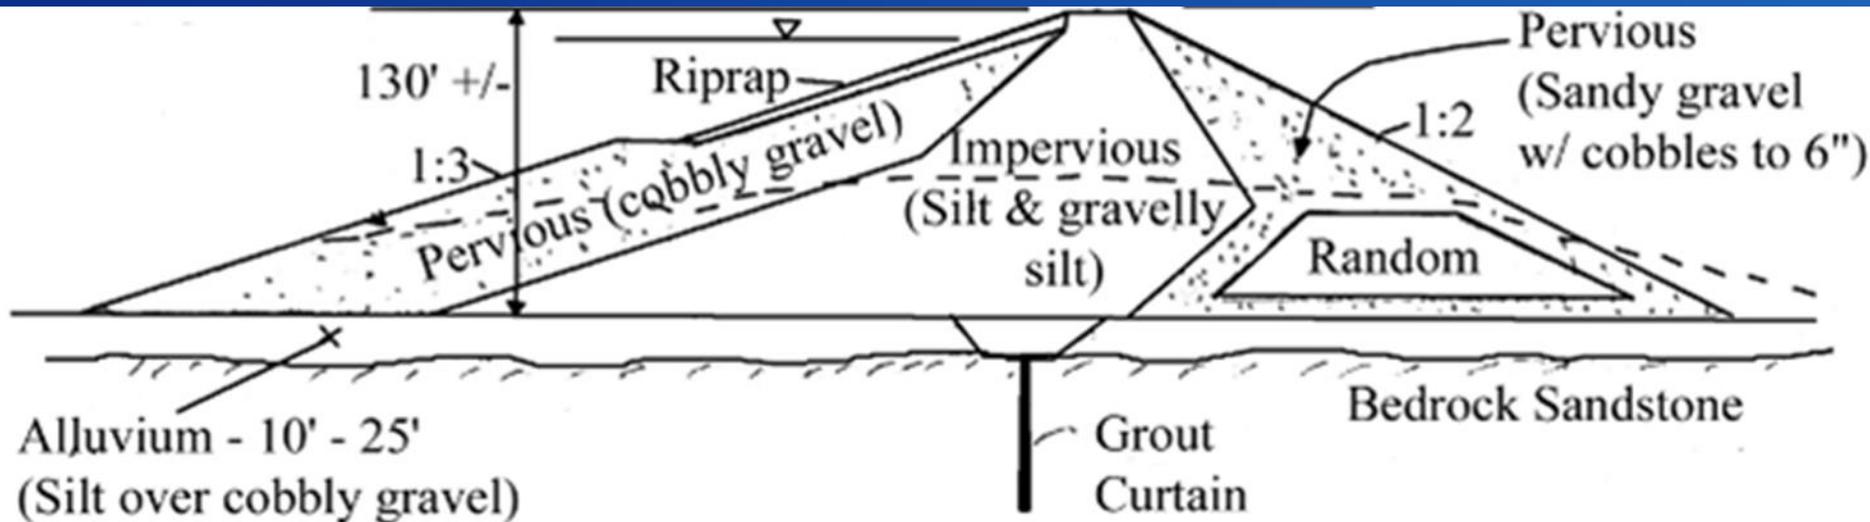
Low PI Core Material – silt, sand, gravel

Shell – sandy gravel, it should filter the core

Alluvium left under most of the dam

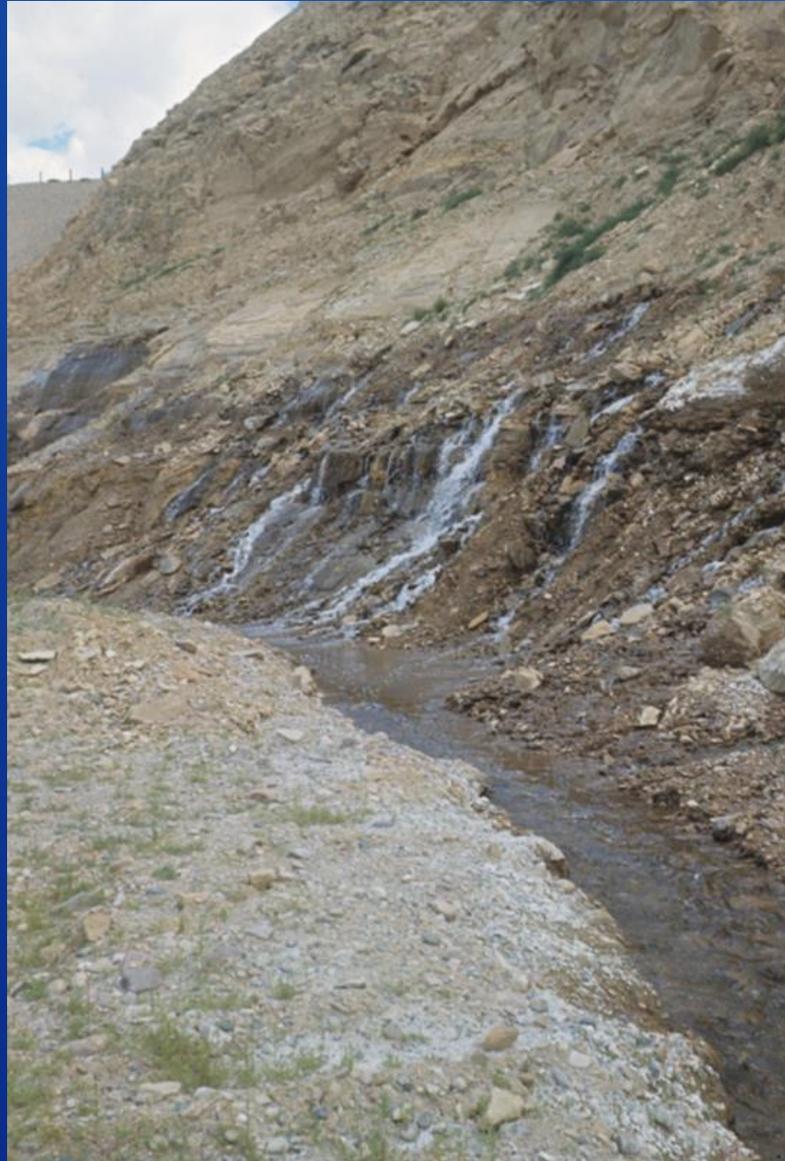
Weeping Rock

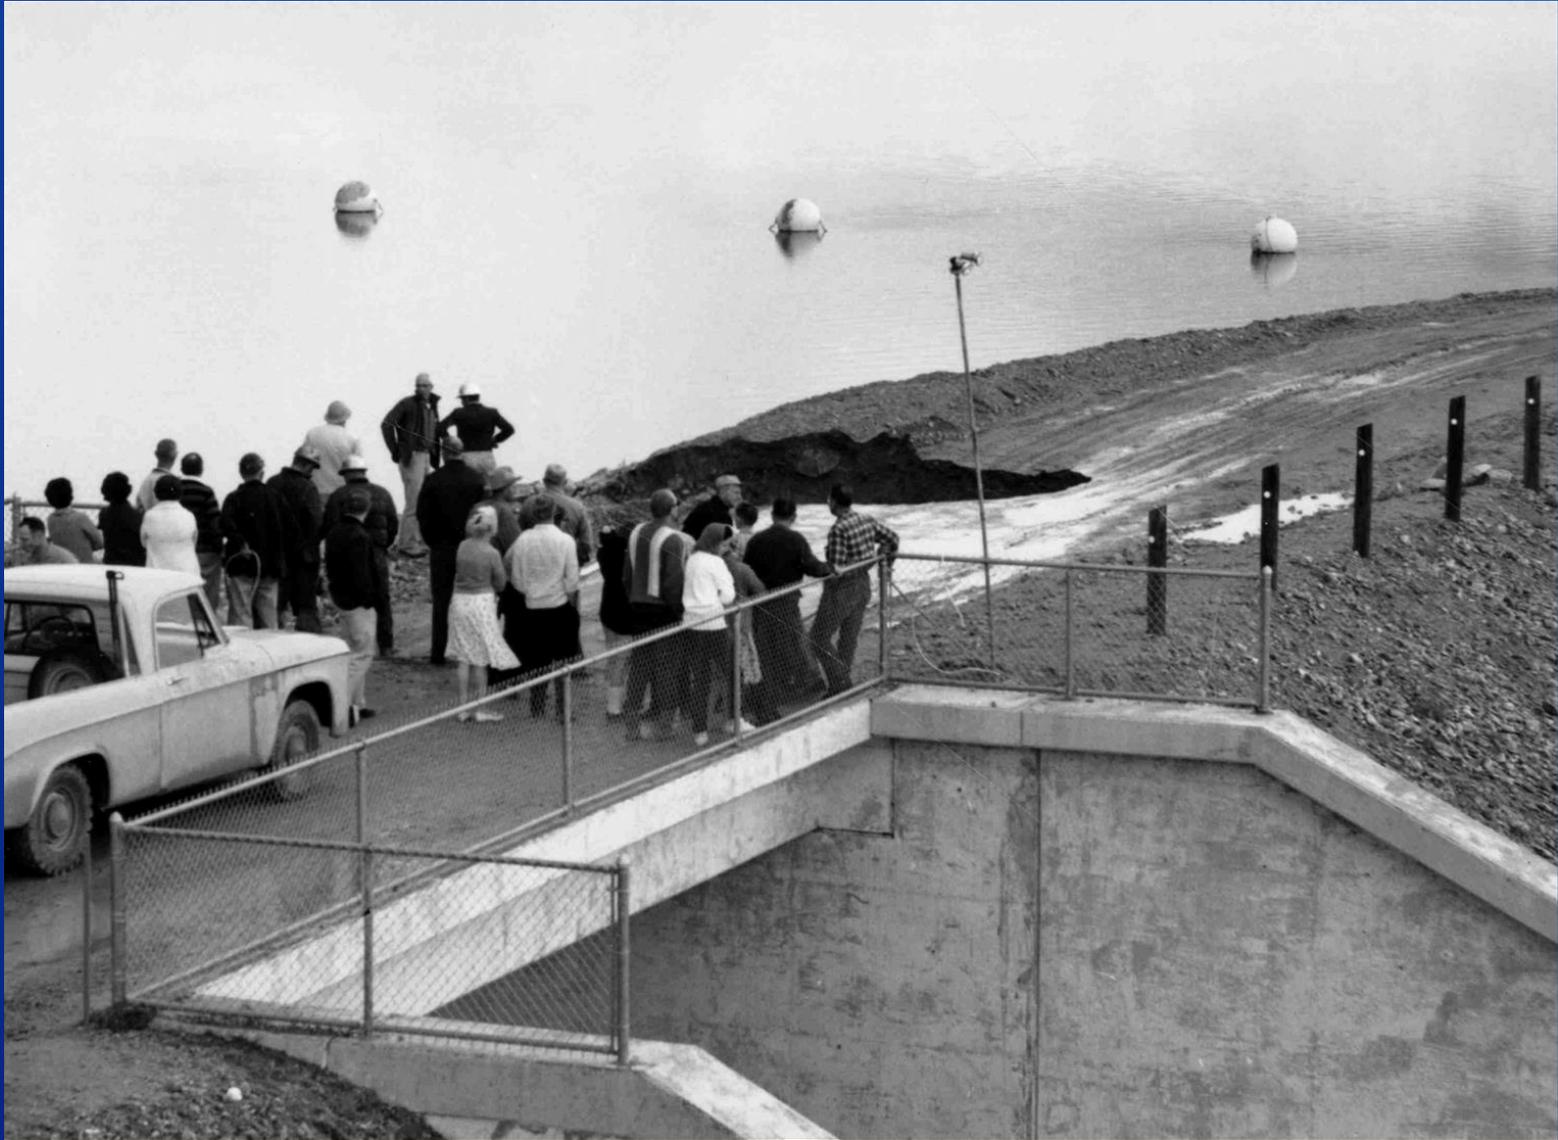
Sinkhole forming

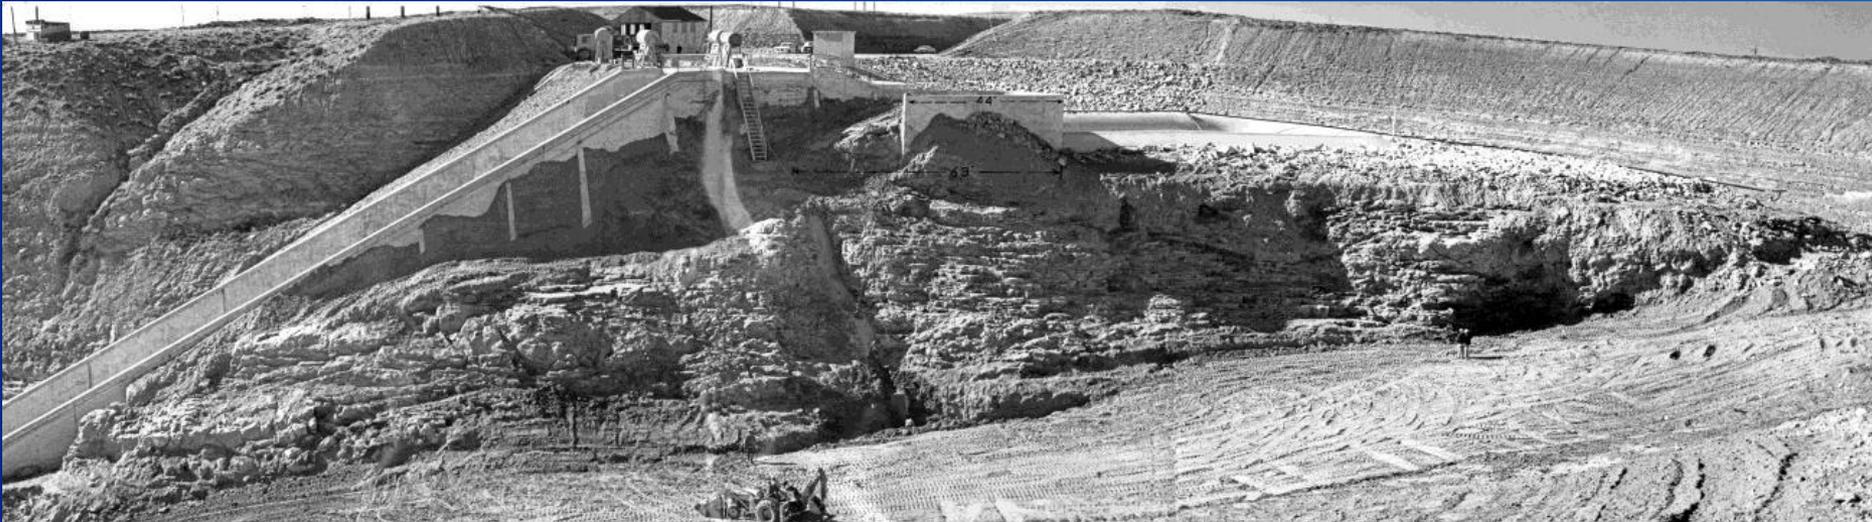
Problem is leakage through bedrock.
Excavation in November 1965

Inadequate grouting of open joints

**Affected areas excavated, more
grouting done**

Embankment replaced

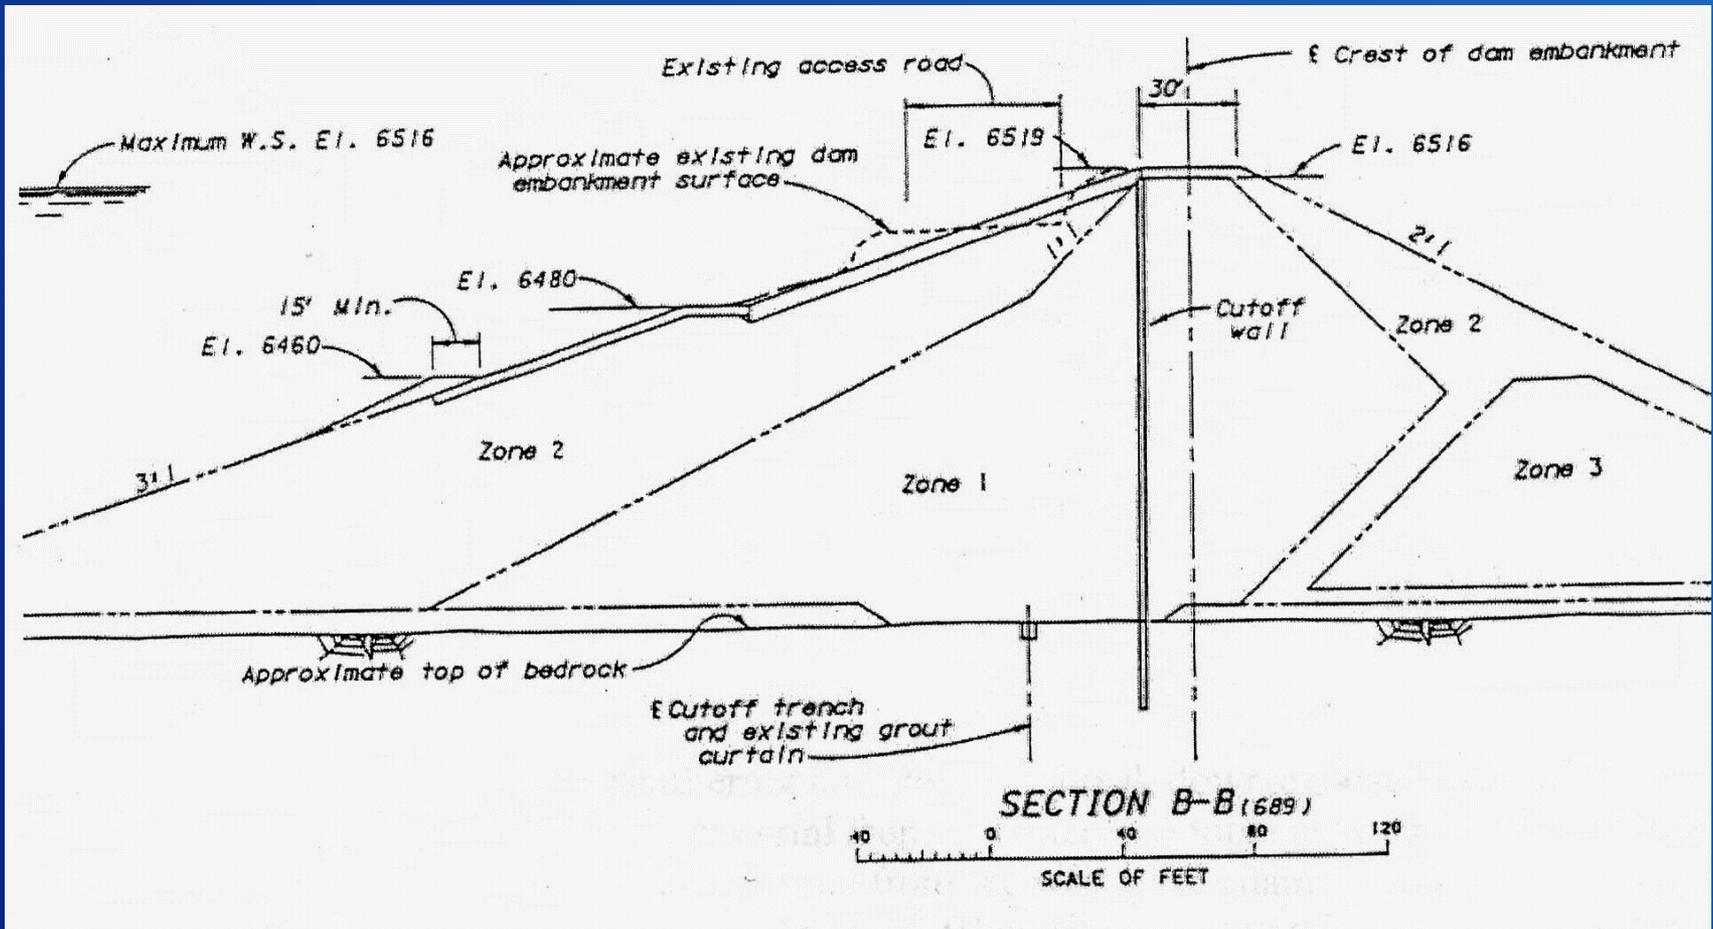
Cutoff Wall

Problem was core not properly filtered

Concrete unreinforced seepage cutoff wall built 1985-1988

Extended into bedrock 20 feet
