***2014 Mine Design, Operations & Closure
Conference***

Lessons from Kennecott Utah Copper's Manefay Slide
Cody Sutherlin, Manager Cornerstone Operations

April 2014

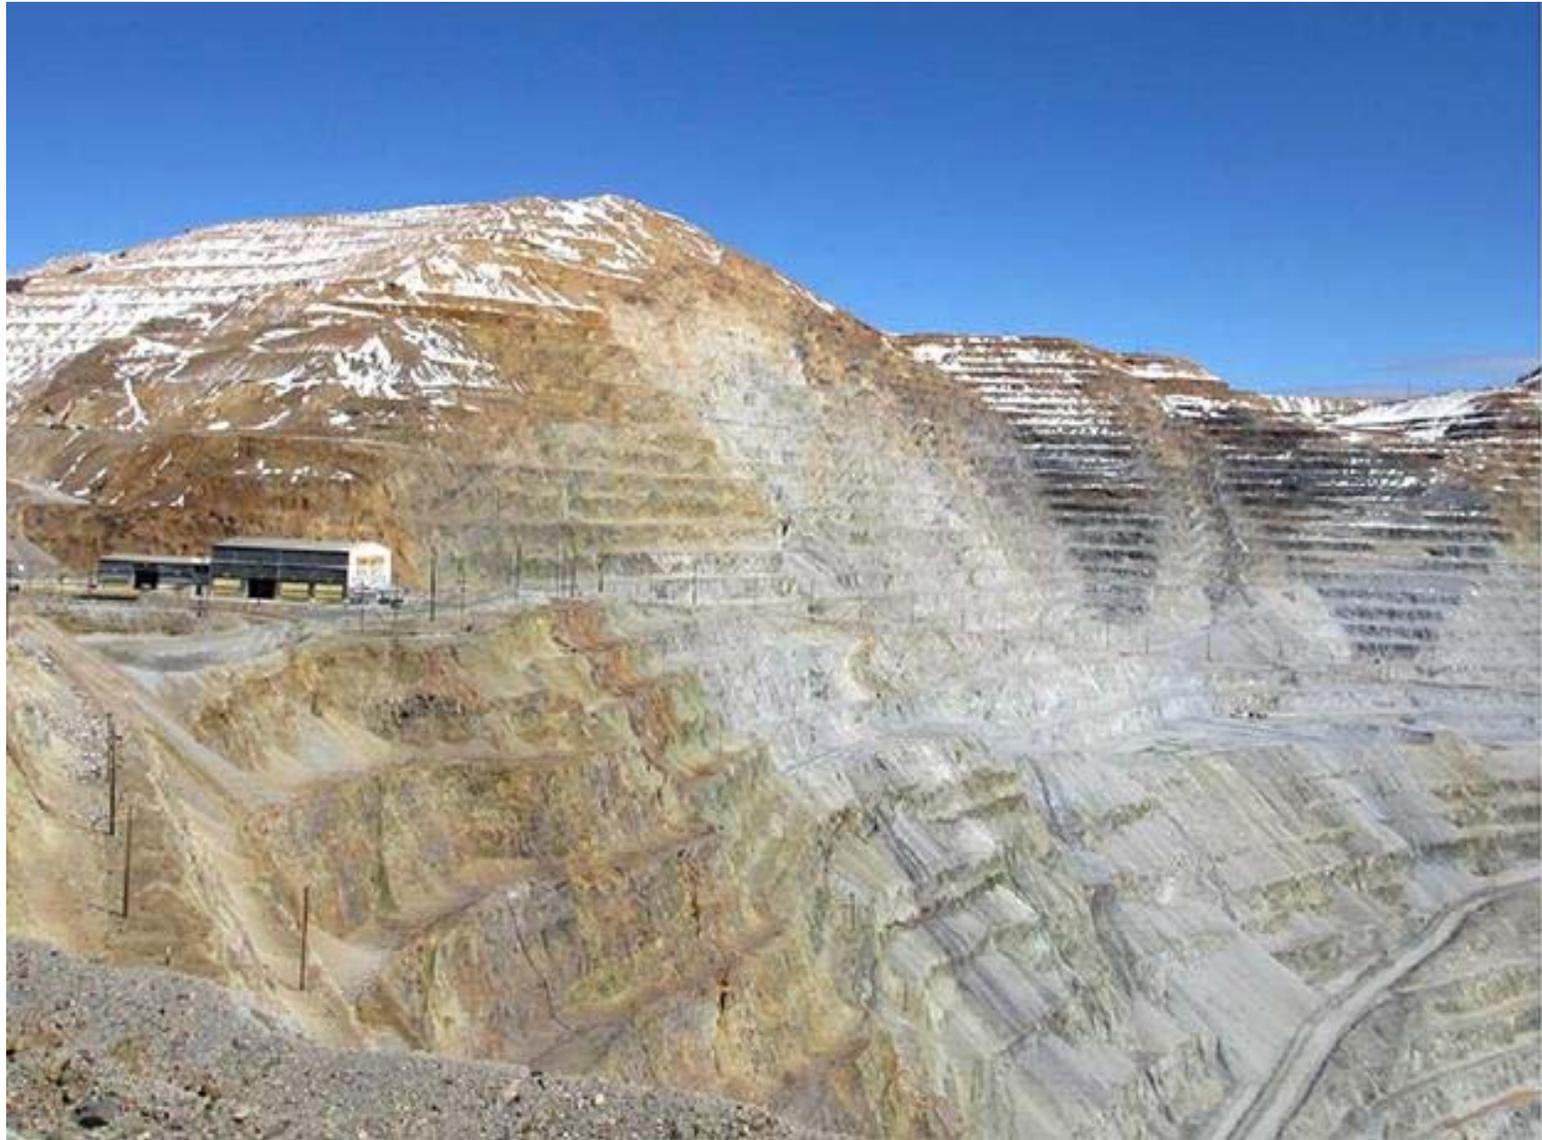
Before the Manefay Slide - April 9th 2013

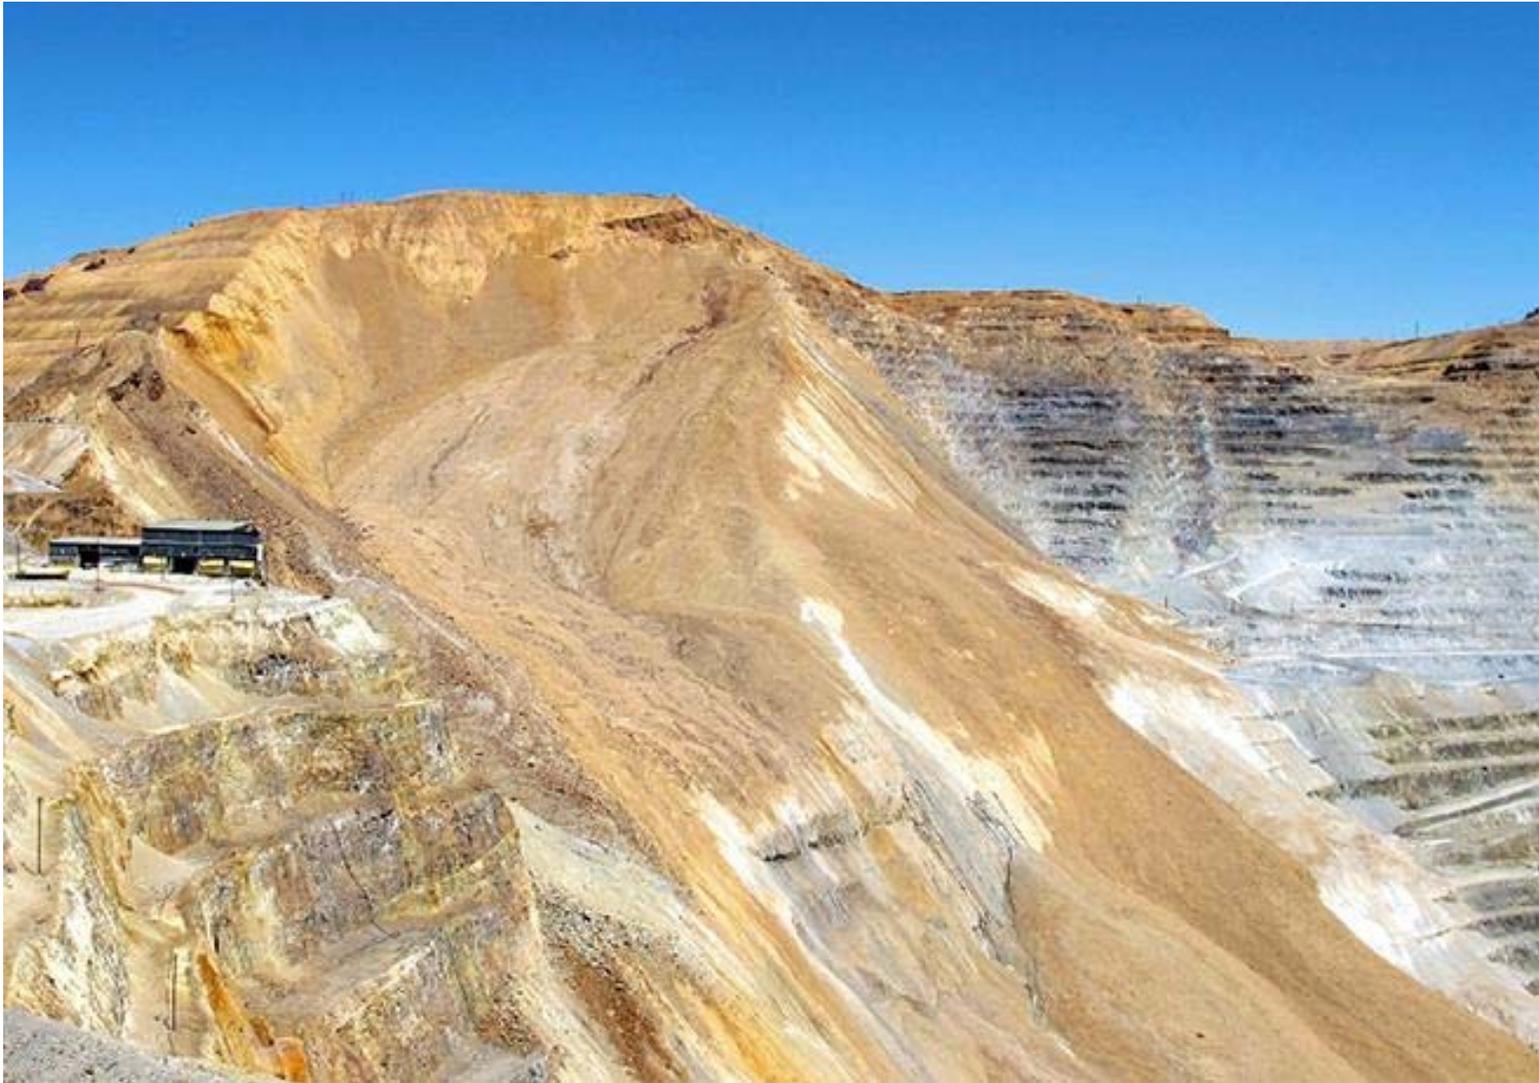
After the Manefay Slide

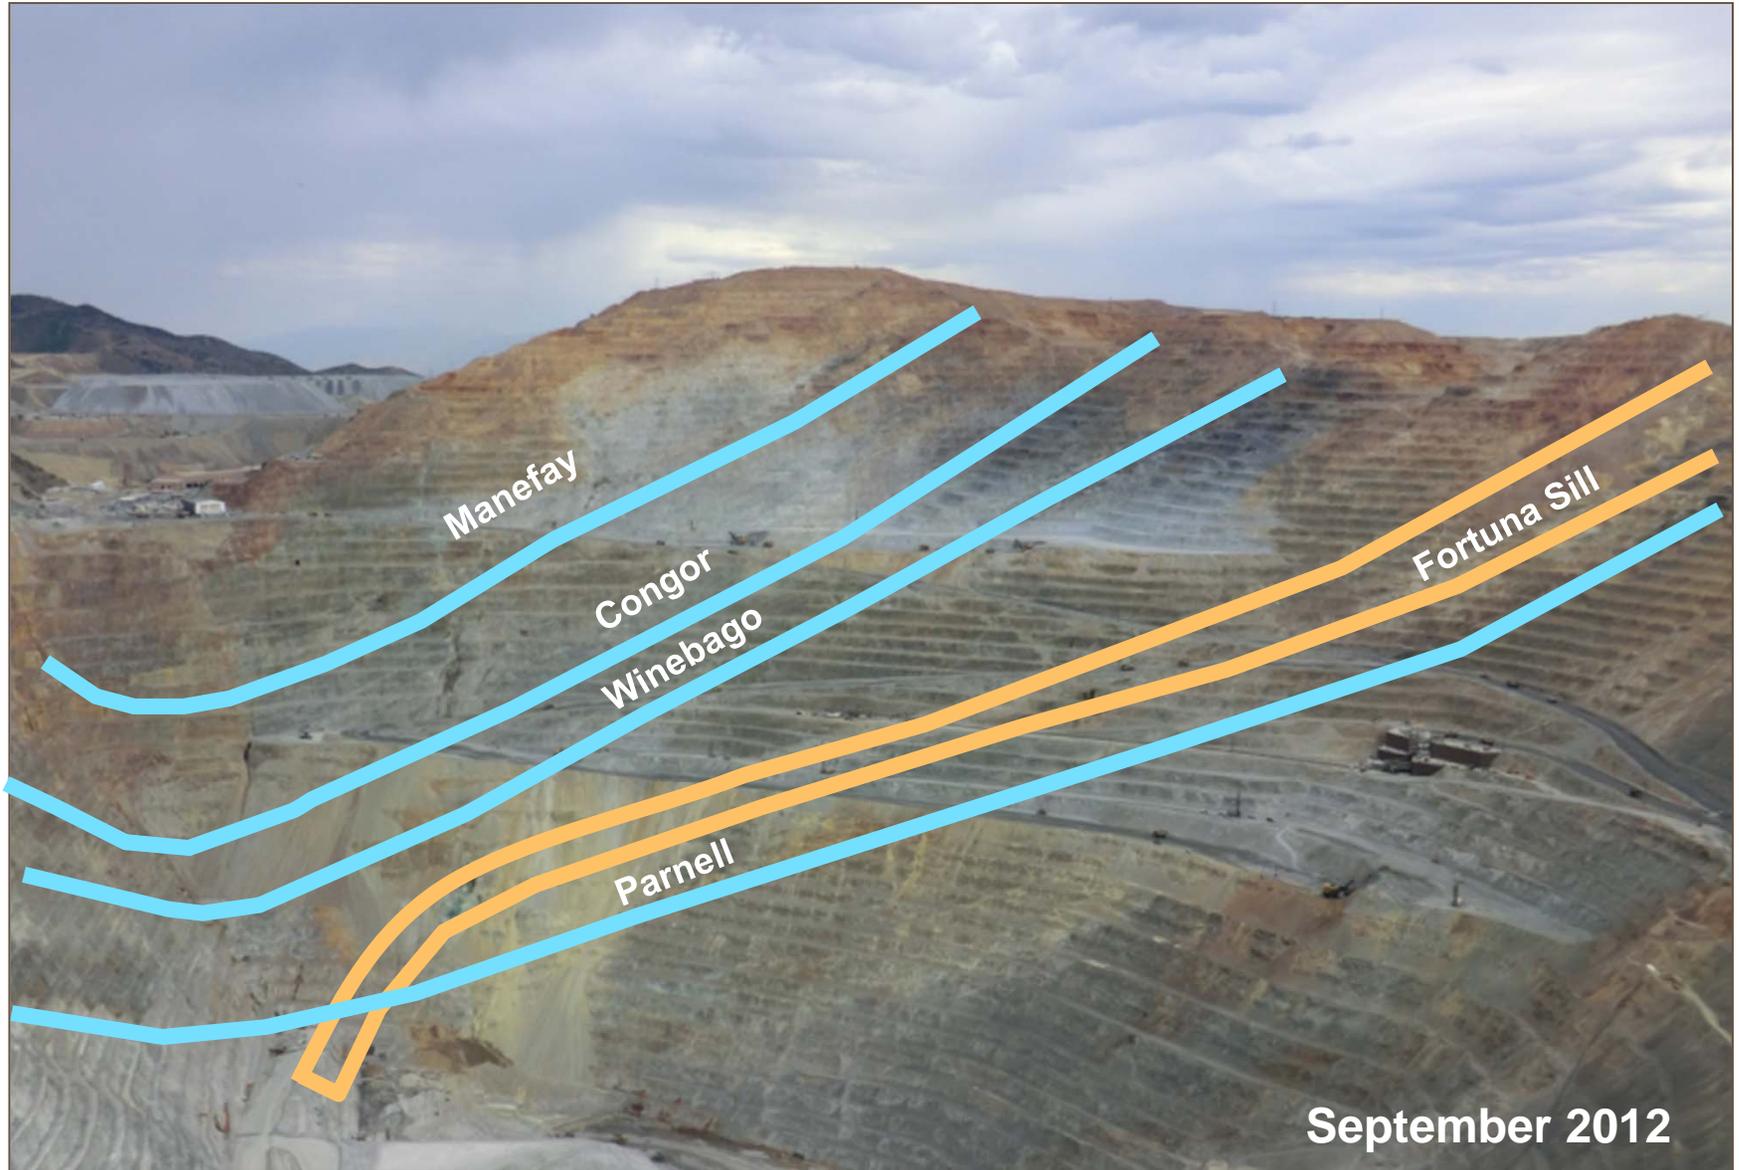
East Wall Geology

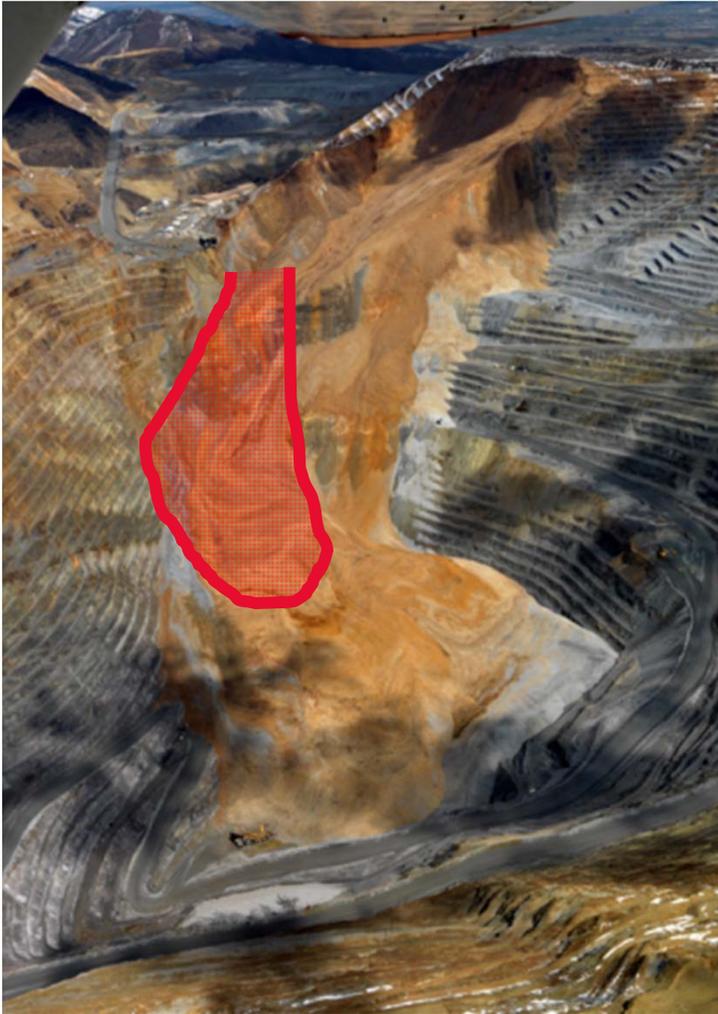
Expected Impact Area
10% of pit floor covered

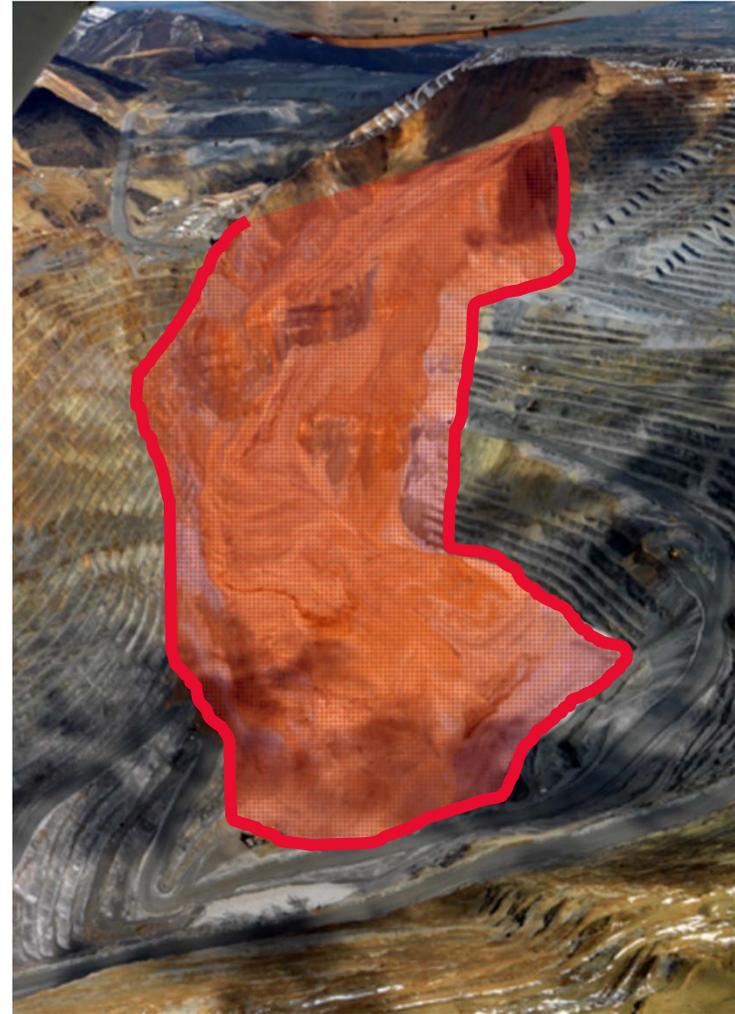
Actual Impact Area
95% of pit floor covered

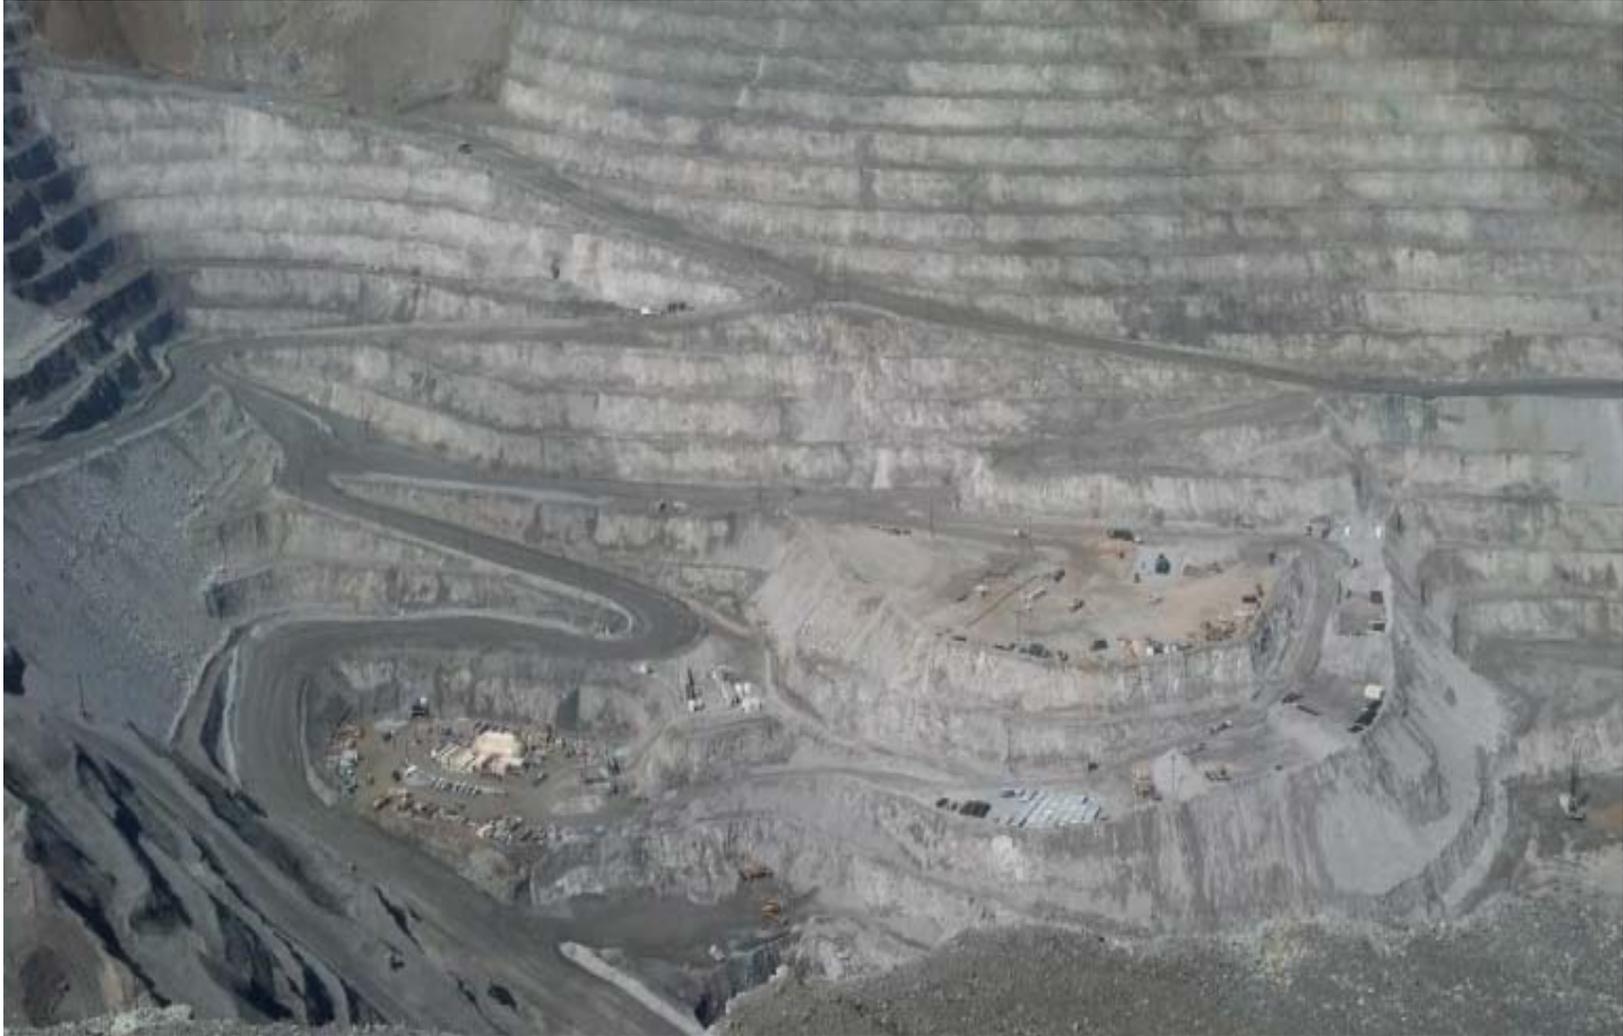
Pre-Incident Photo of West Pit Floor

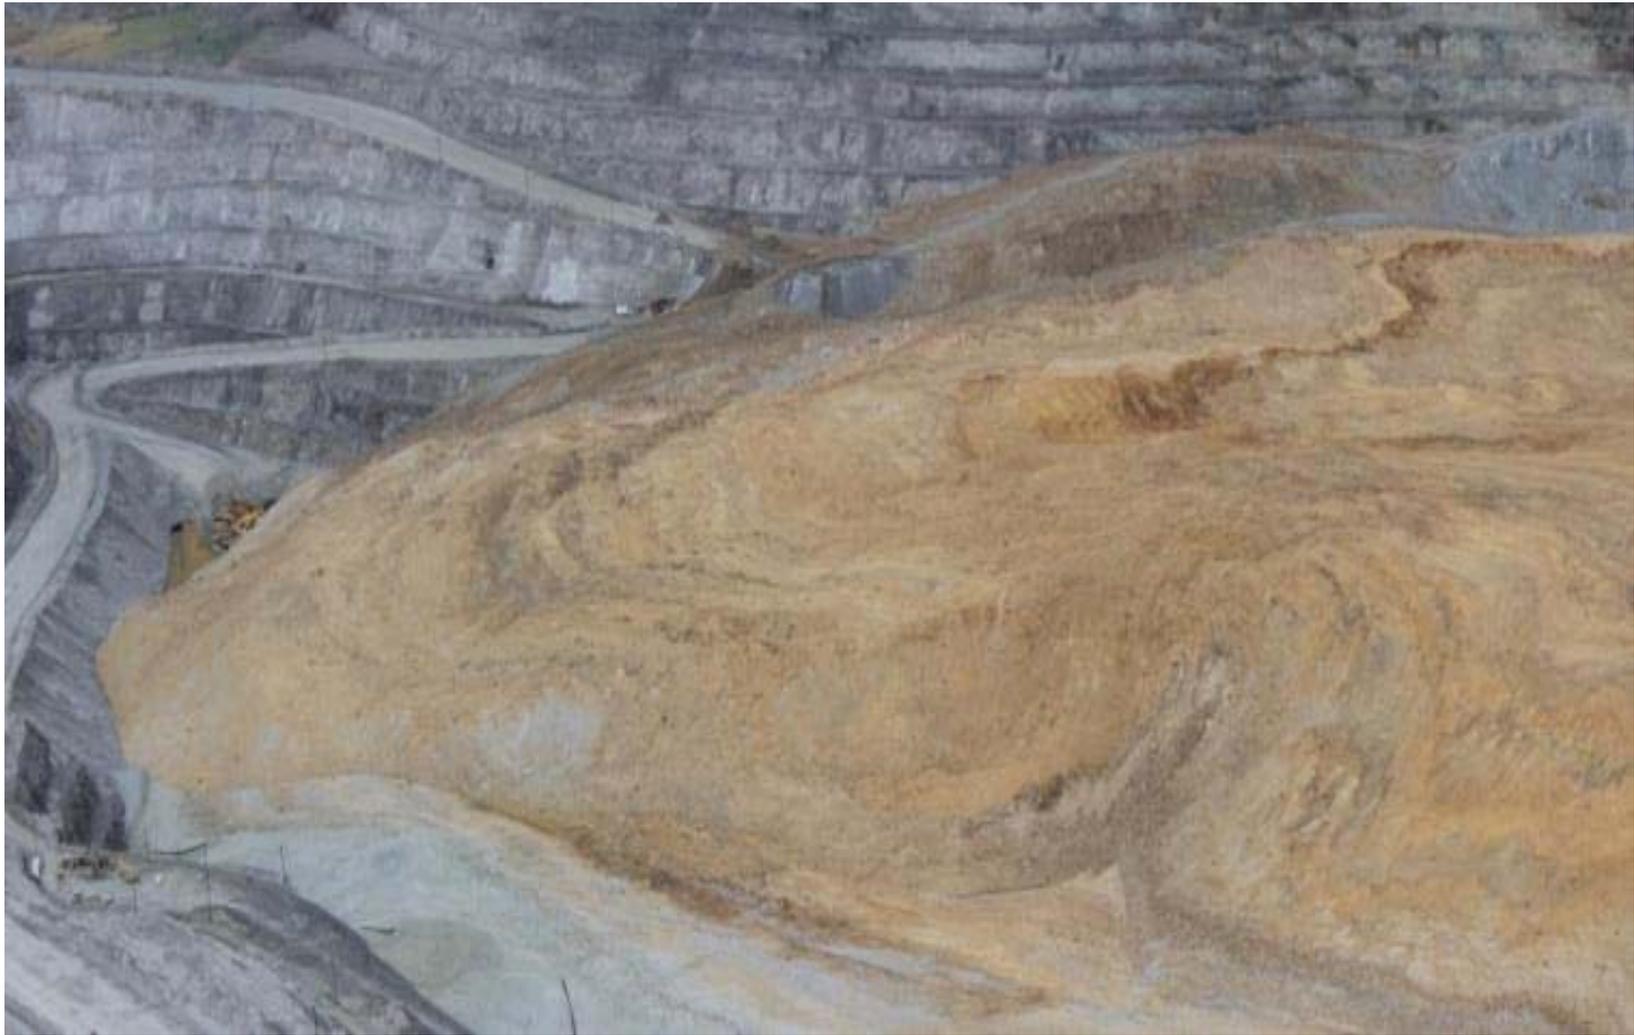
Post-Incident Photo of West Pit Floor

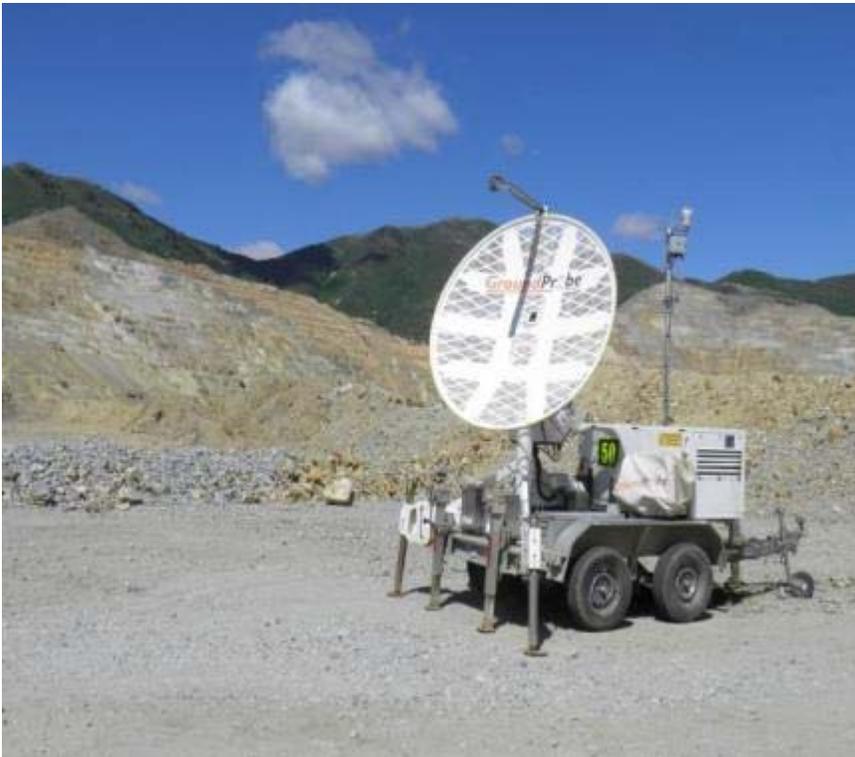
Nine layers of protection

The Geotechnical monitoring system at the Bingham Canyon Mine provides nine layers of safety, mitigating a potentially catastrophic event during Manefay slide

- 1) 800+ trained eyes everywhere
- 2) Routine documented inspections
- 3) IBIS slope stability radars
- 4) GroundProbe slope stability radars
- 5) 300+ Prism network and five RTS skyboxes
- 6) Time Domain Reflectometry
- 7) GPS Monitoring
- 8) Extensometers
- 9) Micro seismic array

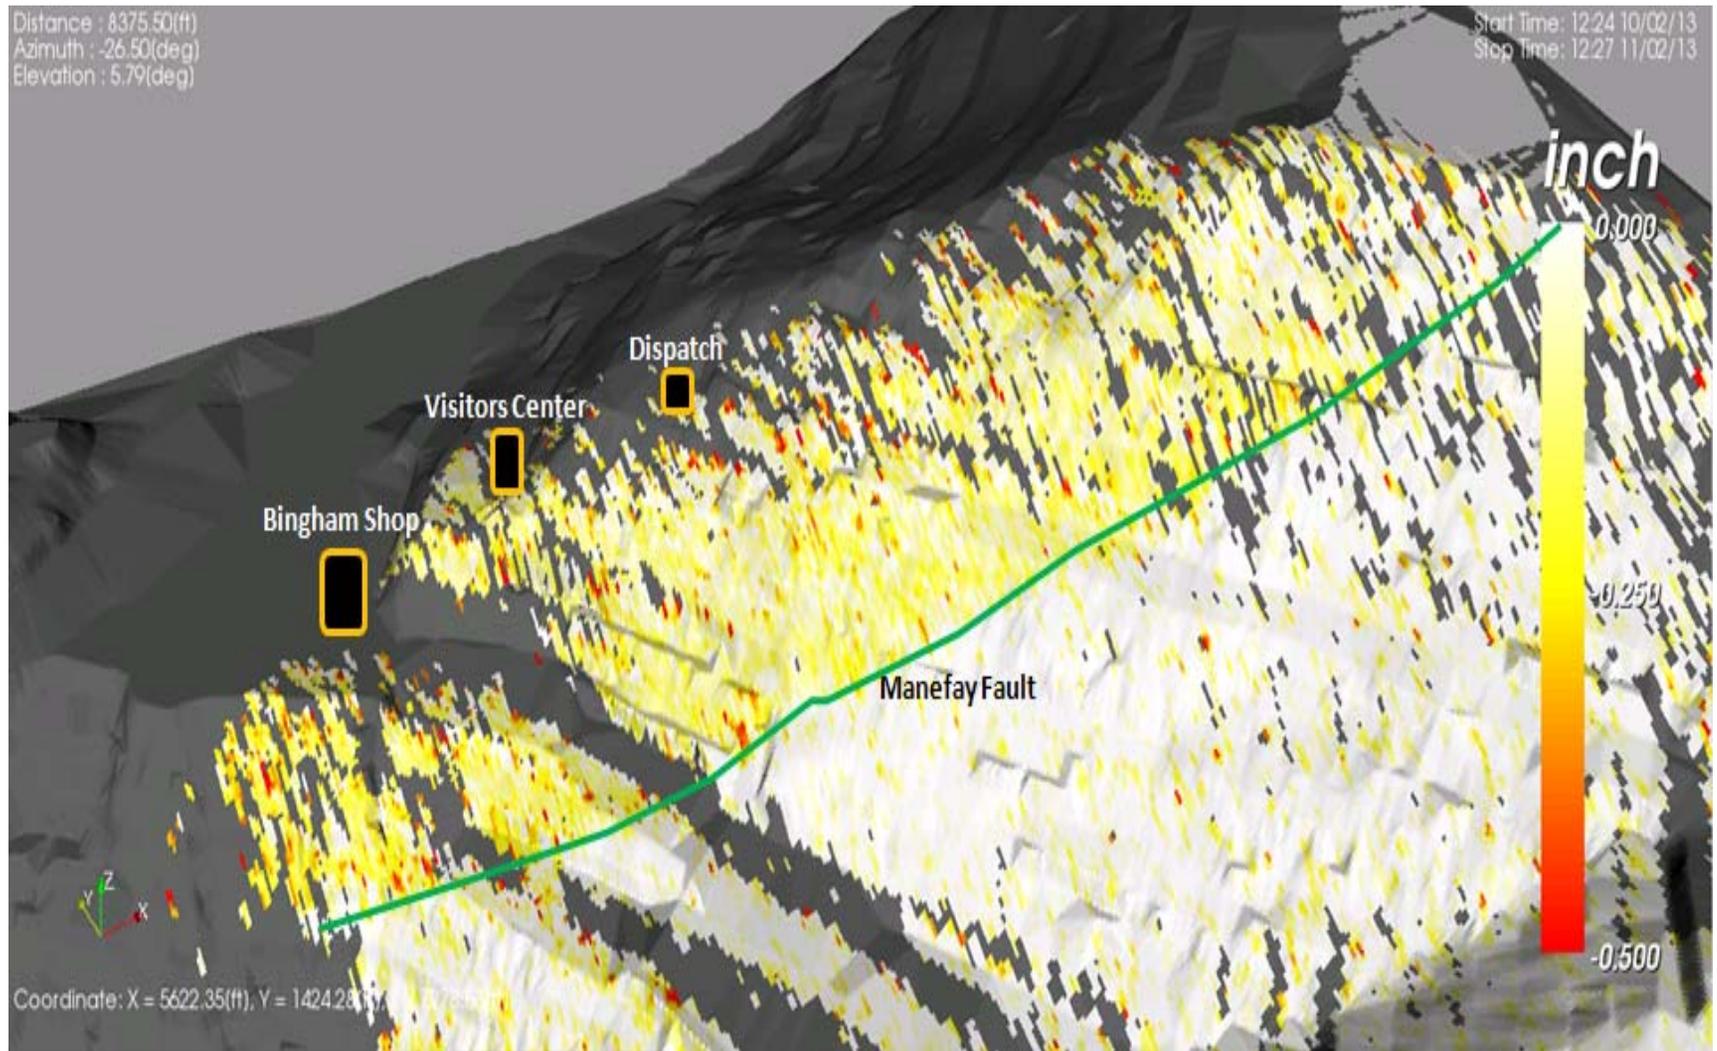
IBIS radar Manefay data

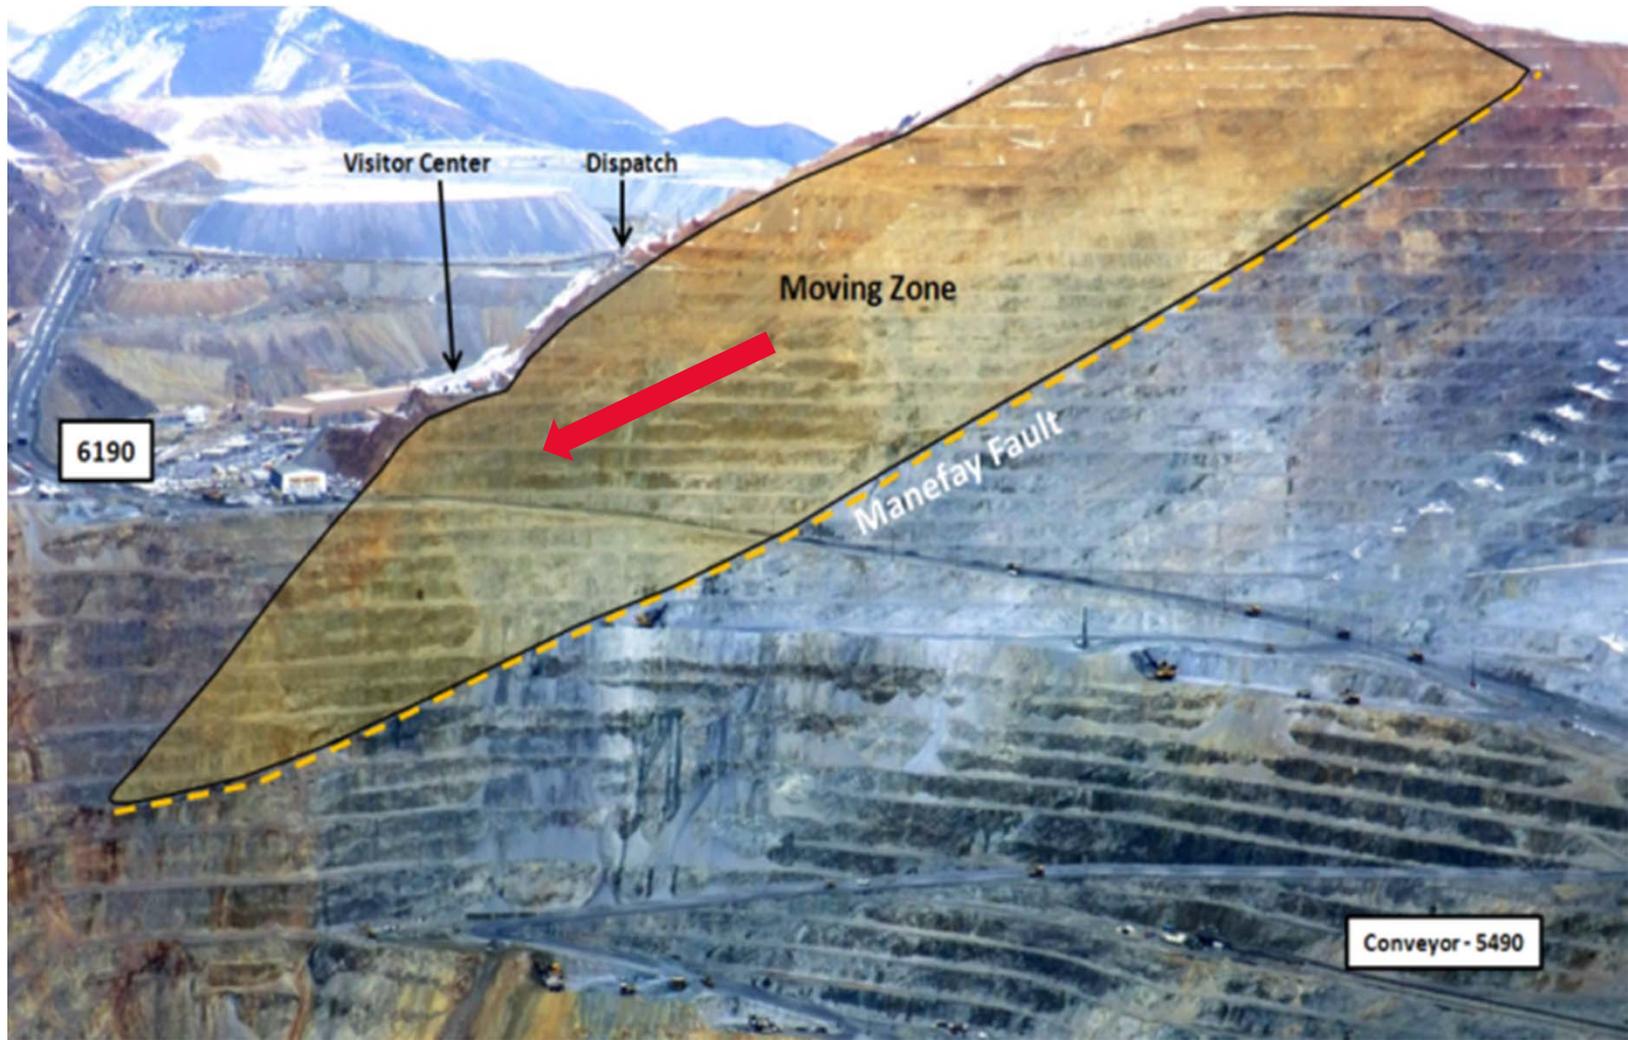
IBIS Radar Manefay Movement

Pre-incident movement zone

Consolidated movement estimated to exceed 100 million tons

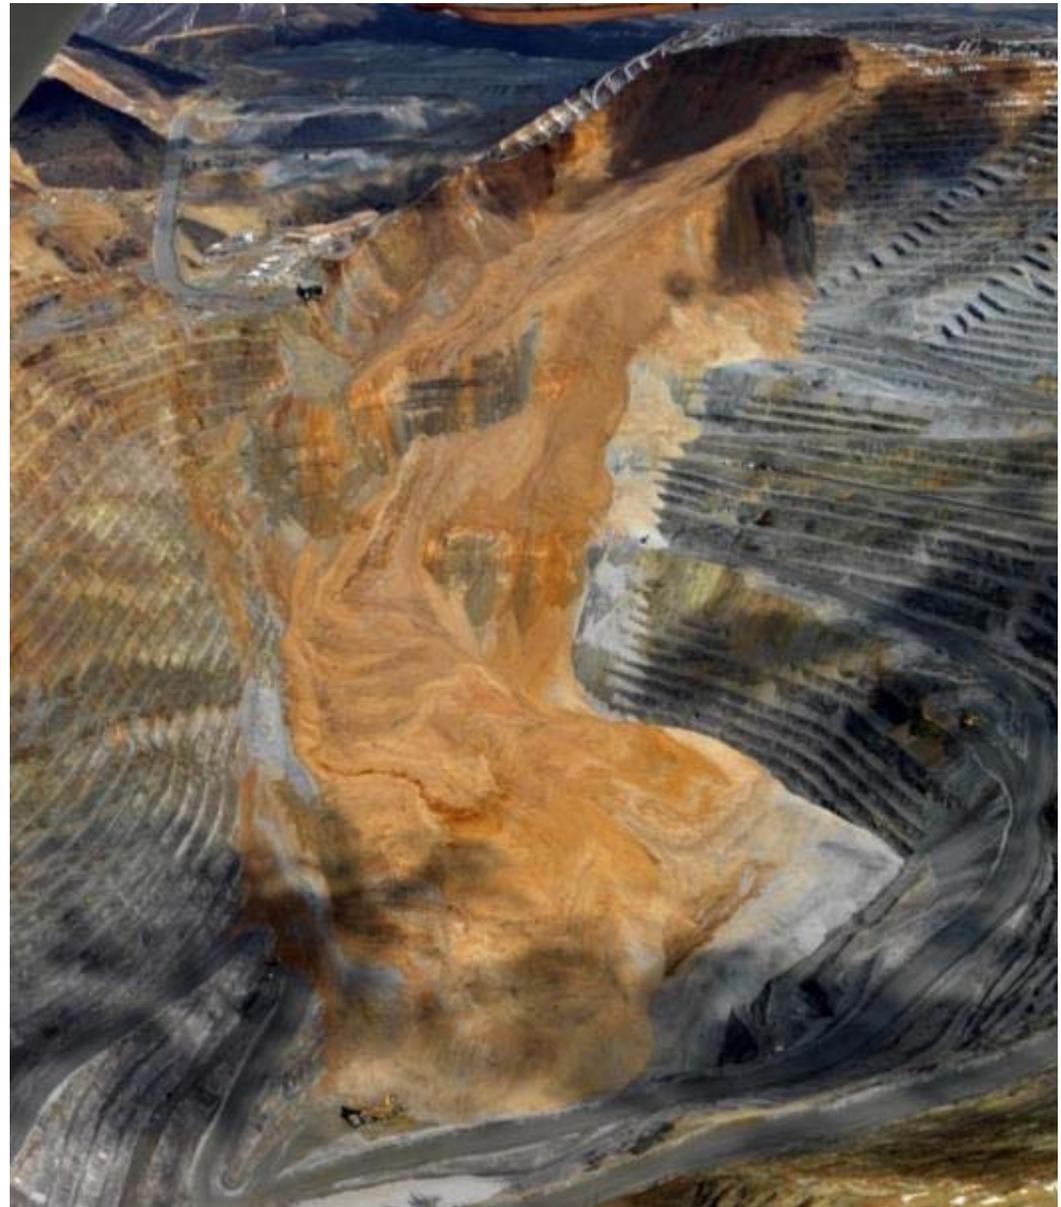
+400ft Vertical Scarps

Remaining Rock mass
on slide plane – Poss.
Of 20Mt failure

Truck Shop Destroyed

Pit Access Road
Destroyed +1500ft

More than 2000
vertical feet of covered
benches

Bottom of pit covered
+300ft deep

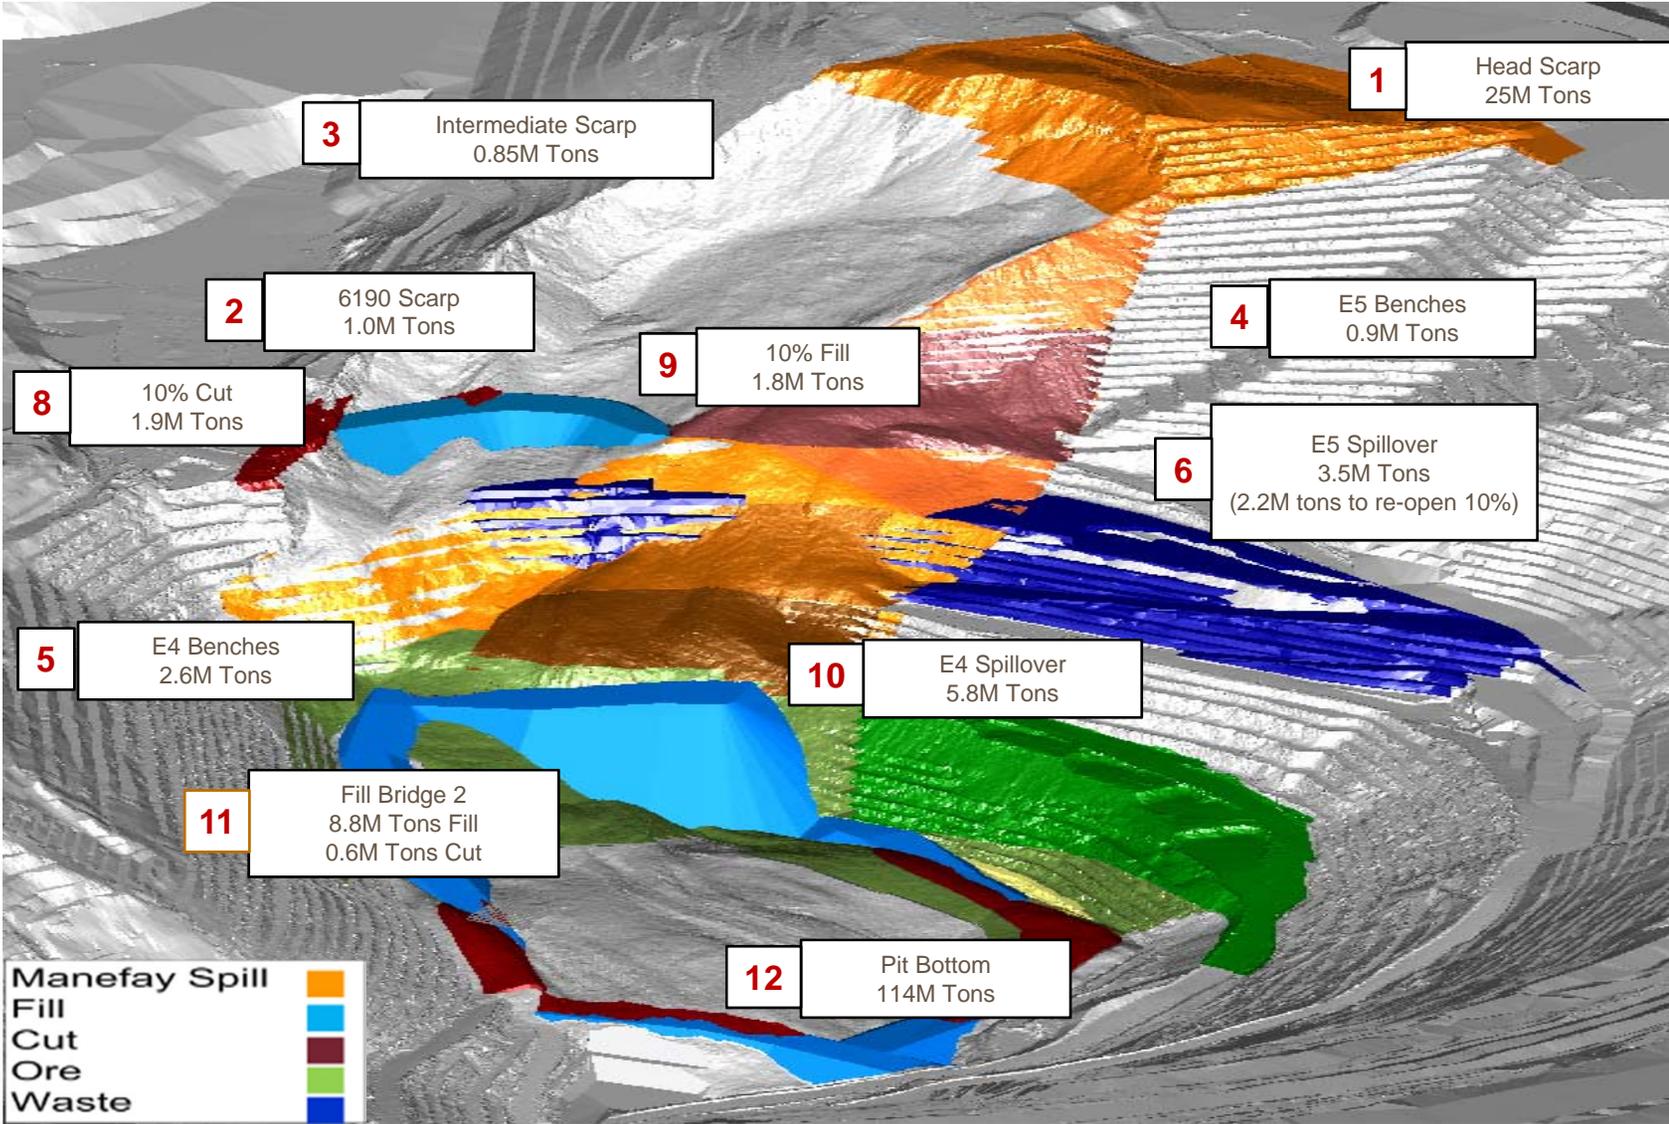
Slide Remediation Workstreams

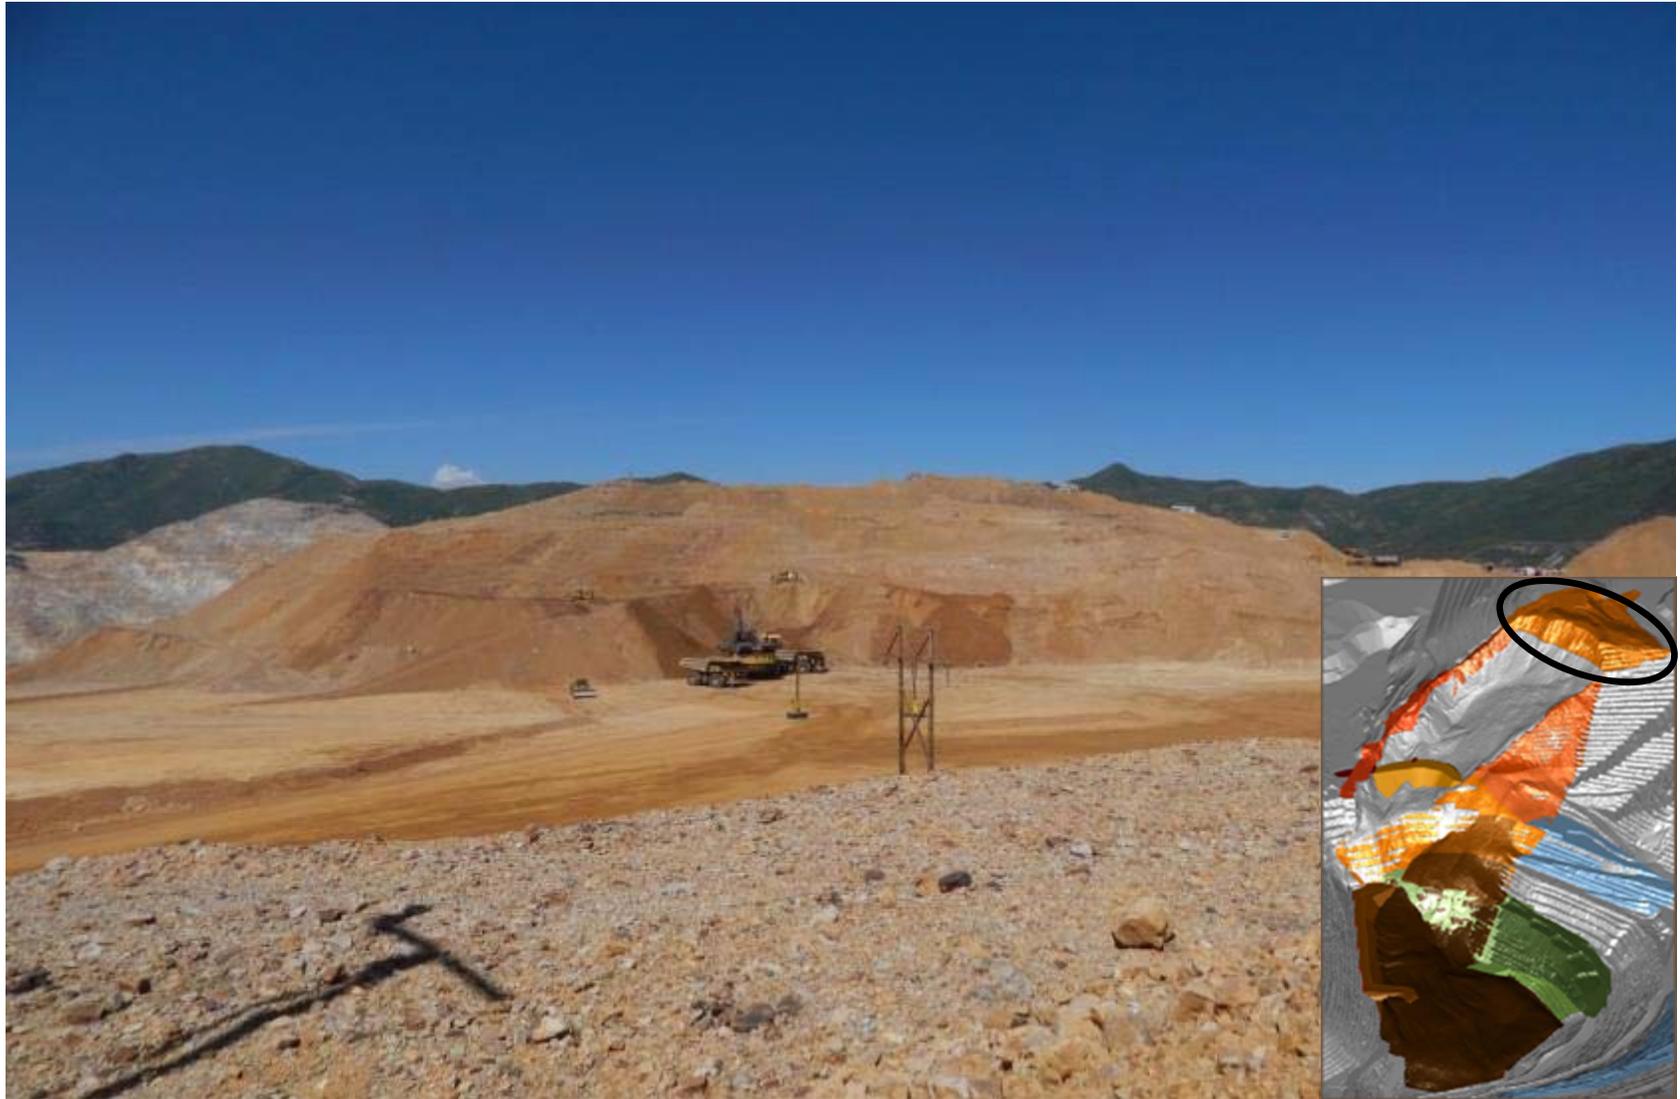
Head Scarp Mining – May 2013

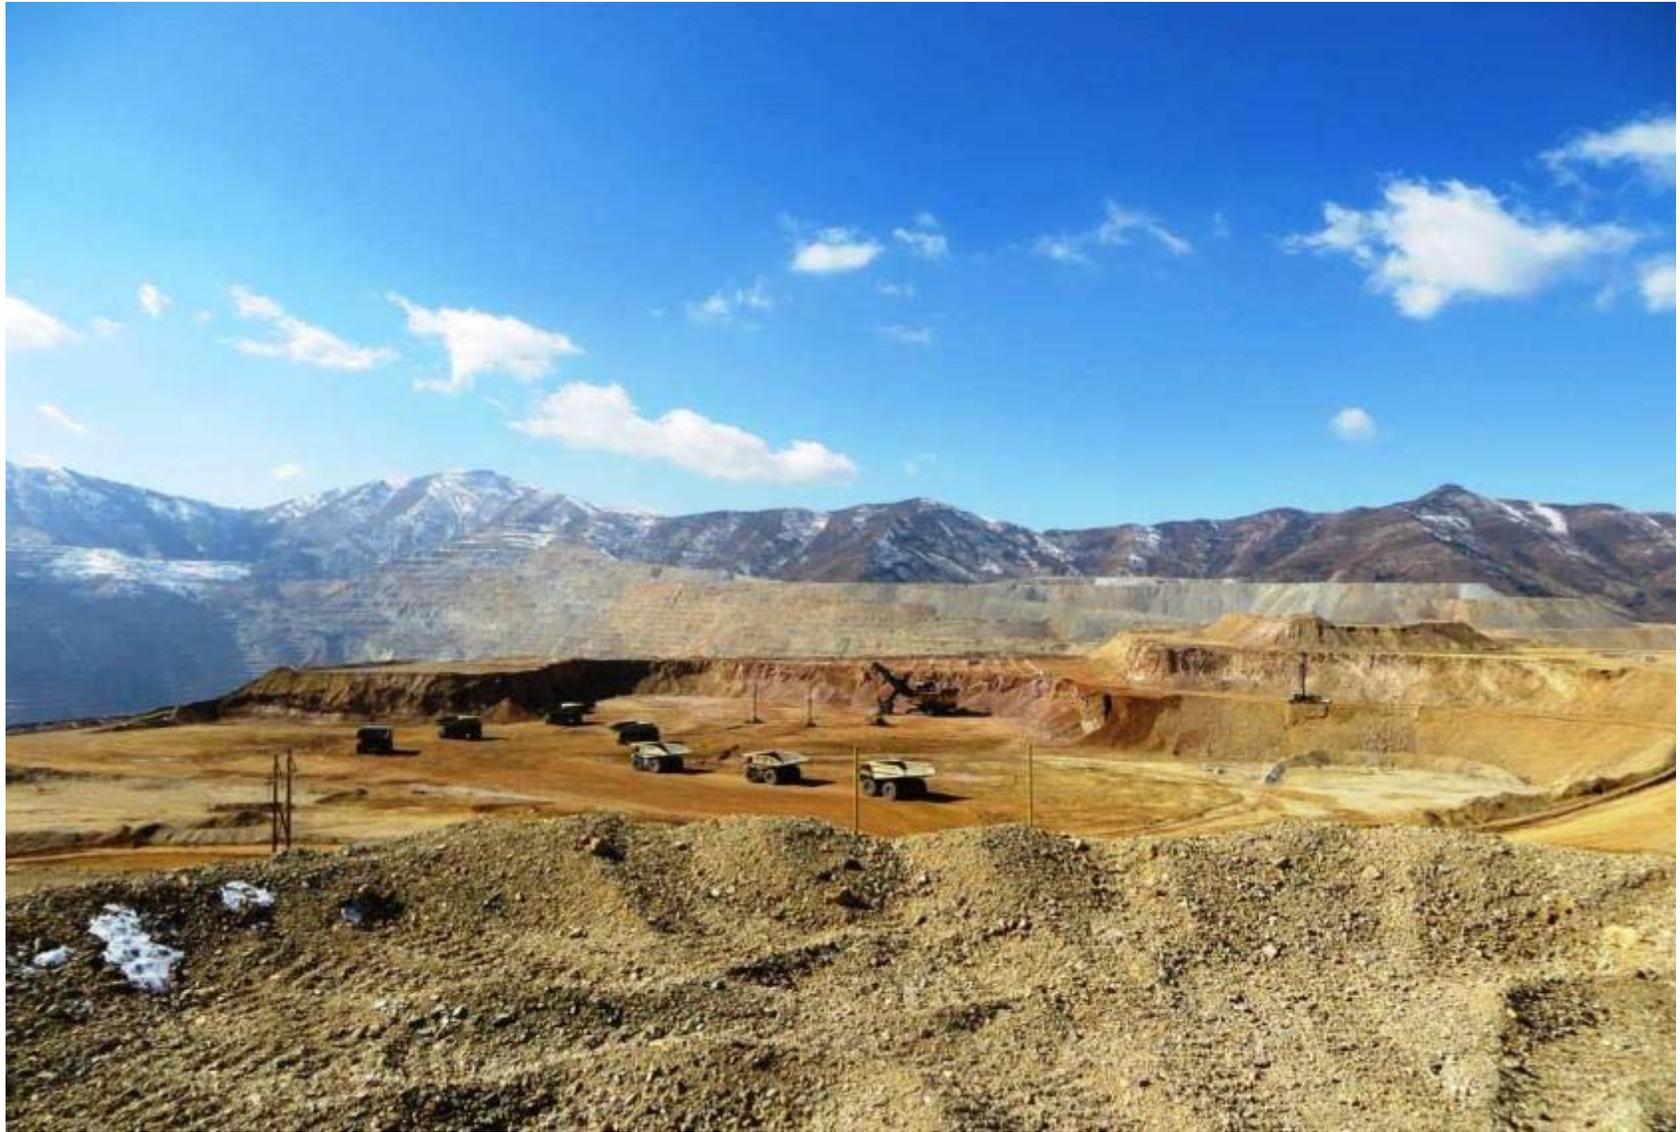
Head Scarp Mining – September 2013
