***2014 Mine Design, Operations & Closure
Conference***

Lessons from Kennecott Utah Copper's Manefay Slide
Cody Sutherlin, Manager Cornerstone Operations

April 2014

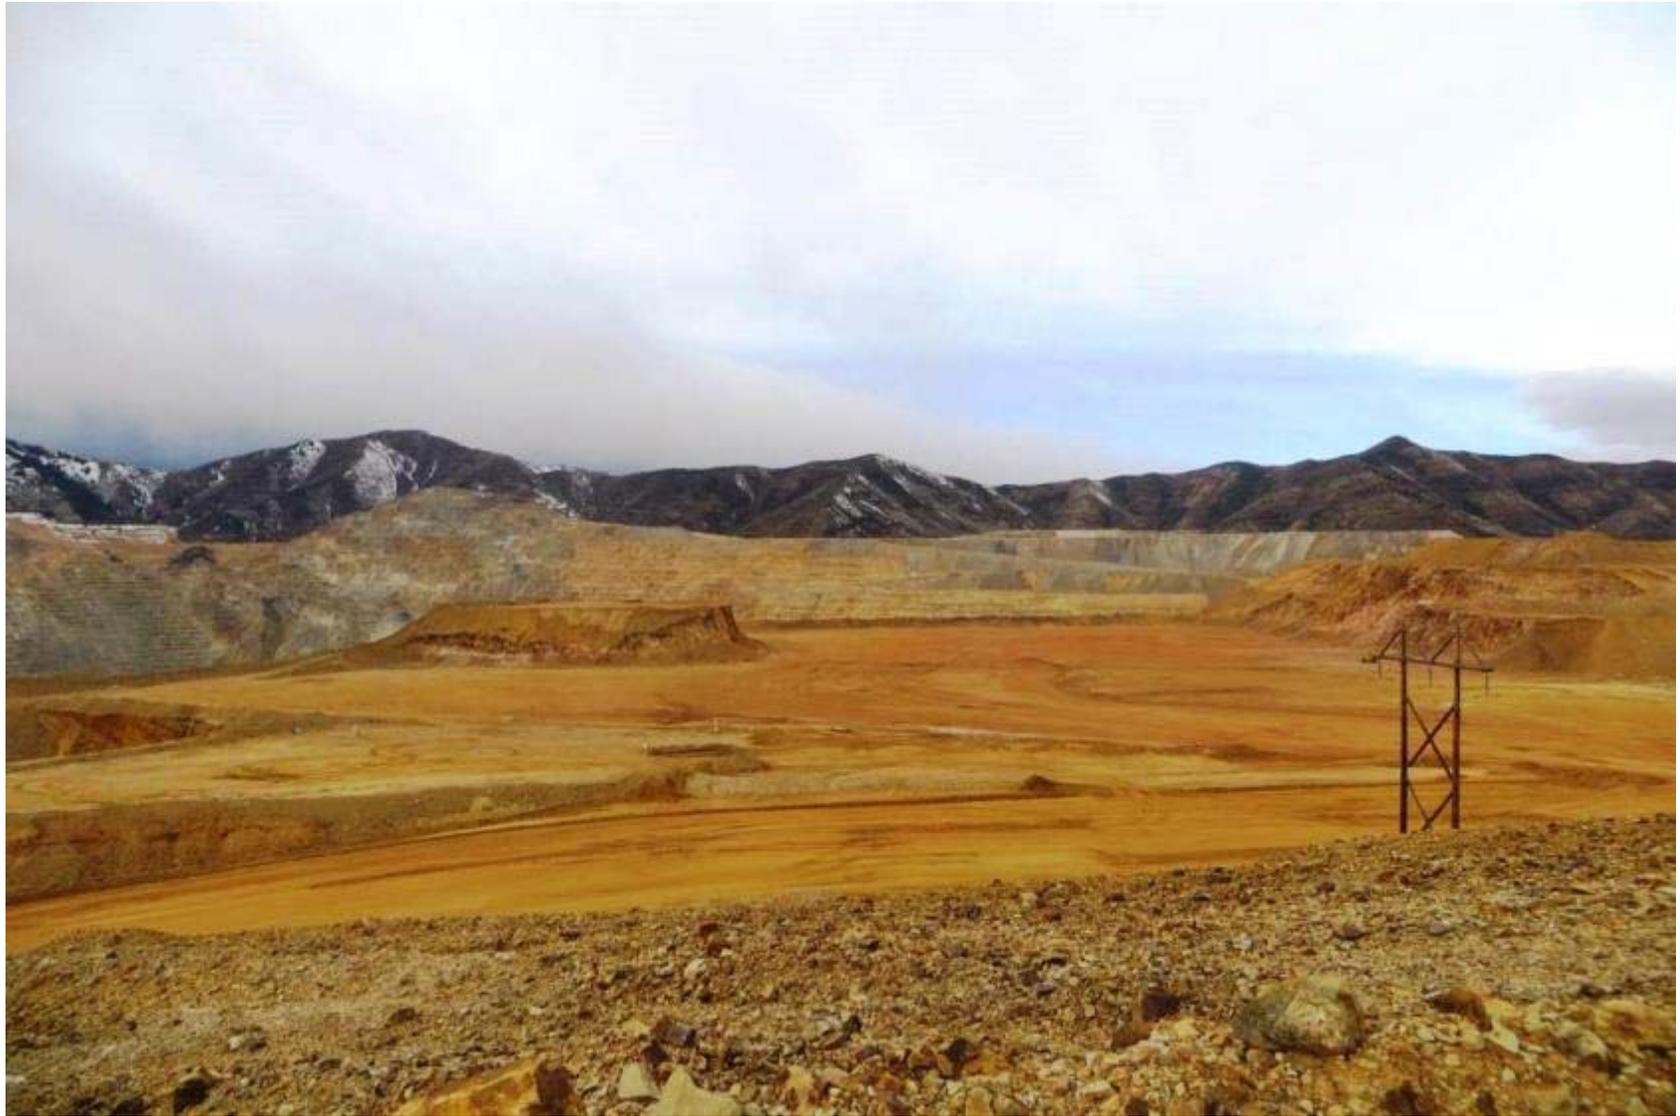
Head Scarp Completion – November 2013

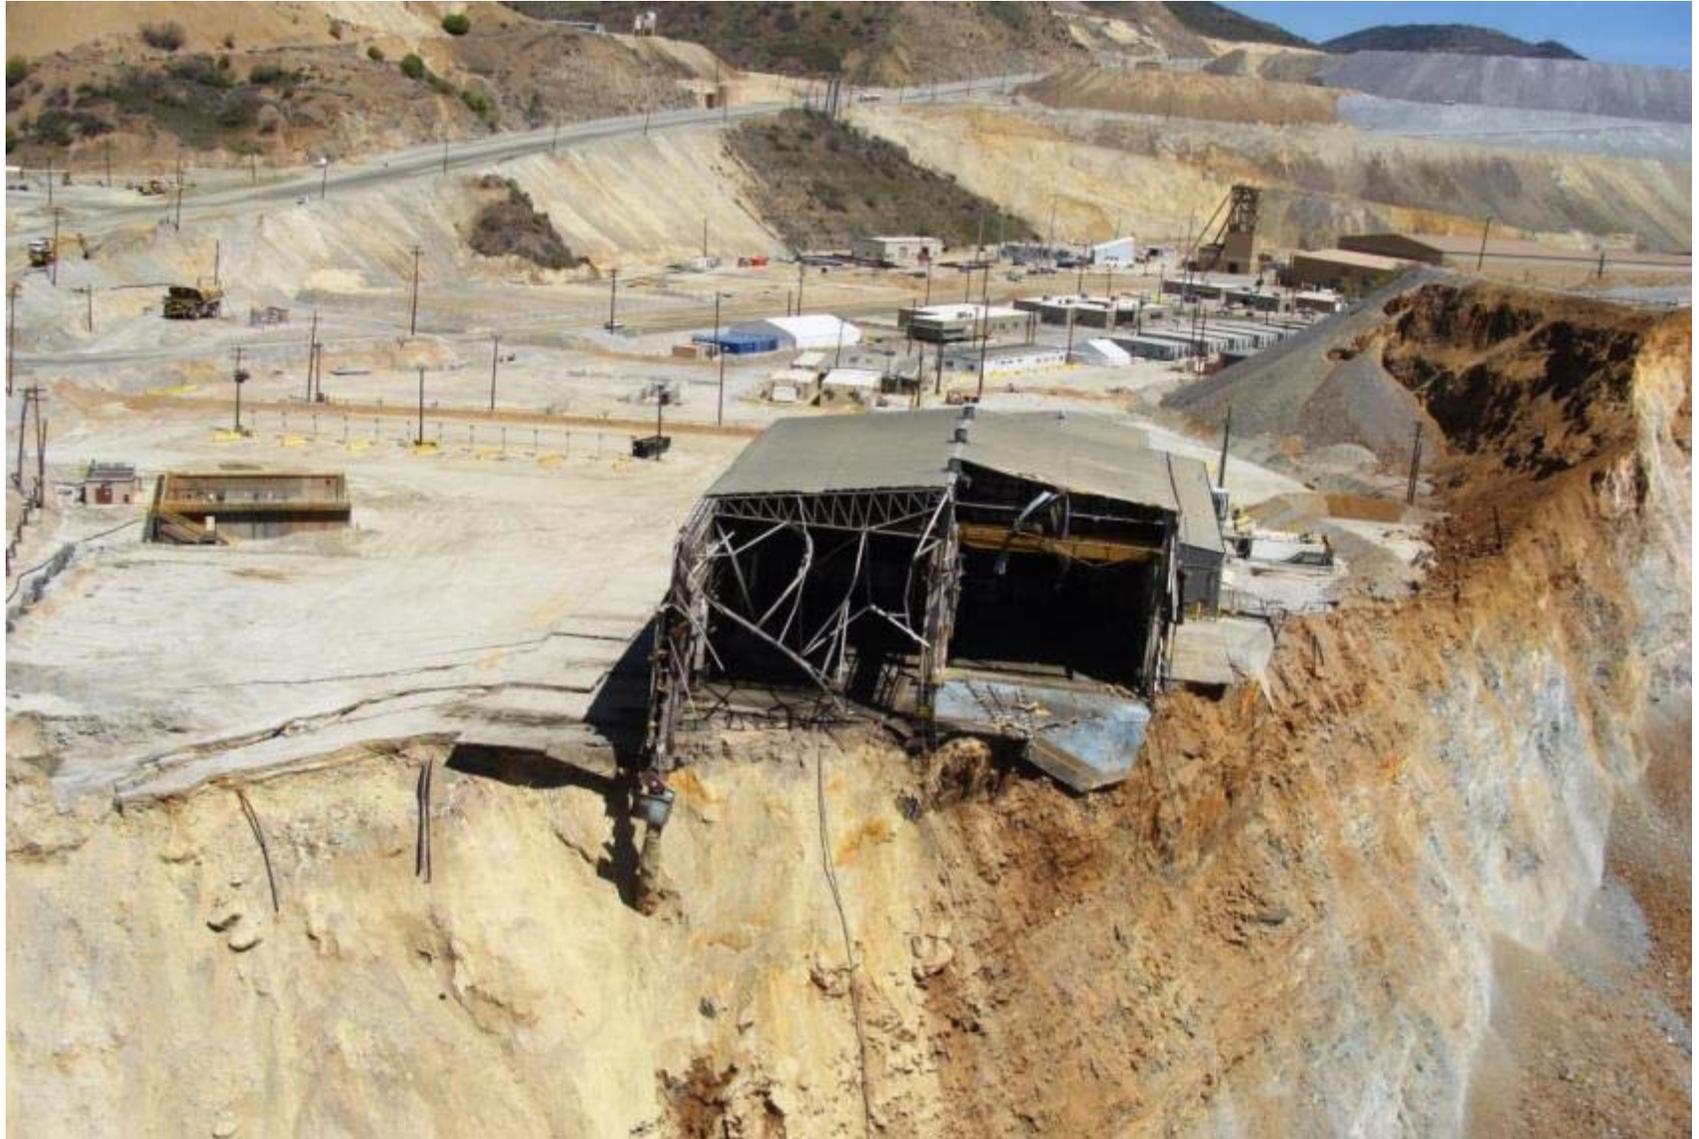
Bingham Shop Removal

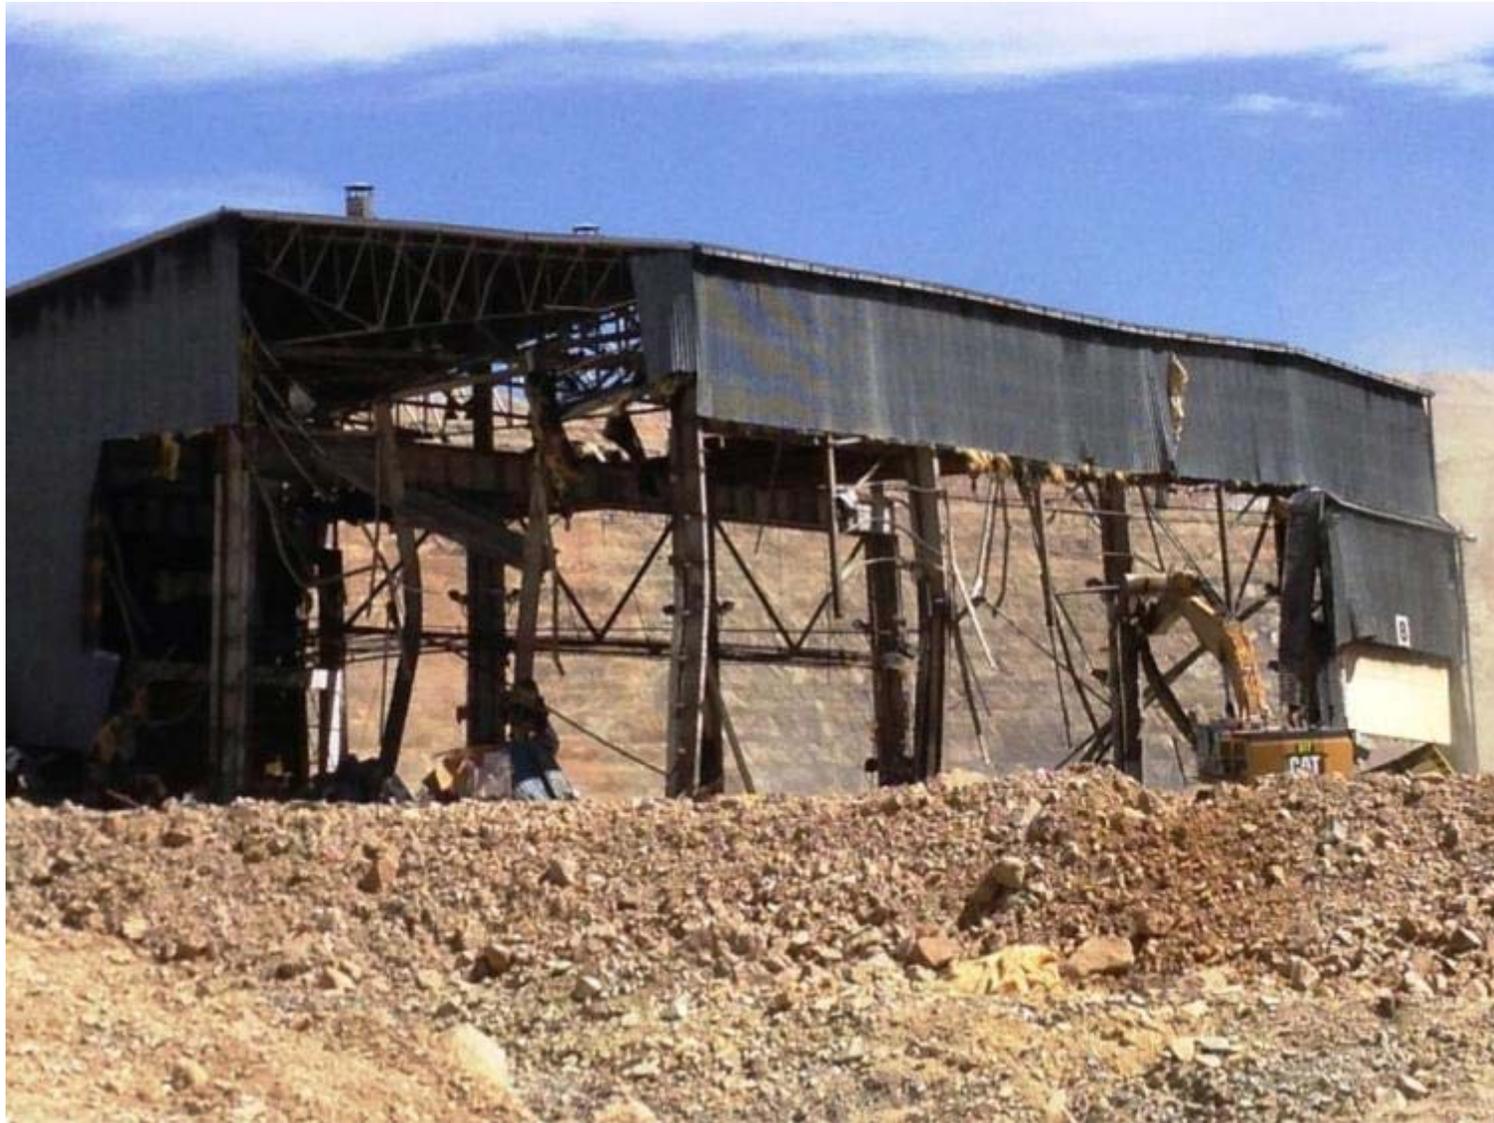
Bingham Shop Removal With Remote Excavator

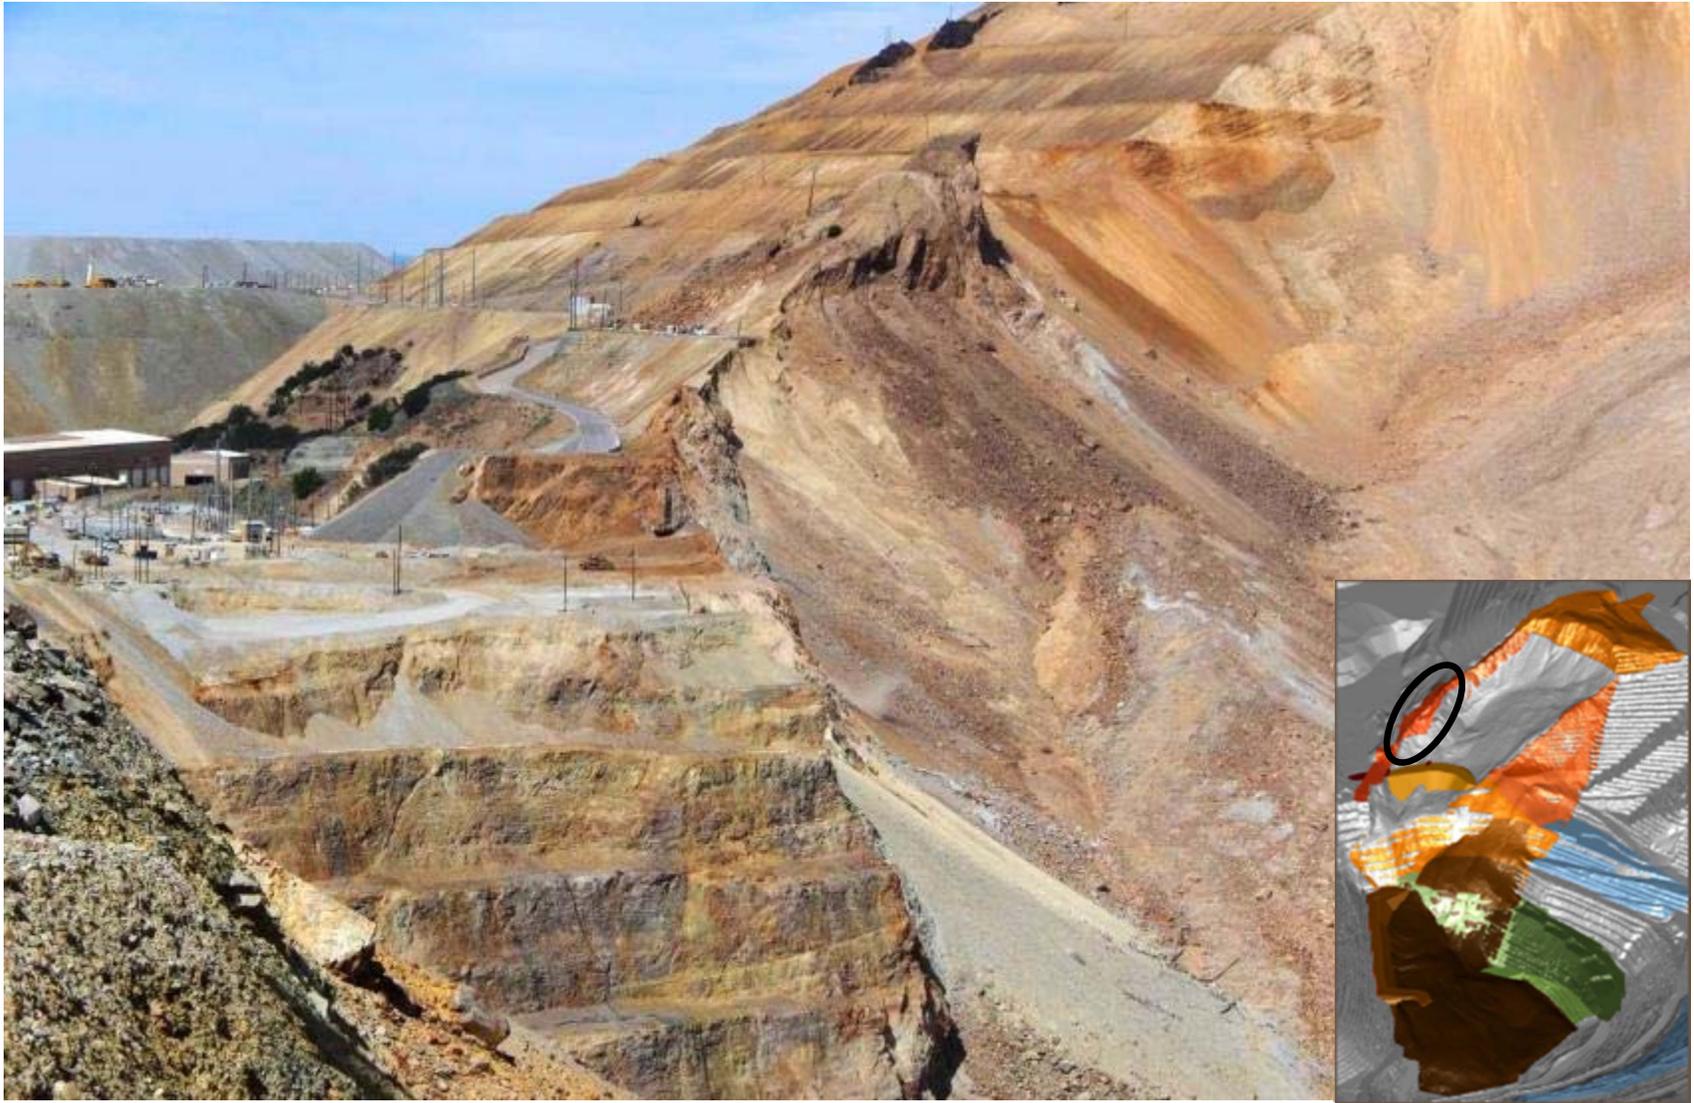
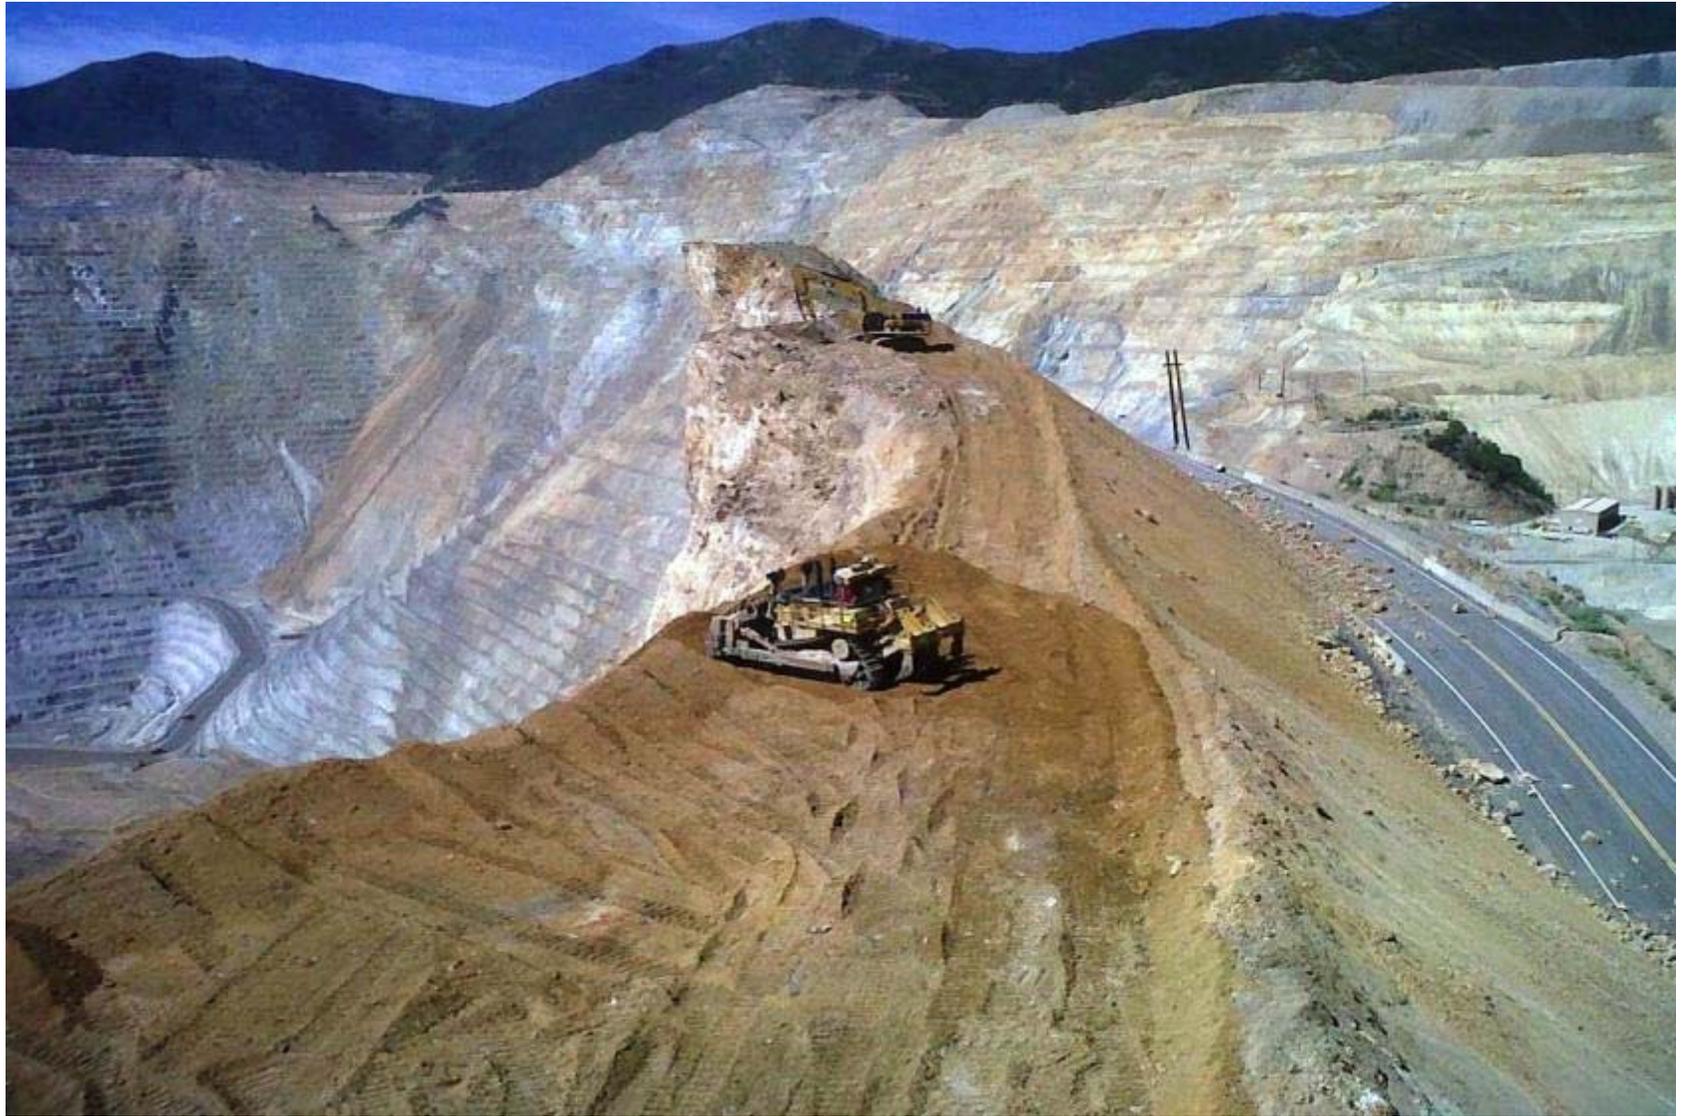
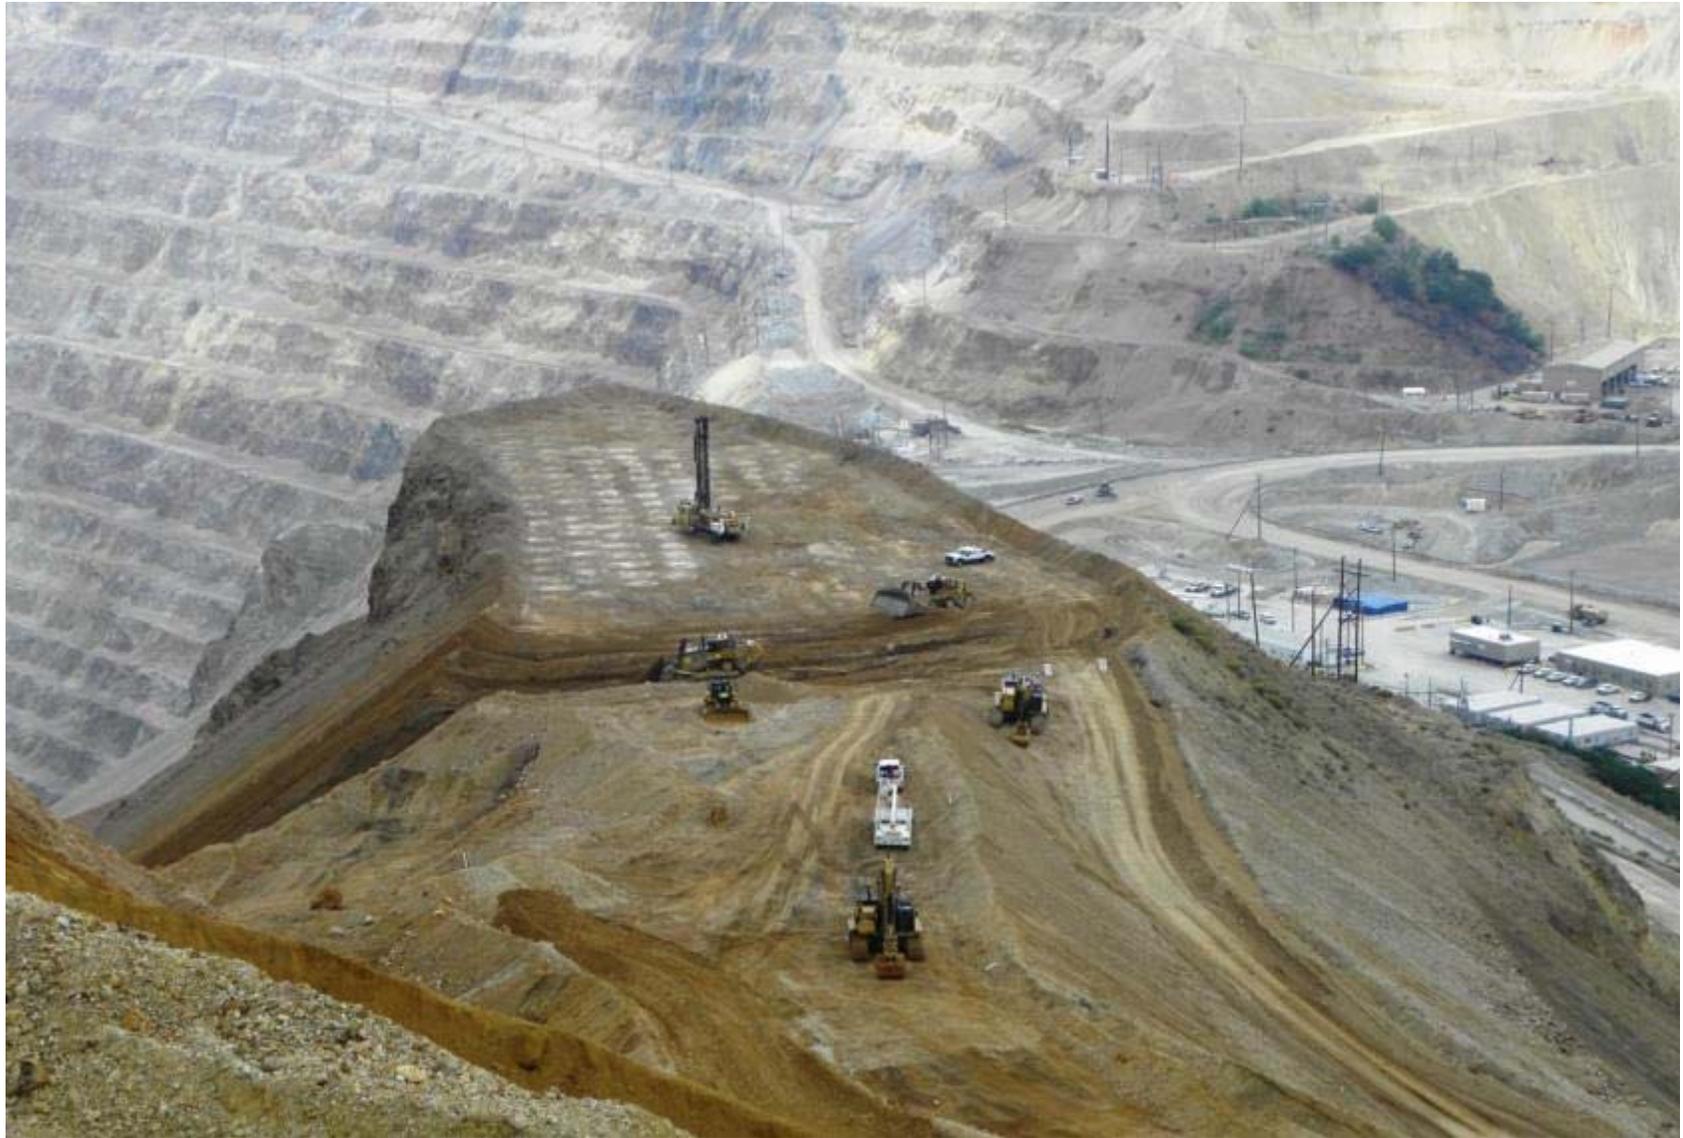
6690 Knob Remediation

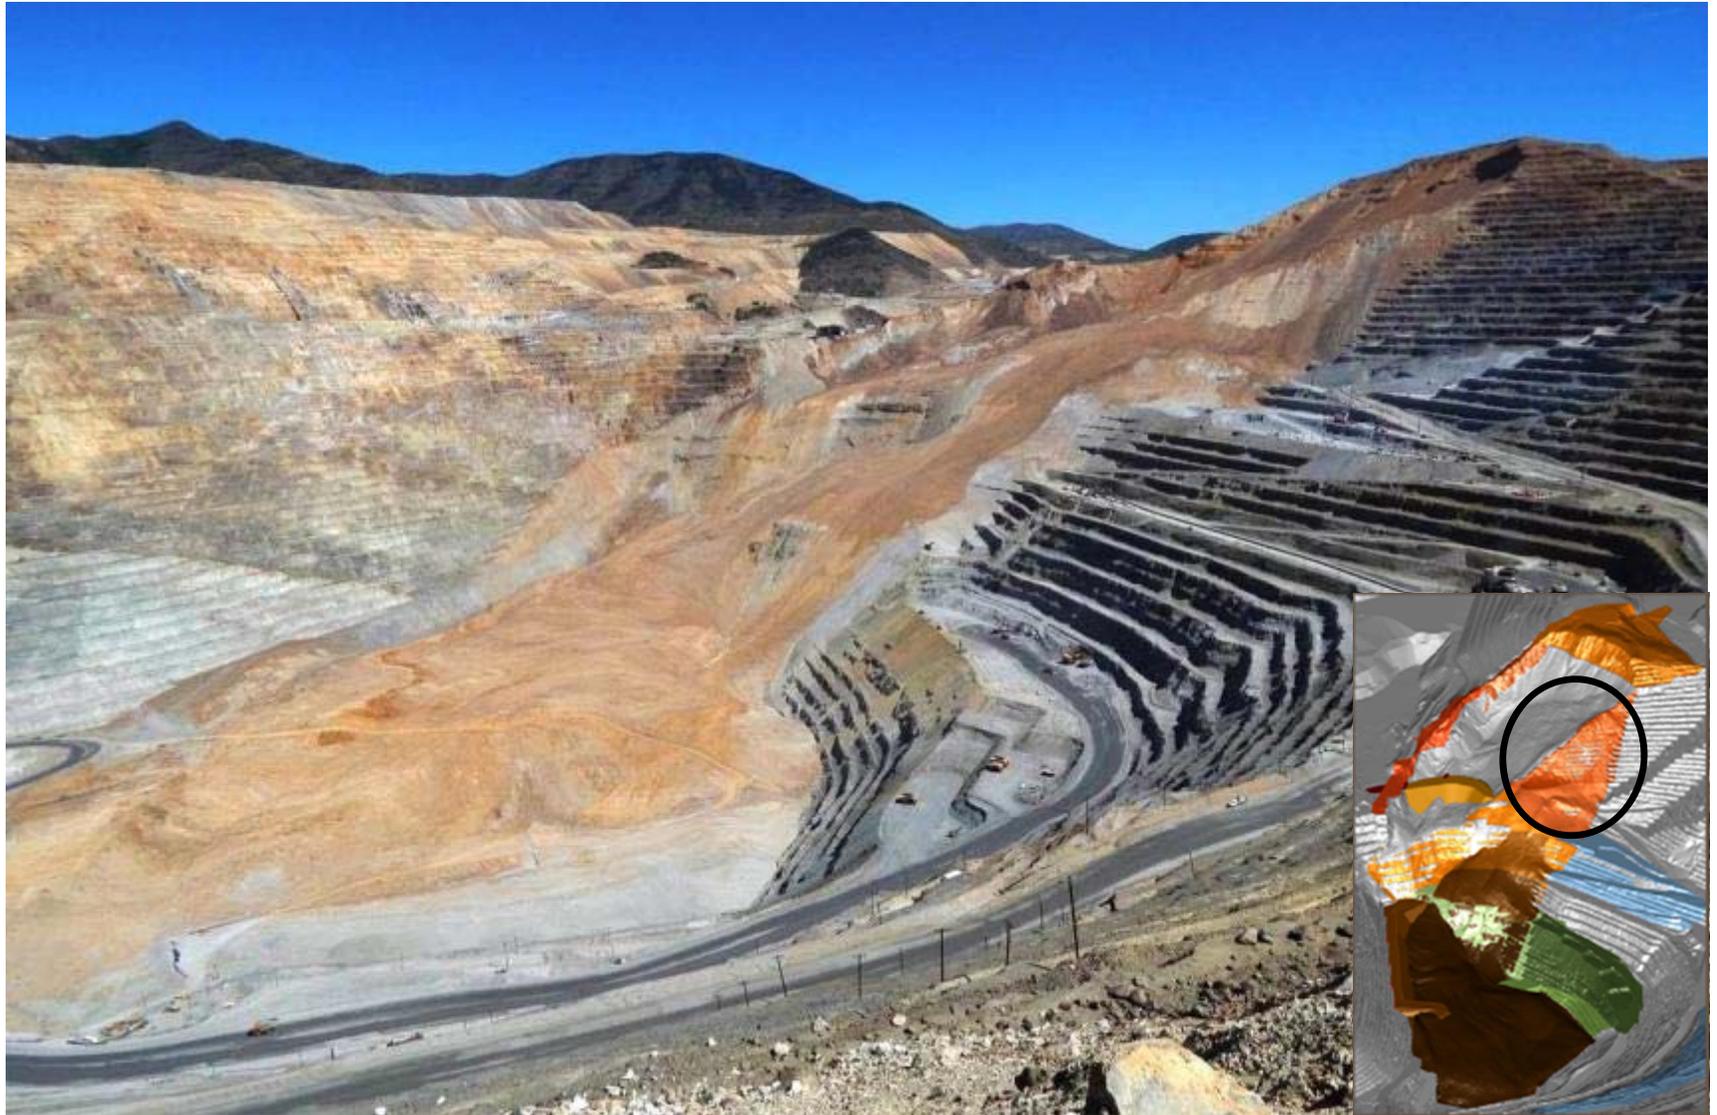
E5 Bench Cleaning

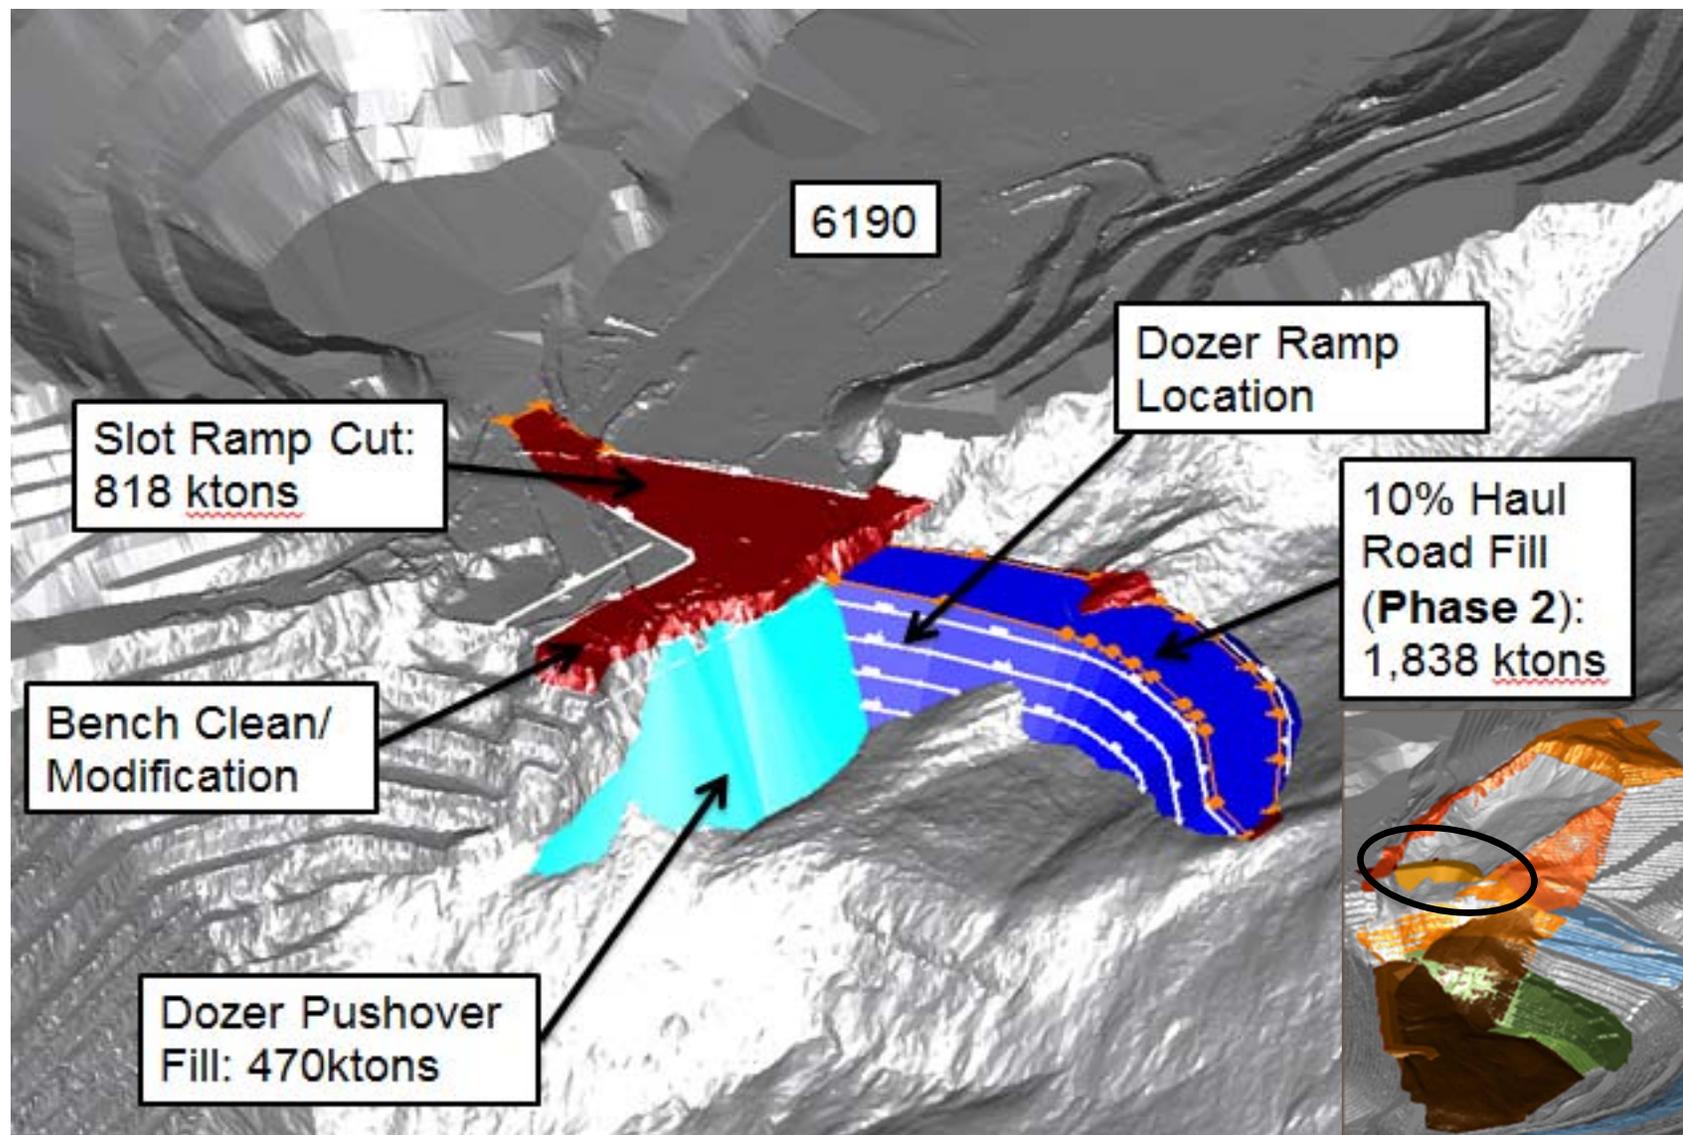
New Pit Access Road Design

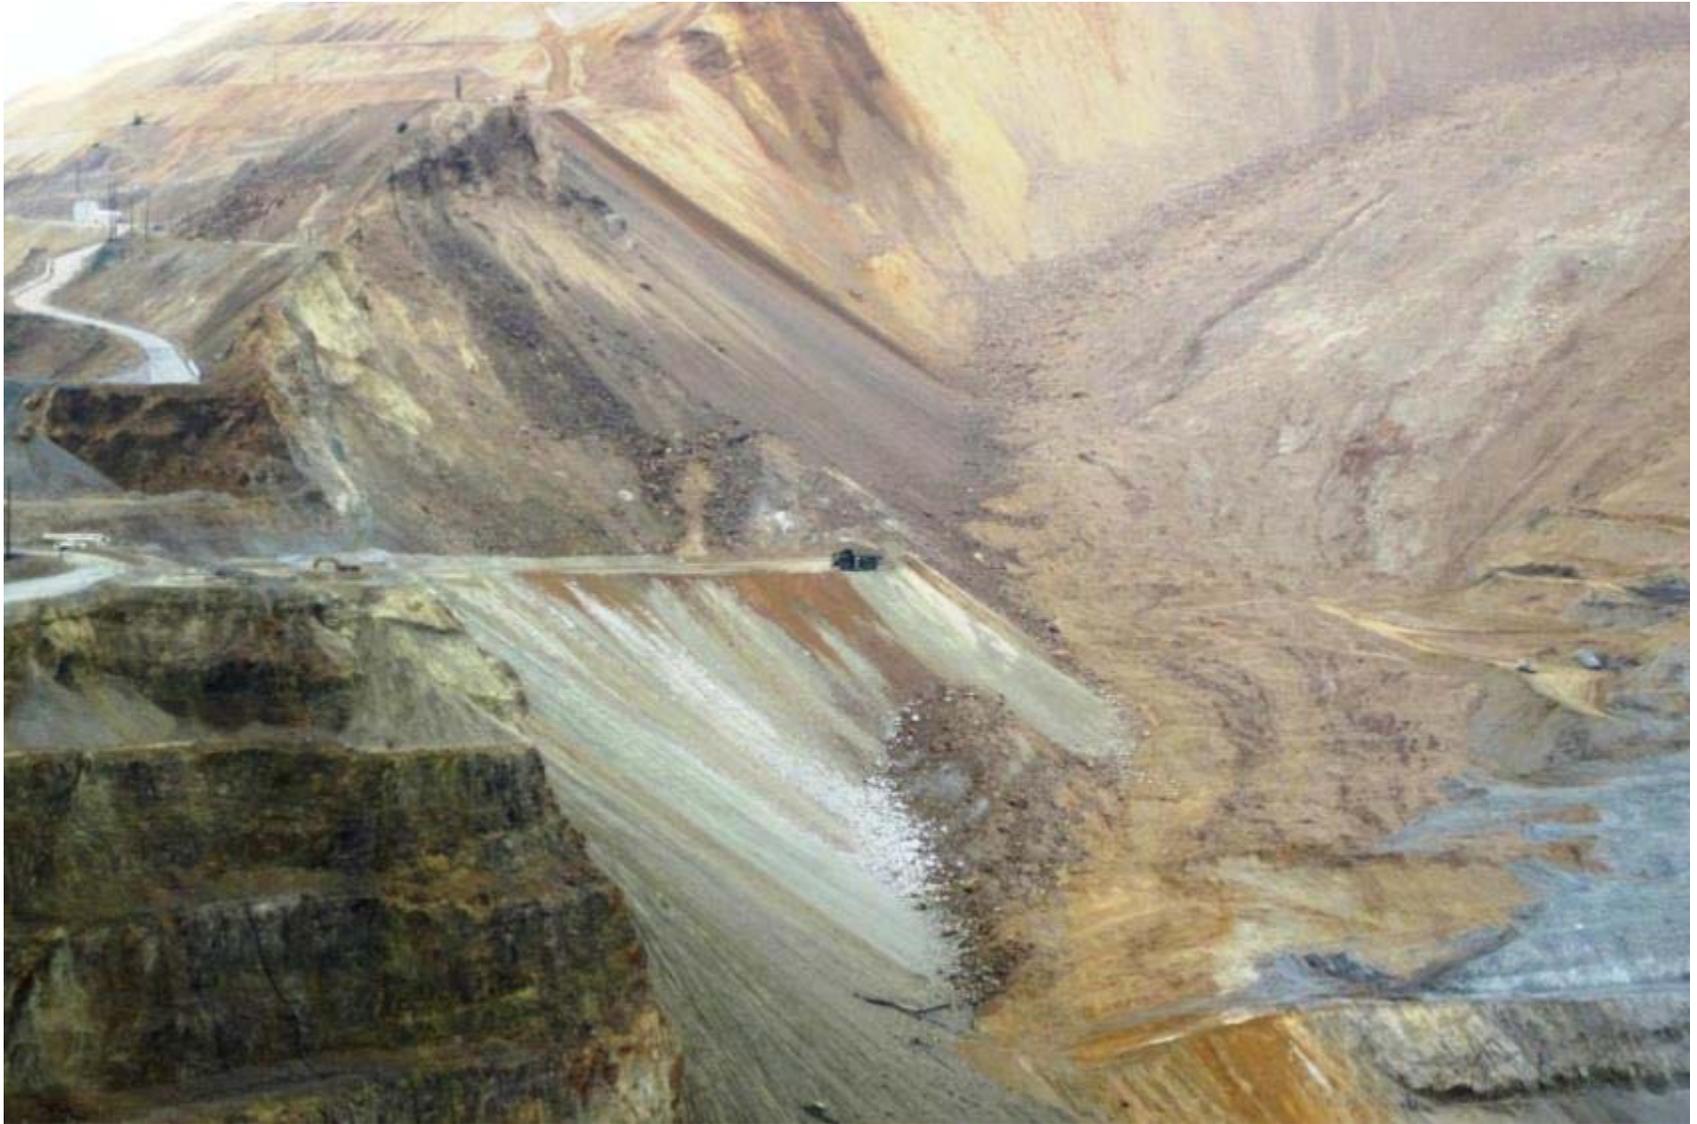
New Pit Access Road Construction
