Dustin G. Wasley, PE, Principal – CES

2012 Montana Mine Design, Operation & Closure Conference

Azurite Mine Overview

OVERVIEW OF AZURITE MINE REMOVAL ACTION

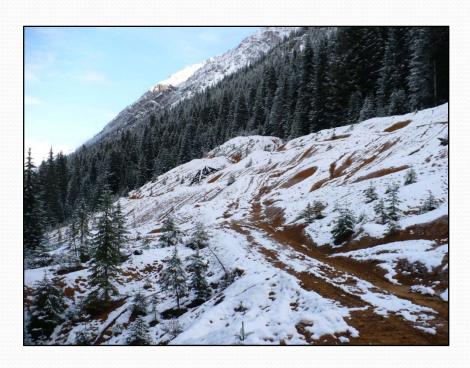
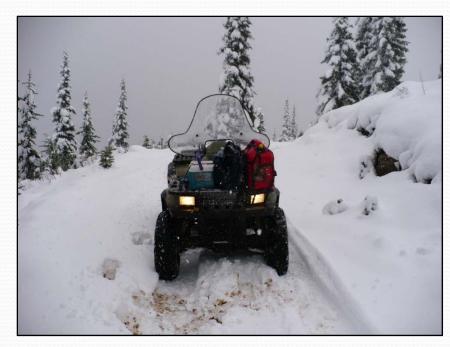
Construction Challenges

Weather Conditions (rain, snow, heat)

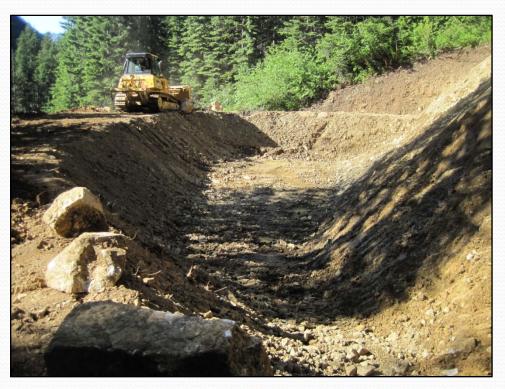
Erosion and Sediment Control

- Run-On Ditches
 - Waste Rock / Tailings
- Silt Fence
 - Borrow Area / Waste Rock
- Filter Berms
 - Borrow Area / Waste Rock
- Sedimentation Pond
 - Tailings / Repository

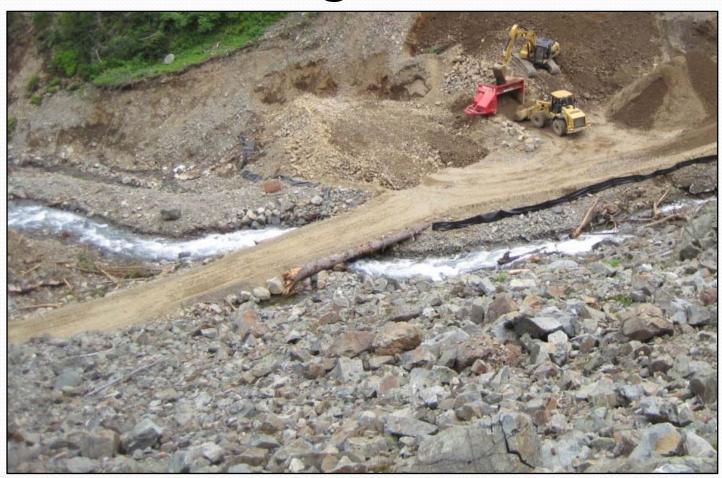
Mill Creek Crossing

Access Waste Rock Pile, and Transport to Repository

• Three, 48-inch CMPs

Temporarily Divert Mill
 Creek Away From Waste
 Rock Pile

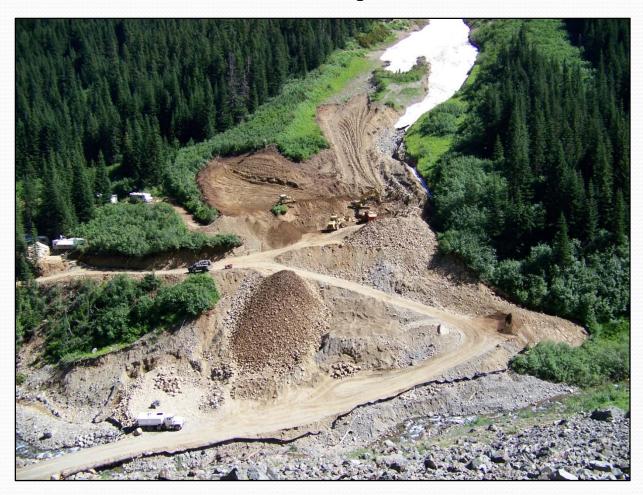
Borrow Area Development

- Onsite Source for Screening / 3 Products
- 2-inch minus
 - Stabilized Slope Fill, Road Bed/Base, Fill Material
 - 40,000+ cubic yards used, more remains onsite
- 2-inch to 36-inch
 - Repository cover, rocked diversion ditches
 - ~20,000 cubic yards
- 36-inch plus
 - Misc. Placement, armoring

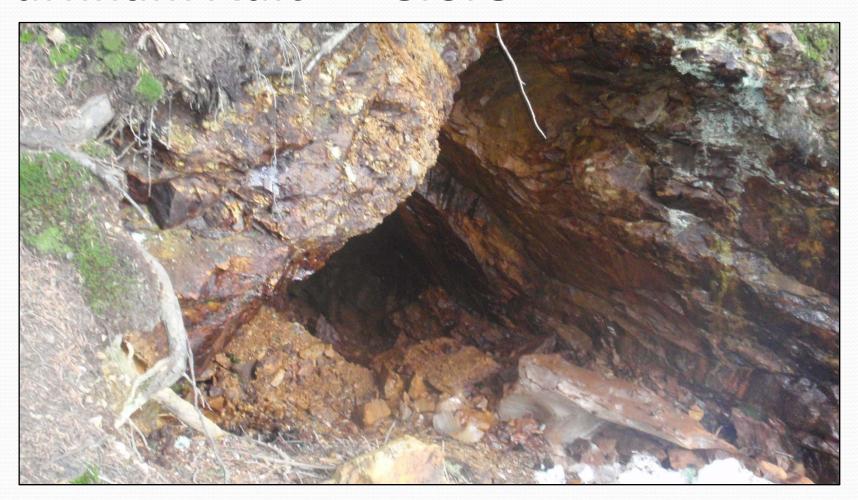
Burnham Adit – Before

- Planned for 5 Closures (4 Adits / 1 Vent)
- Pre-Cut Steel and Culverts Delivered to Site
- Final Onsite Fabrication
- Installation with Helicopter and Onsite Welder
- 4 Closures
 - Burnham, Tinson, and Discovery Adits
 - Discovery Vent
- Wenatchee Adit
 - Collapsed No Bat Gate Installed

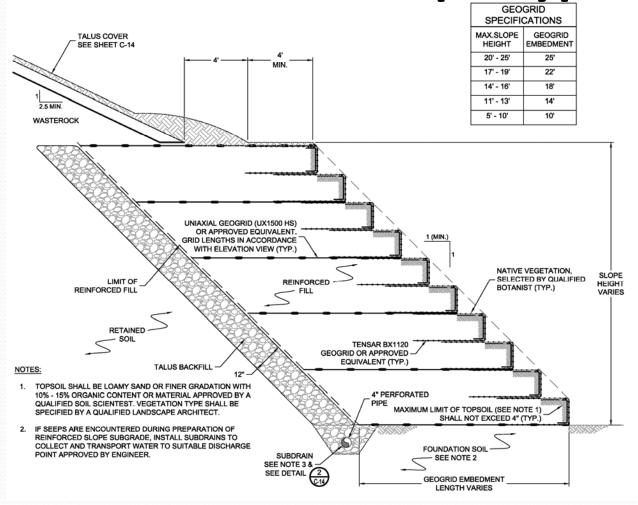
Reinforced Stabilized Slope Typical

- Designed to Stabilize/Retain the Repository
- Original Design was 15-feet (H) x 15-feet (W) 12 lifts
- Final Layout was 22-feet (H) x 25-feet (W) 17 lifts
 - Competent Soil Deeper Than Planned
 - Increased Quantities For Borrow Material/Geogrid
- Onsite QA/QC Testing All Final Tests Met Compaction Requirements (95% of Proctor)
- 23 days to build
 - Bottom lifts ~ 1.5 days to complete
 - Upper lifts ~ 1 day to complete

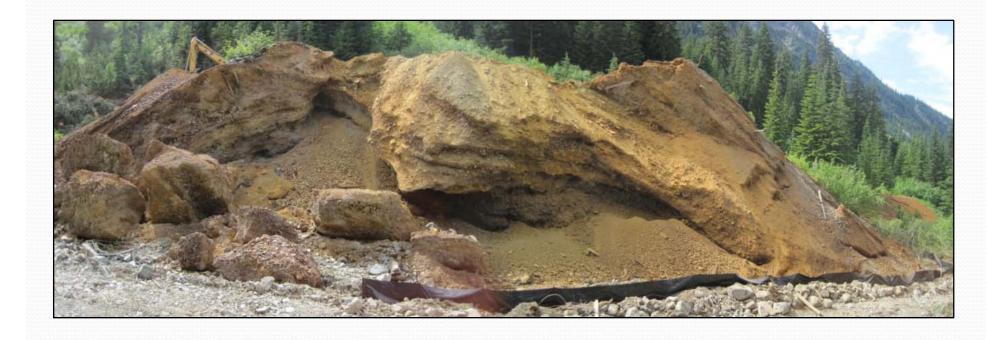
Waste Rock Pile - Before

- Design Estimate was 22,000 bcy of Waste Rock
 - 16,000 bcy Upper / 6,000 bcy Lower
- Risk Assessment Cleanup Goal 104 mg/kg Total Arsenic
- Revised Cleanup Goal 204 mg/kg Total Arsenic
 - Additional Background Soil Sampling
 - Used MTCA Stat 3.0 to Calculate Natural Background
- In-Field Screening with Niton XRF (RPDs ≤ 33%)
- Final Quantities
 - 13,500 bcy Upper WR
 - 2,900 bcy Lower WR

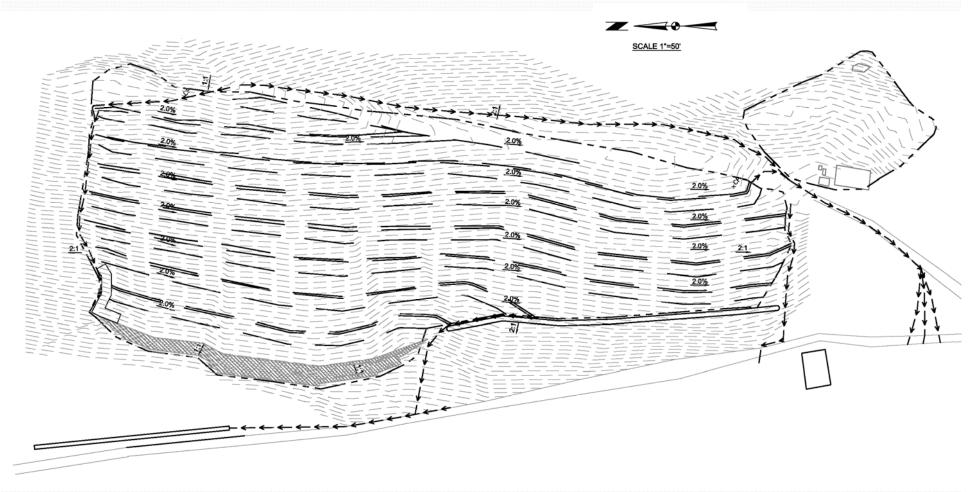
Repository Grading Plan

- Overall Slope = 2.5:1
- Reinforced Slope and Berm to Stabilize Repository
- Waste Rock Blended with Tailings to Achieve Slope
- In-sloped Benches Every 9 Vertical Feet to Relieve Precip
- Repository Cover (Multi-Layer)
 - Talus/Rock Cover Top
 - Geogrid
 - 3. 12-oz Nonwoven Geotextile
 - 4. 40-mil HDPE Membrane
 - 5. 12-oz Nonwoven Geotextile
 - 6. Waste Rock/Tailings Bottom

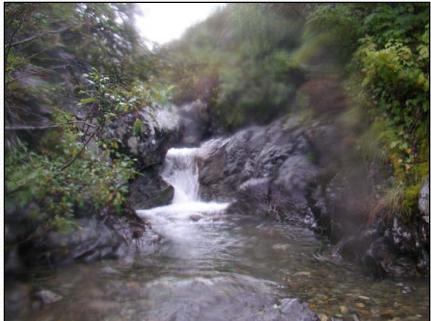
- Mill Creek Fish Barrier Survey
 - Multiple Fish Barriers, No Fish Within 2.5 Miles

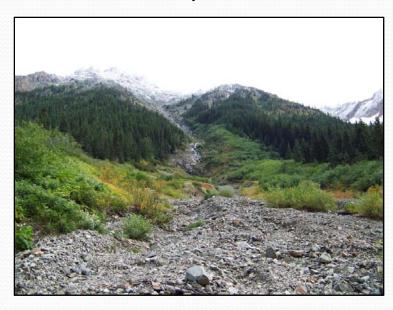
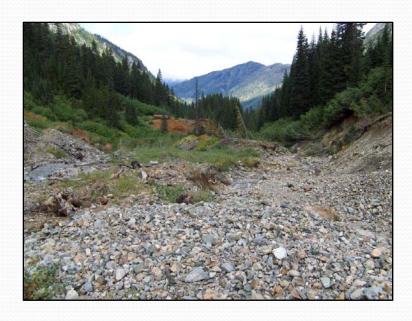
Removal Action Data Gaps – 2007

- Mill Creek Fish Barrier Survey
 - Multiple Fish Barriers, No Fish Within 2.5 Miles
- Borrow Material Assessment
 - Onsite Talus/Rock Areas

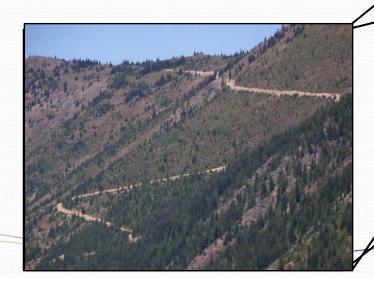
Culvert Installation

2010 – Access Road Improvements

CES Design, Palm Construction/USFS
