REMEDIATING AND RESTORING SMELTER-DEVASTATED LANDS NEAR ANACONDA, MONTANA

State
owned
area for
remedy
and
restoration

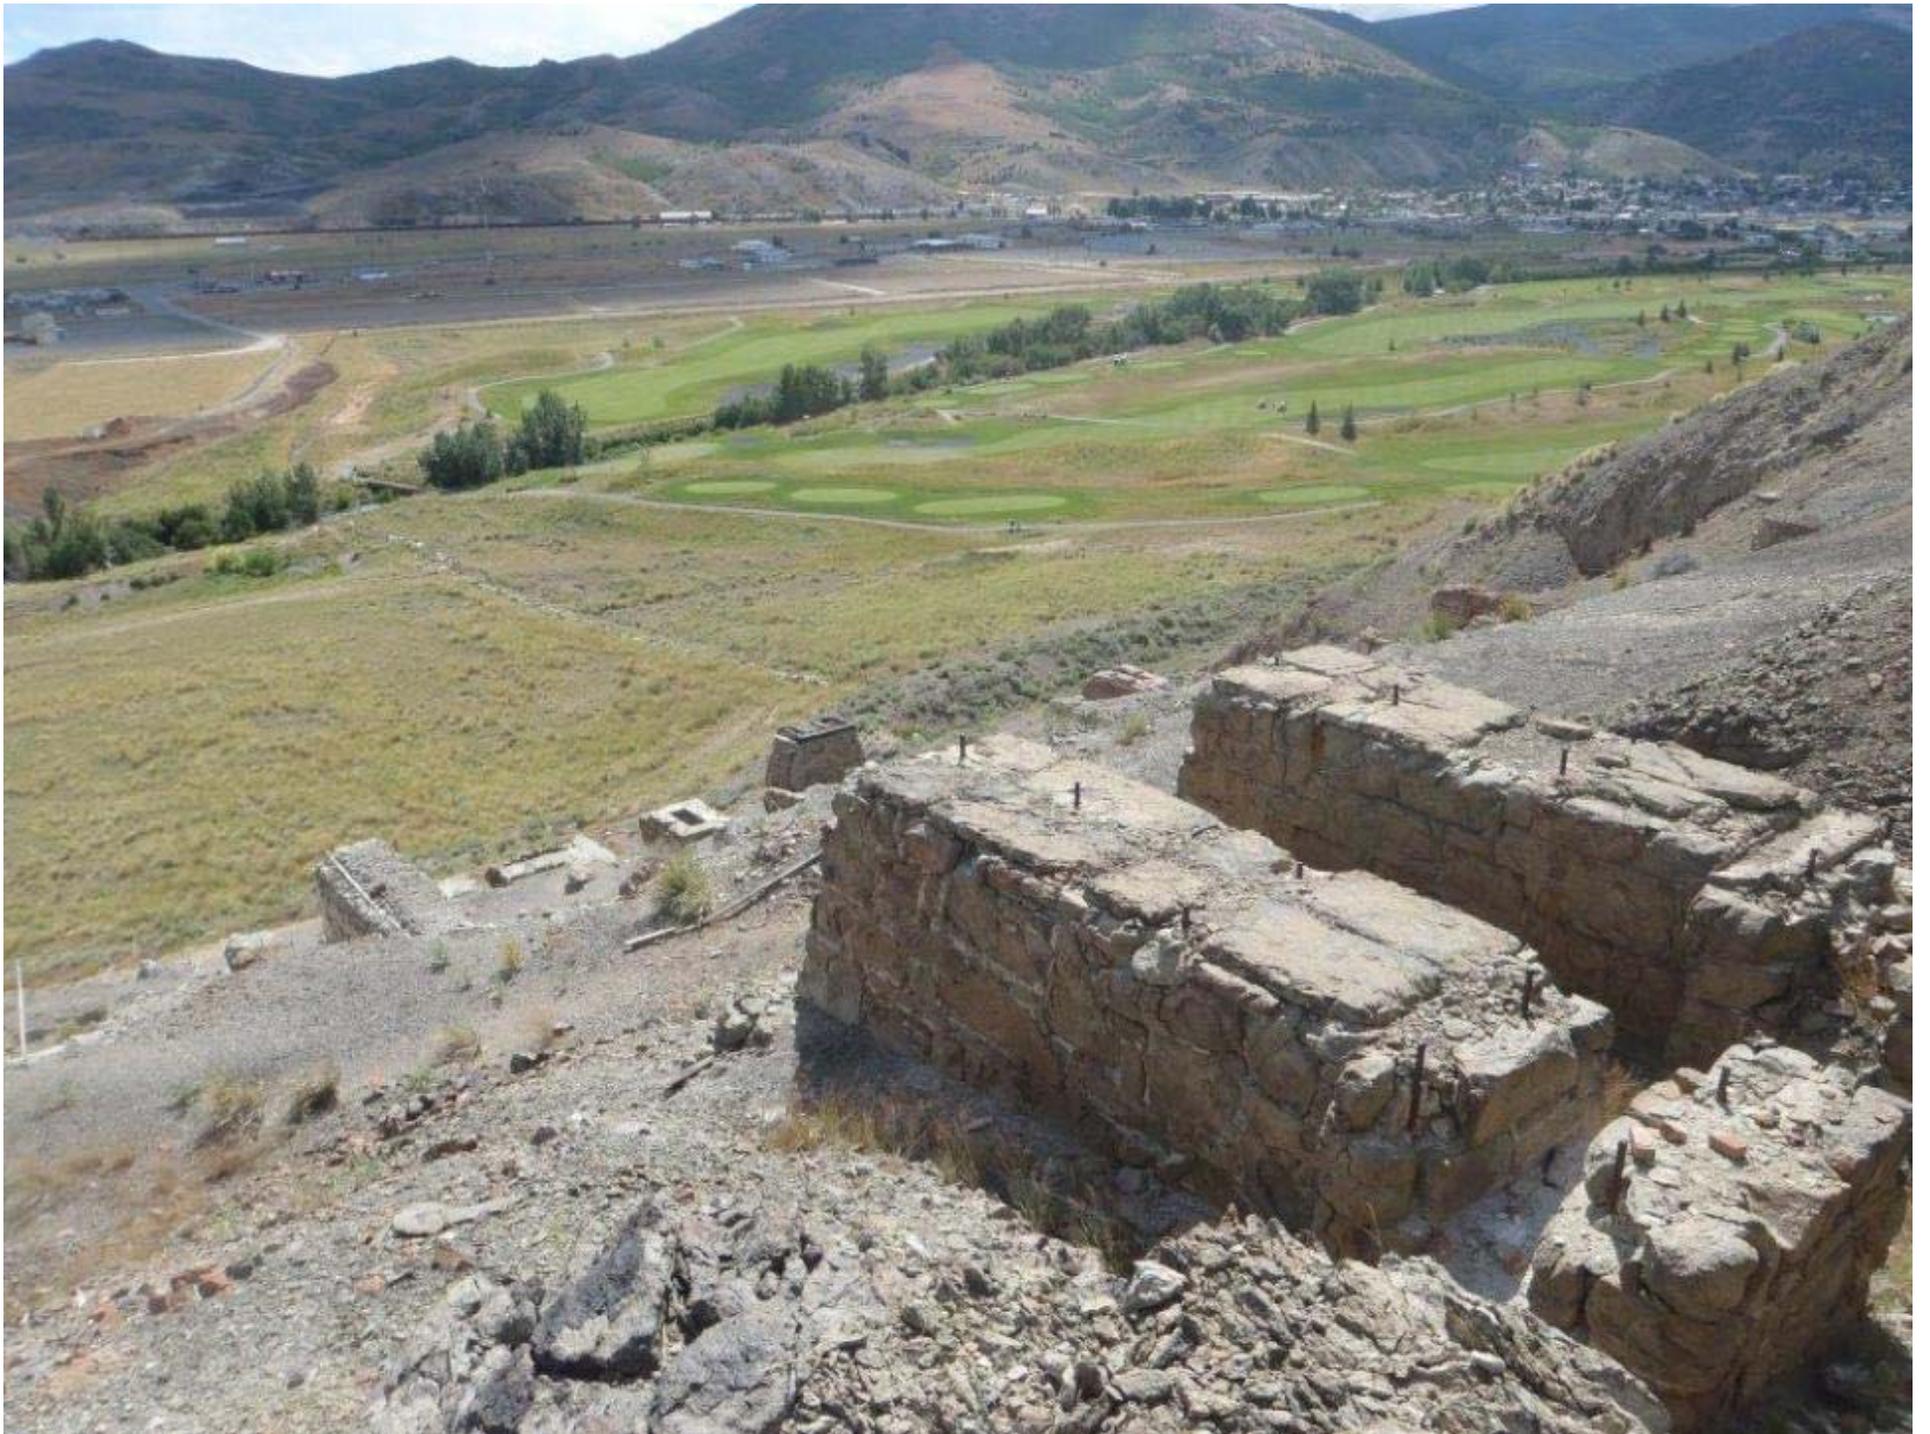
Old Works Smelters from 1883- 1900

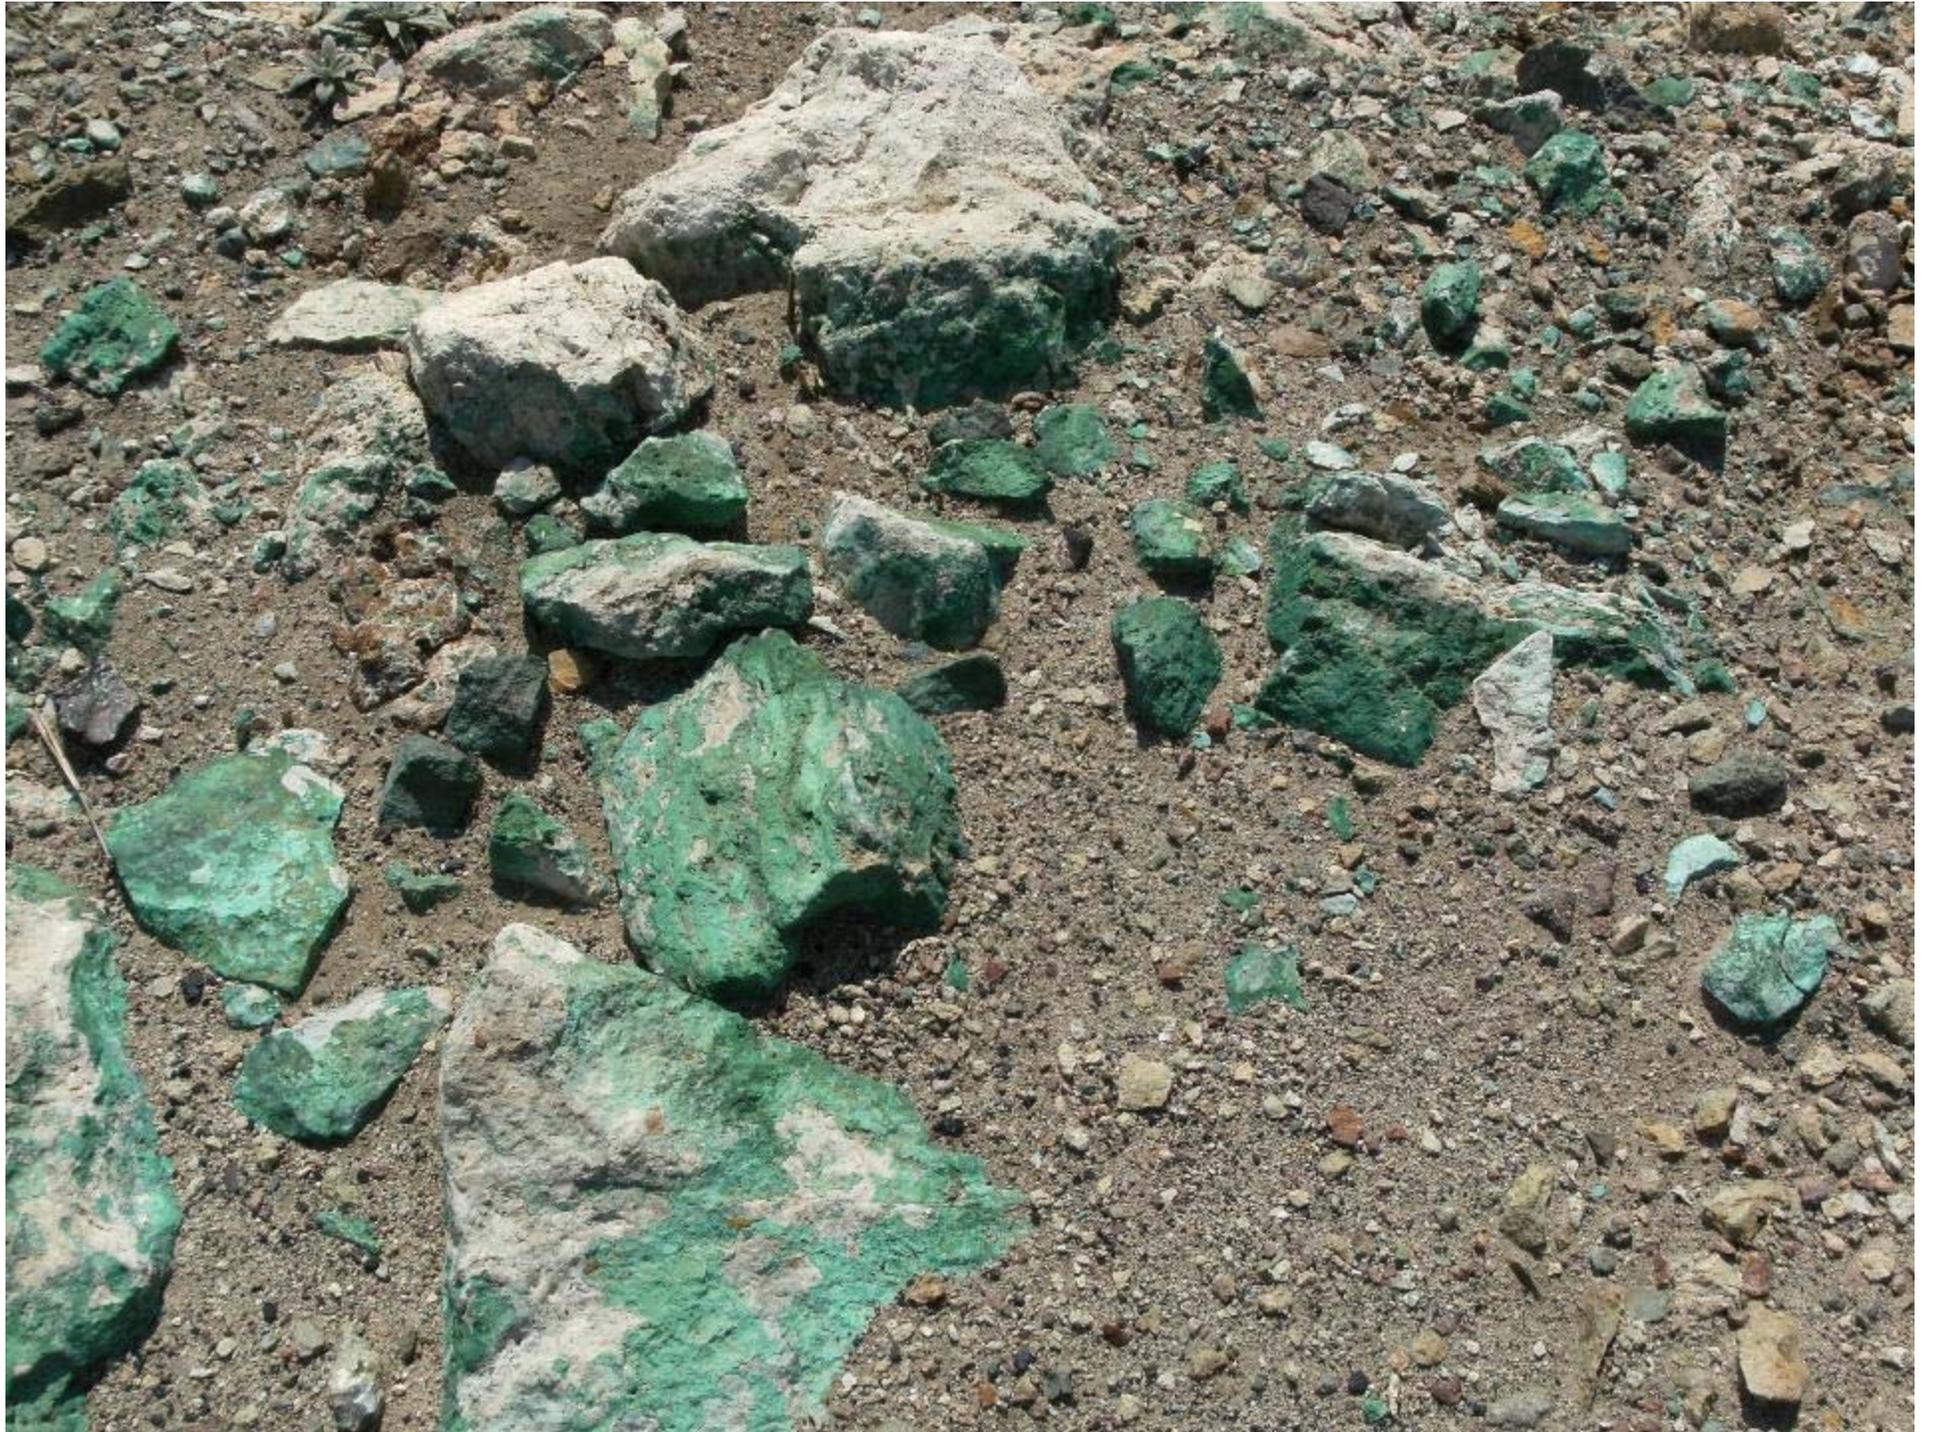
SUBAREA 3 PREREMEDIATION SOILS

Upper Half Foot

2nd Half Foot

OM	2.3%	not sampled
pH	4.4	4.9
pH	4.9	5.3
As	185 ppm	76 ppm
Cd	2.8 ppm	2.7 ppm
Cu	1,480 ppm	990 ppm

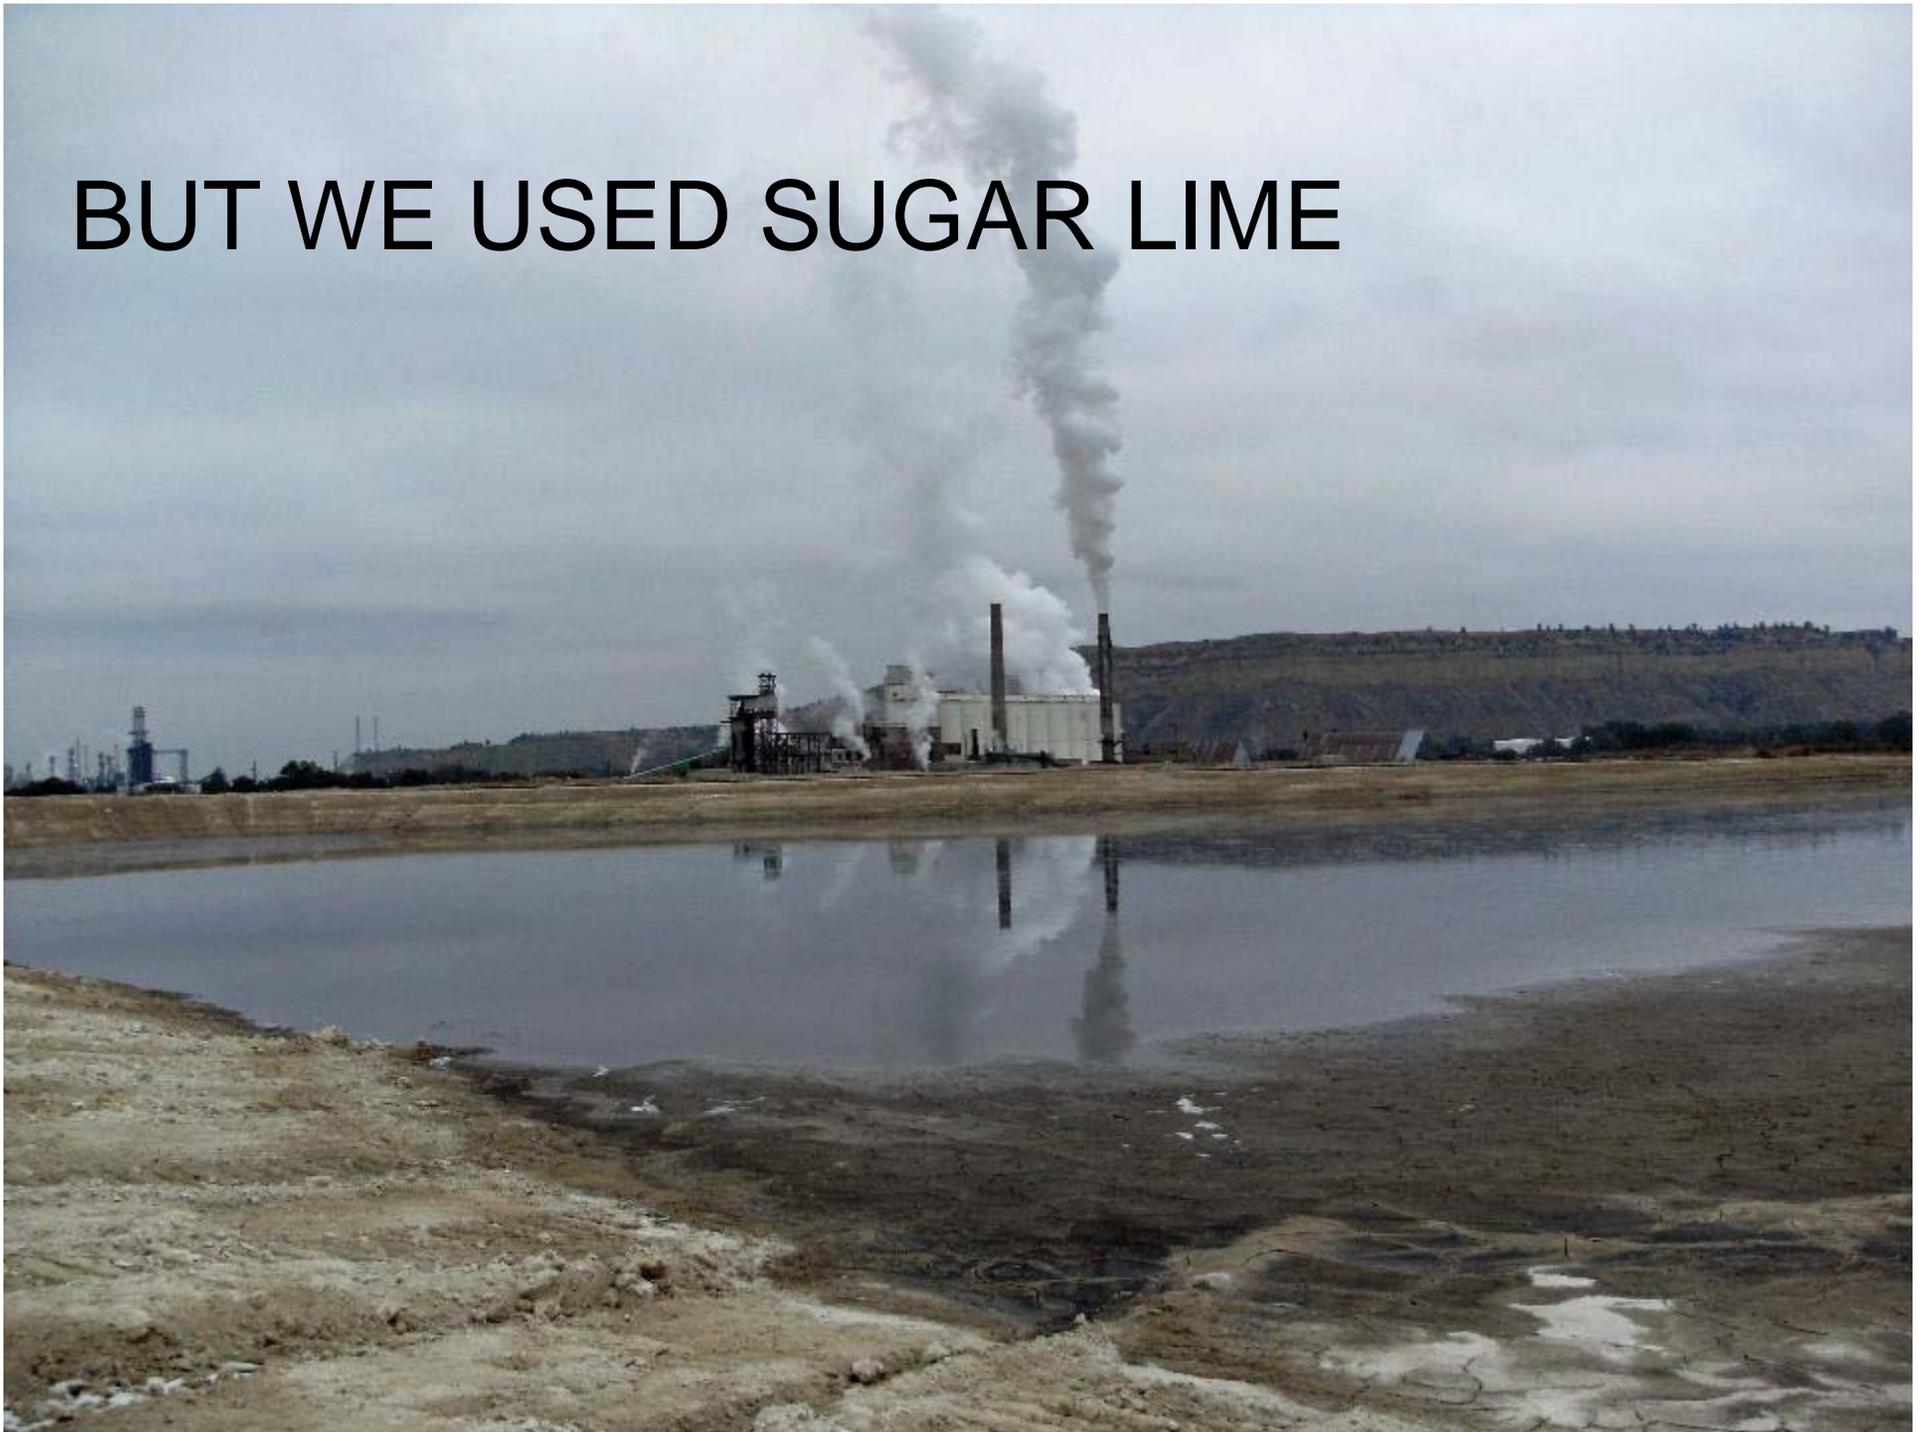
CORRECT SUGAR LIME TO
EQUIVALENT PURE FINE
AGRICULTURAL LIME

PURITY, FINENESS, MOISTURE
SUBTRACT SOME ROCKS IN SOIL
(e.g., SA 1 1/3 rocks by volume)

Sugar Lime Example SA 3

Moisture X CaCO_3 Eq. X Fineness
1.25 X 1.28 X 1.00

1.6 tons sugar lime for each
ton of pure, fine, agricultural
lime from Sikora or SMP

FINENESS = 99+%

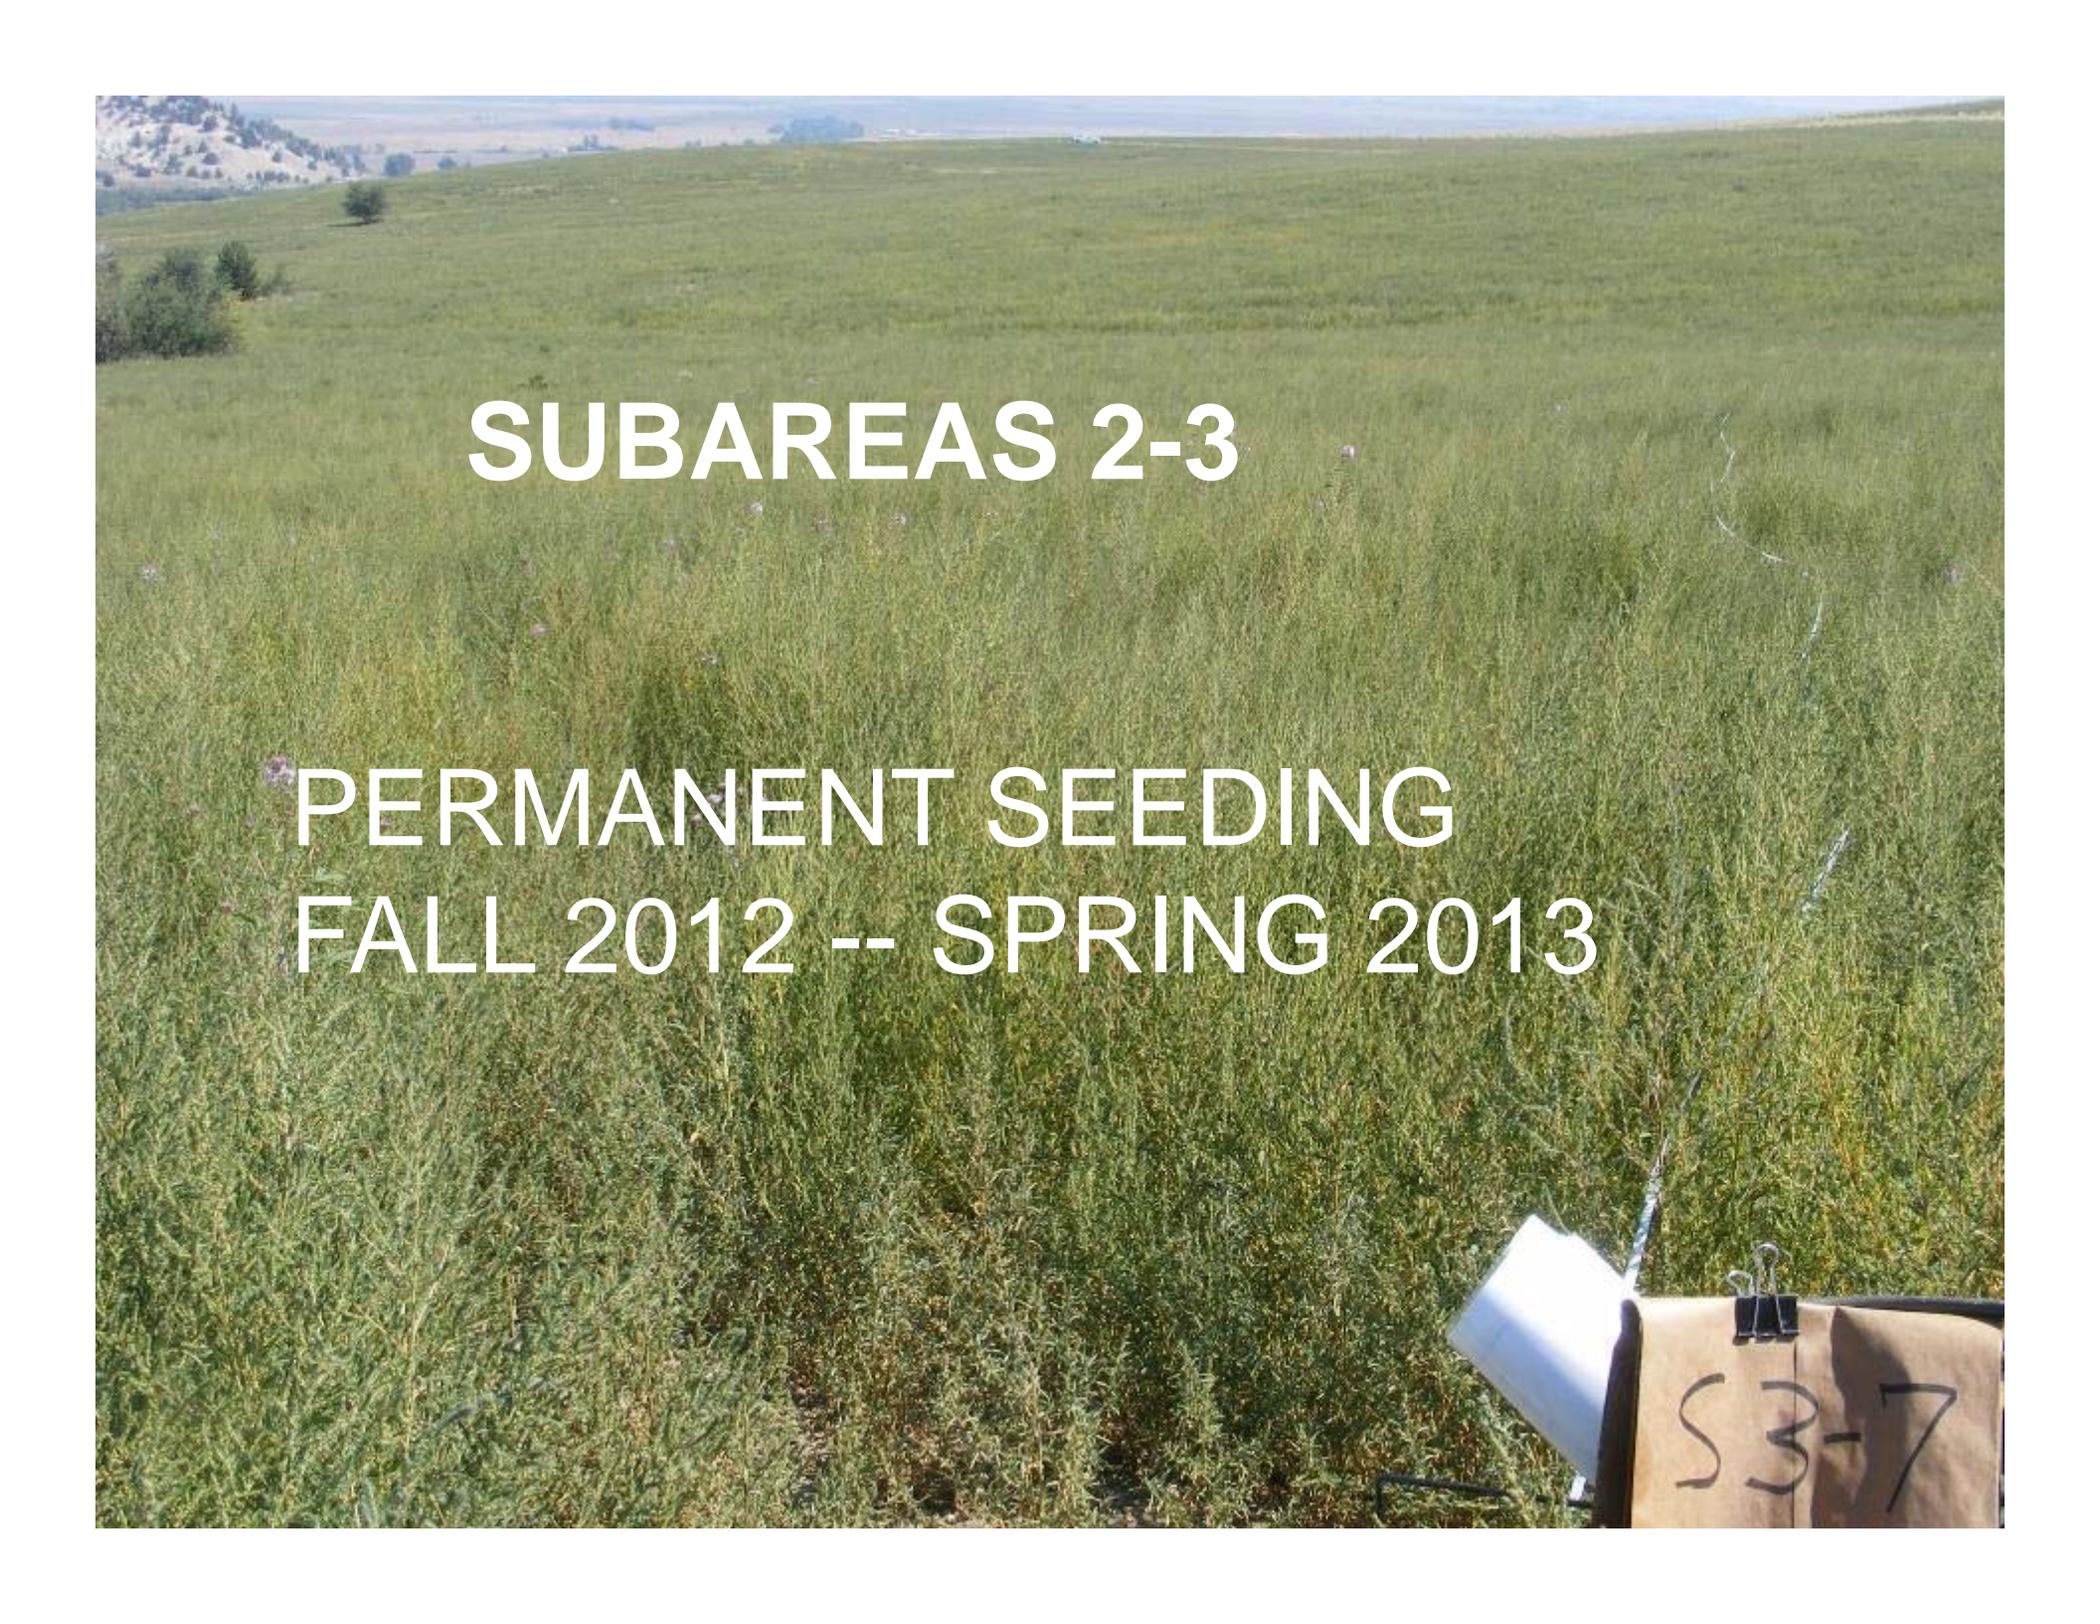
SUBAREA 1

**SUBAREA 1
PERMANENT SEEDING
FALL 2011 – SPRING 2012**

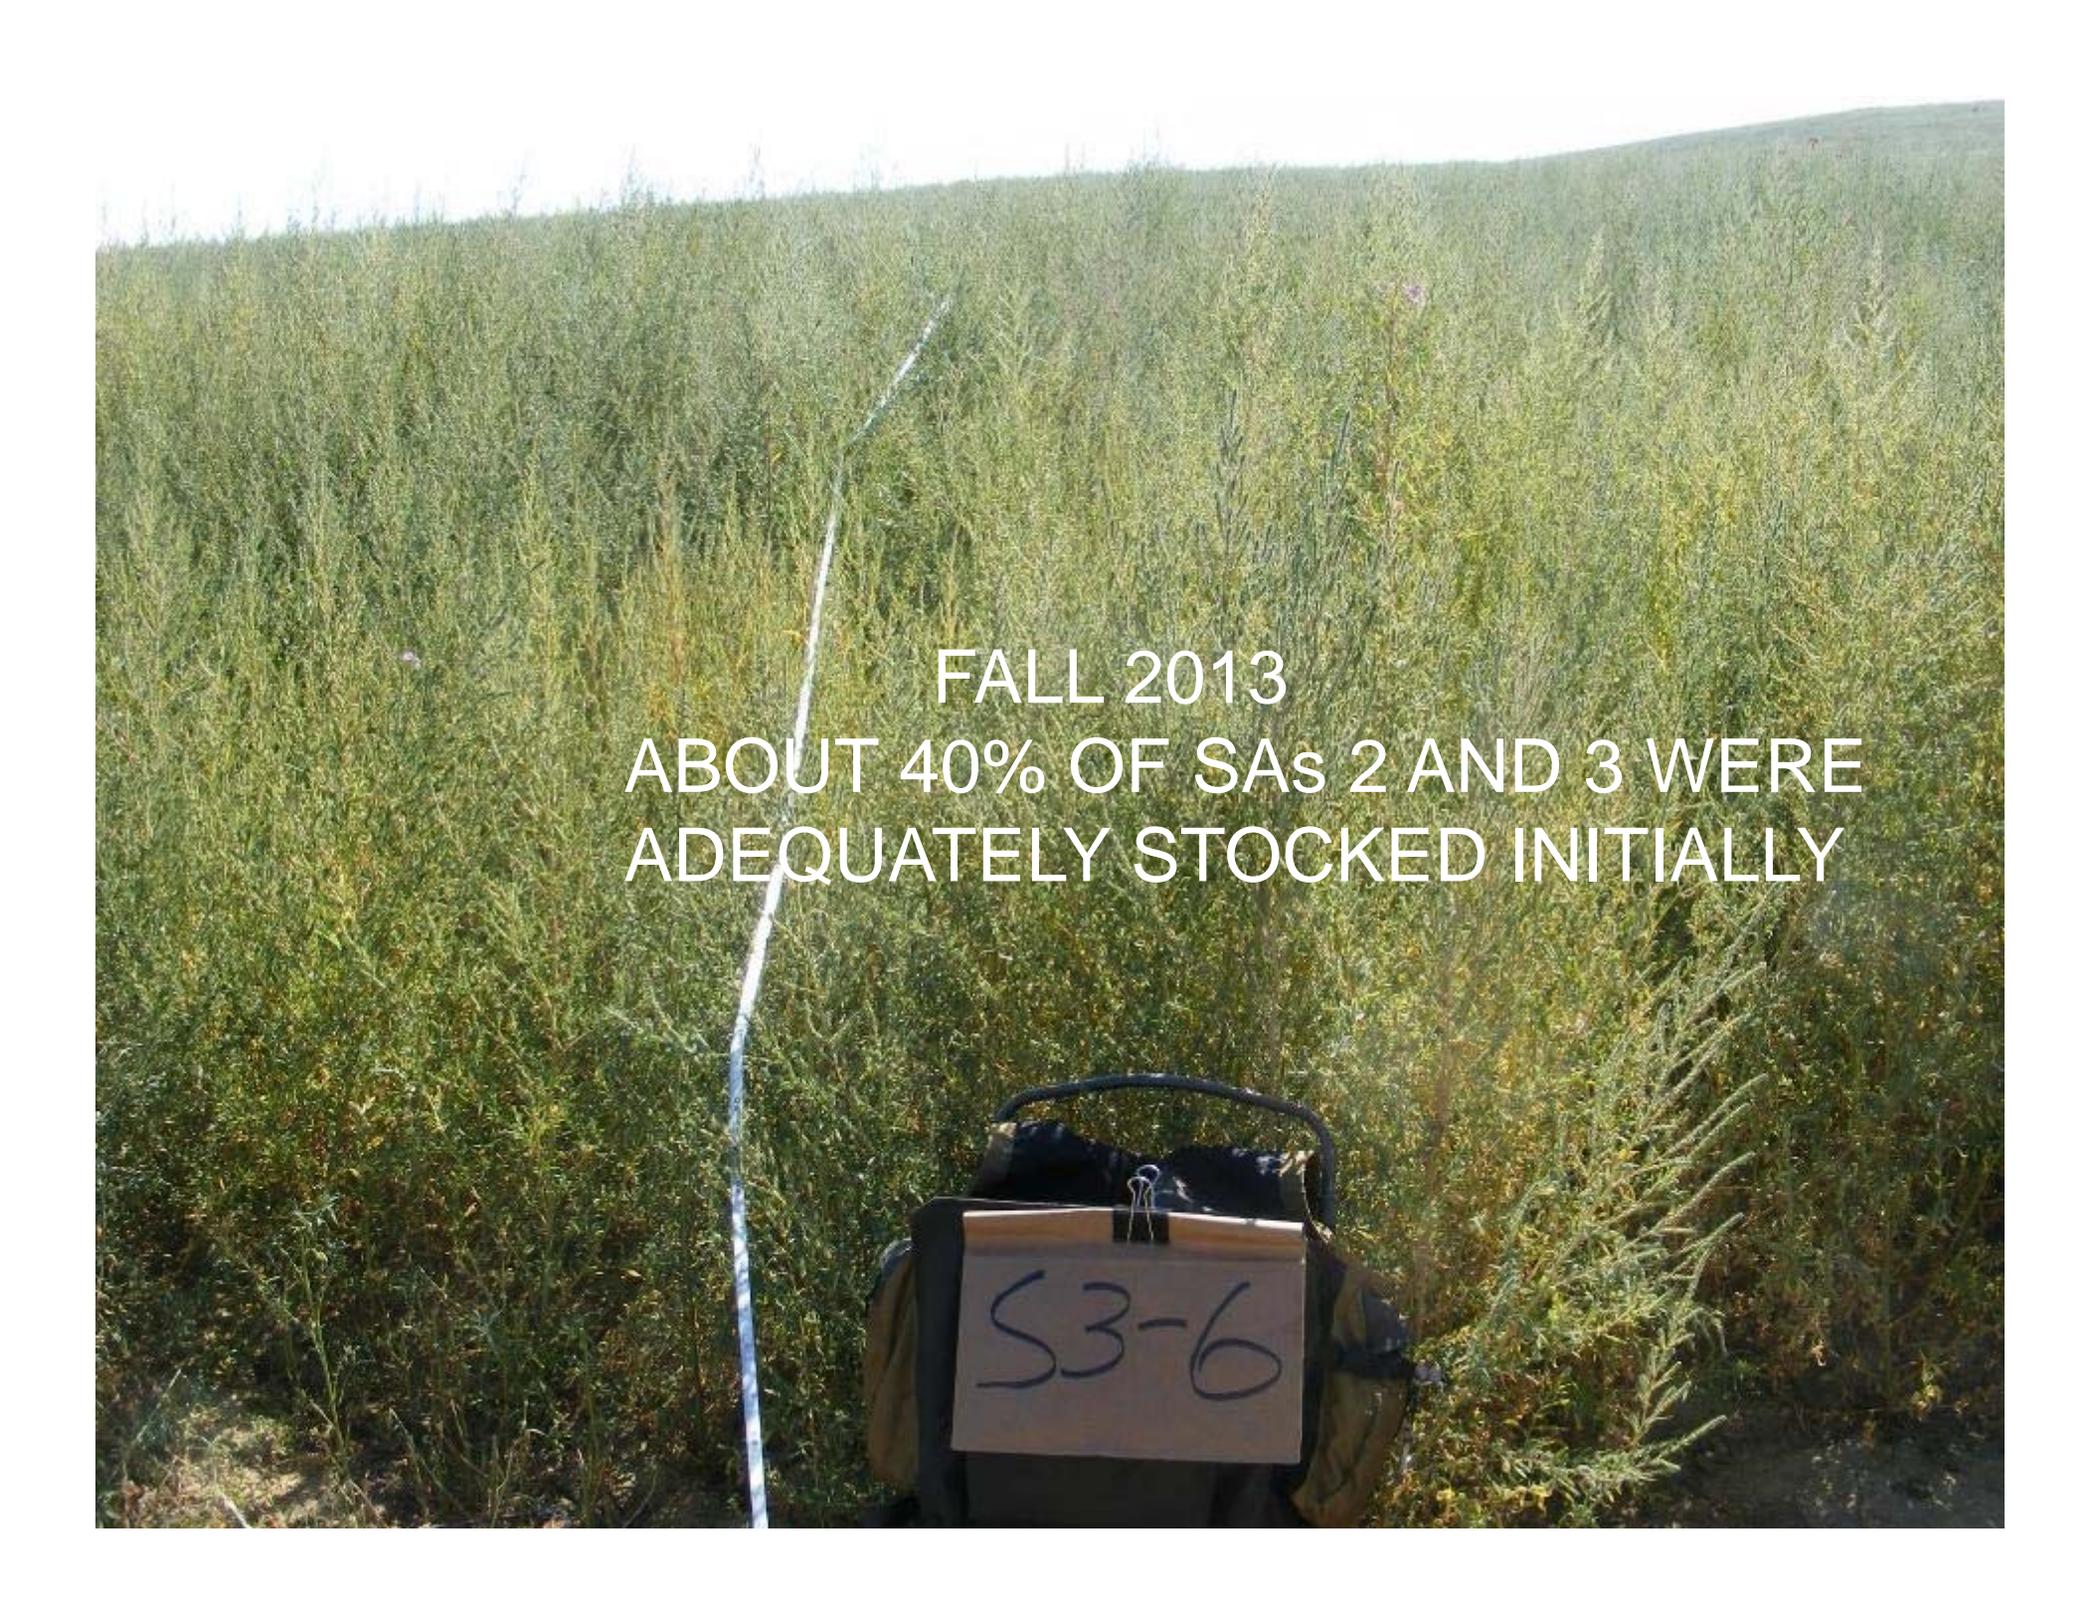
S3-7

A photograph of a field of tall, green grass. In the foreground, a white marker is visible, and a clipboard with a black handle is attached to it. The clipboard has a white sheet of paper with the handwritten text "S3-6" in black ink. The background shows a rolling hill under a clear sky.

FALL 2013
ABOUT 40% OF SAs 2 AND 3 WERE
ADEQUATELY STOCKED INITIALLY

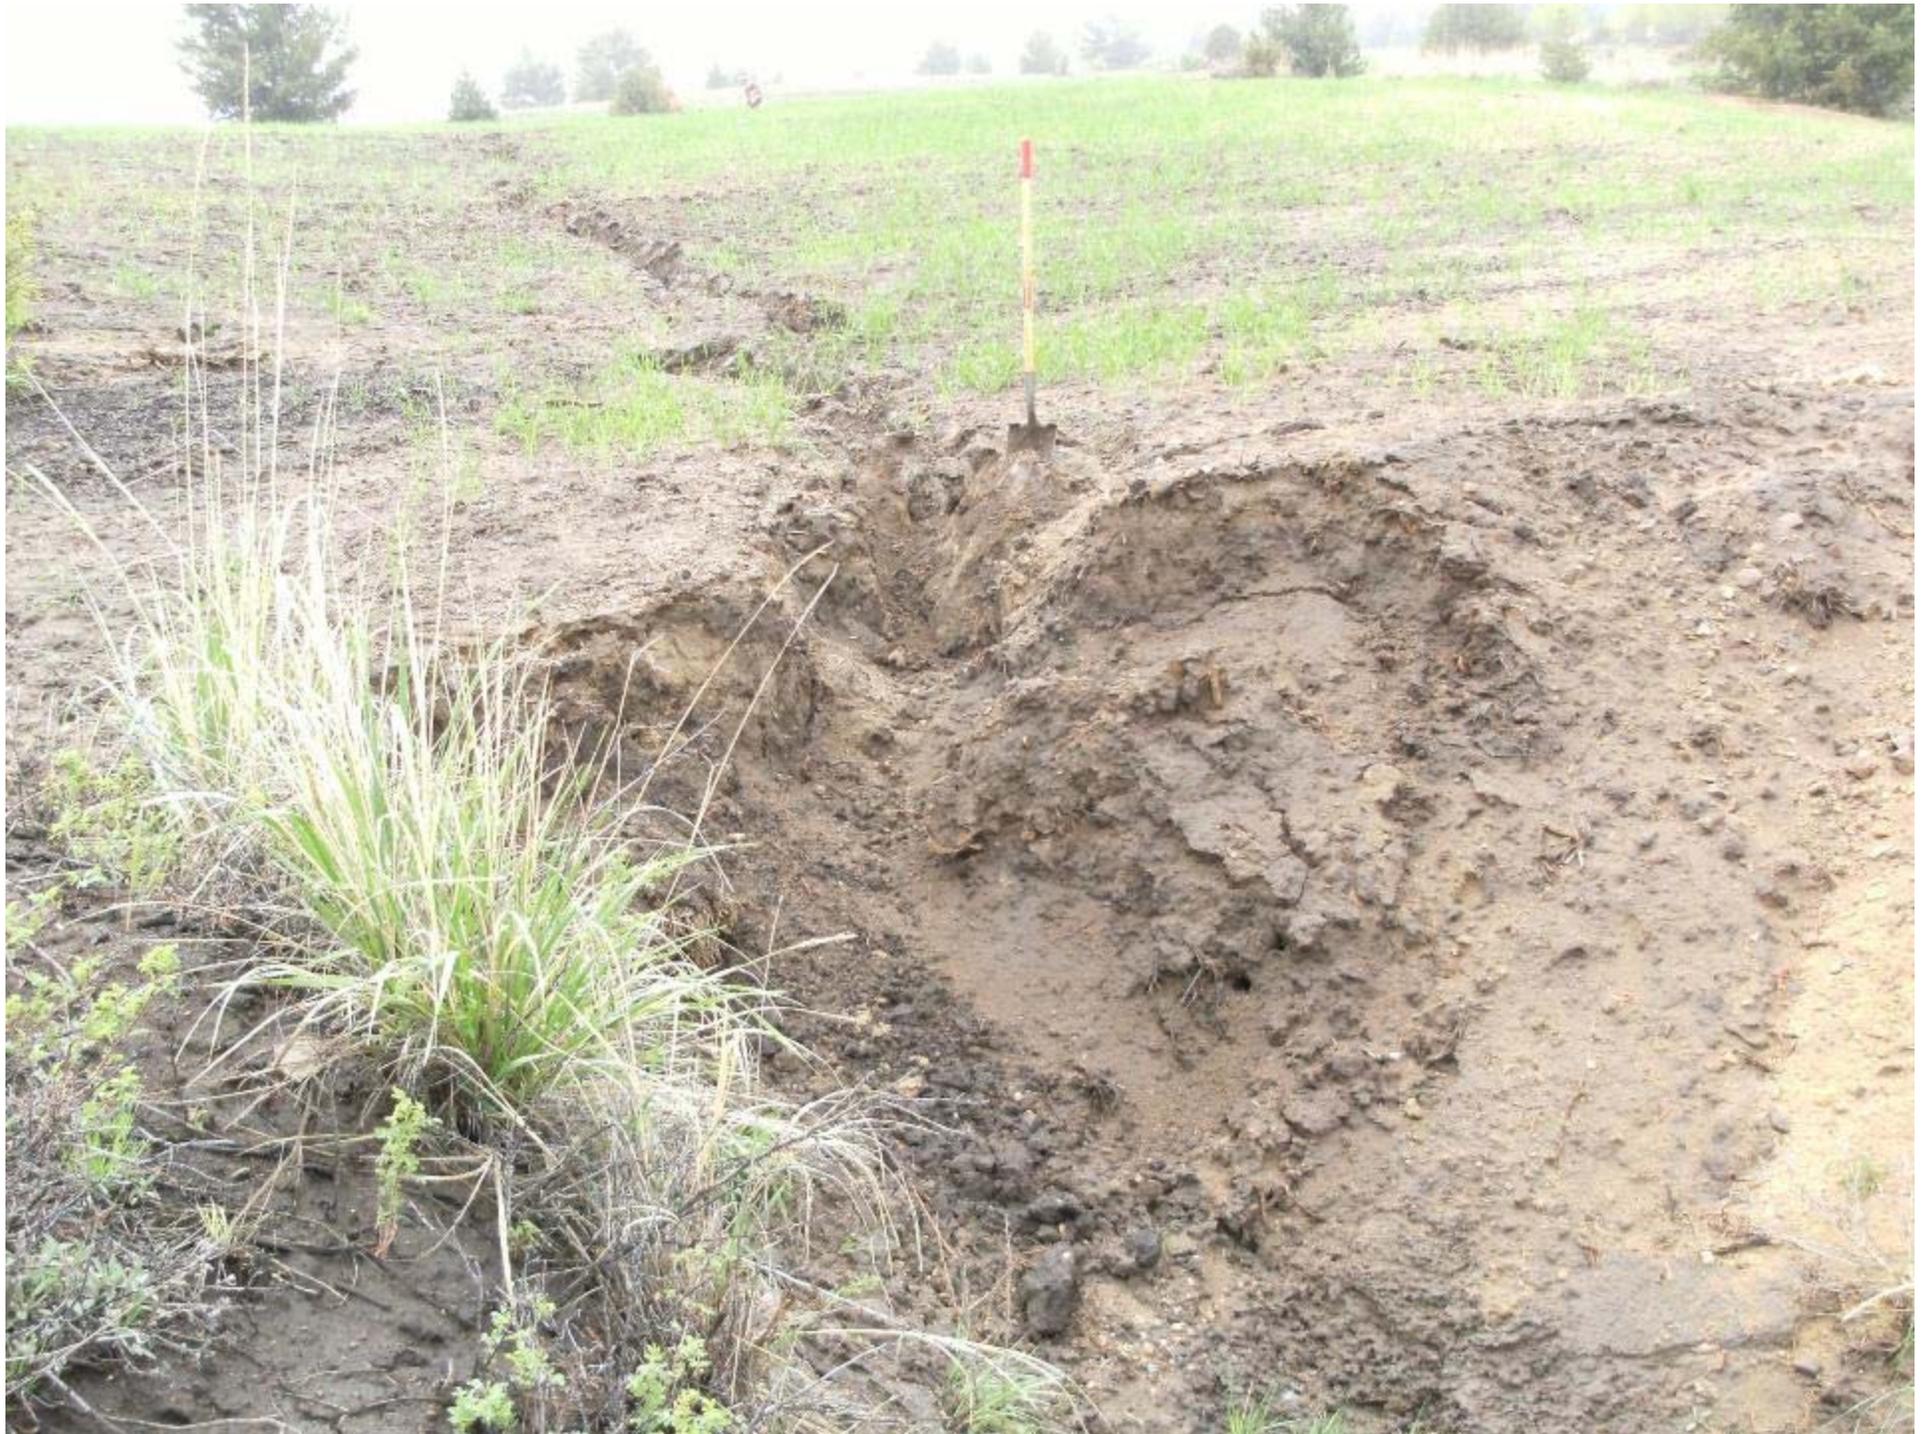
2013

Kochia auto-suppressed to provided 4% Relative Cover in 2016

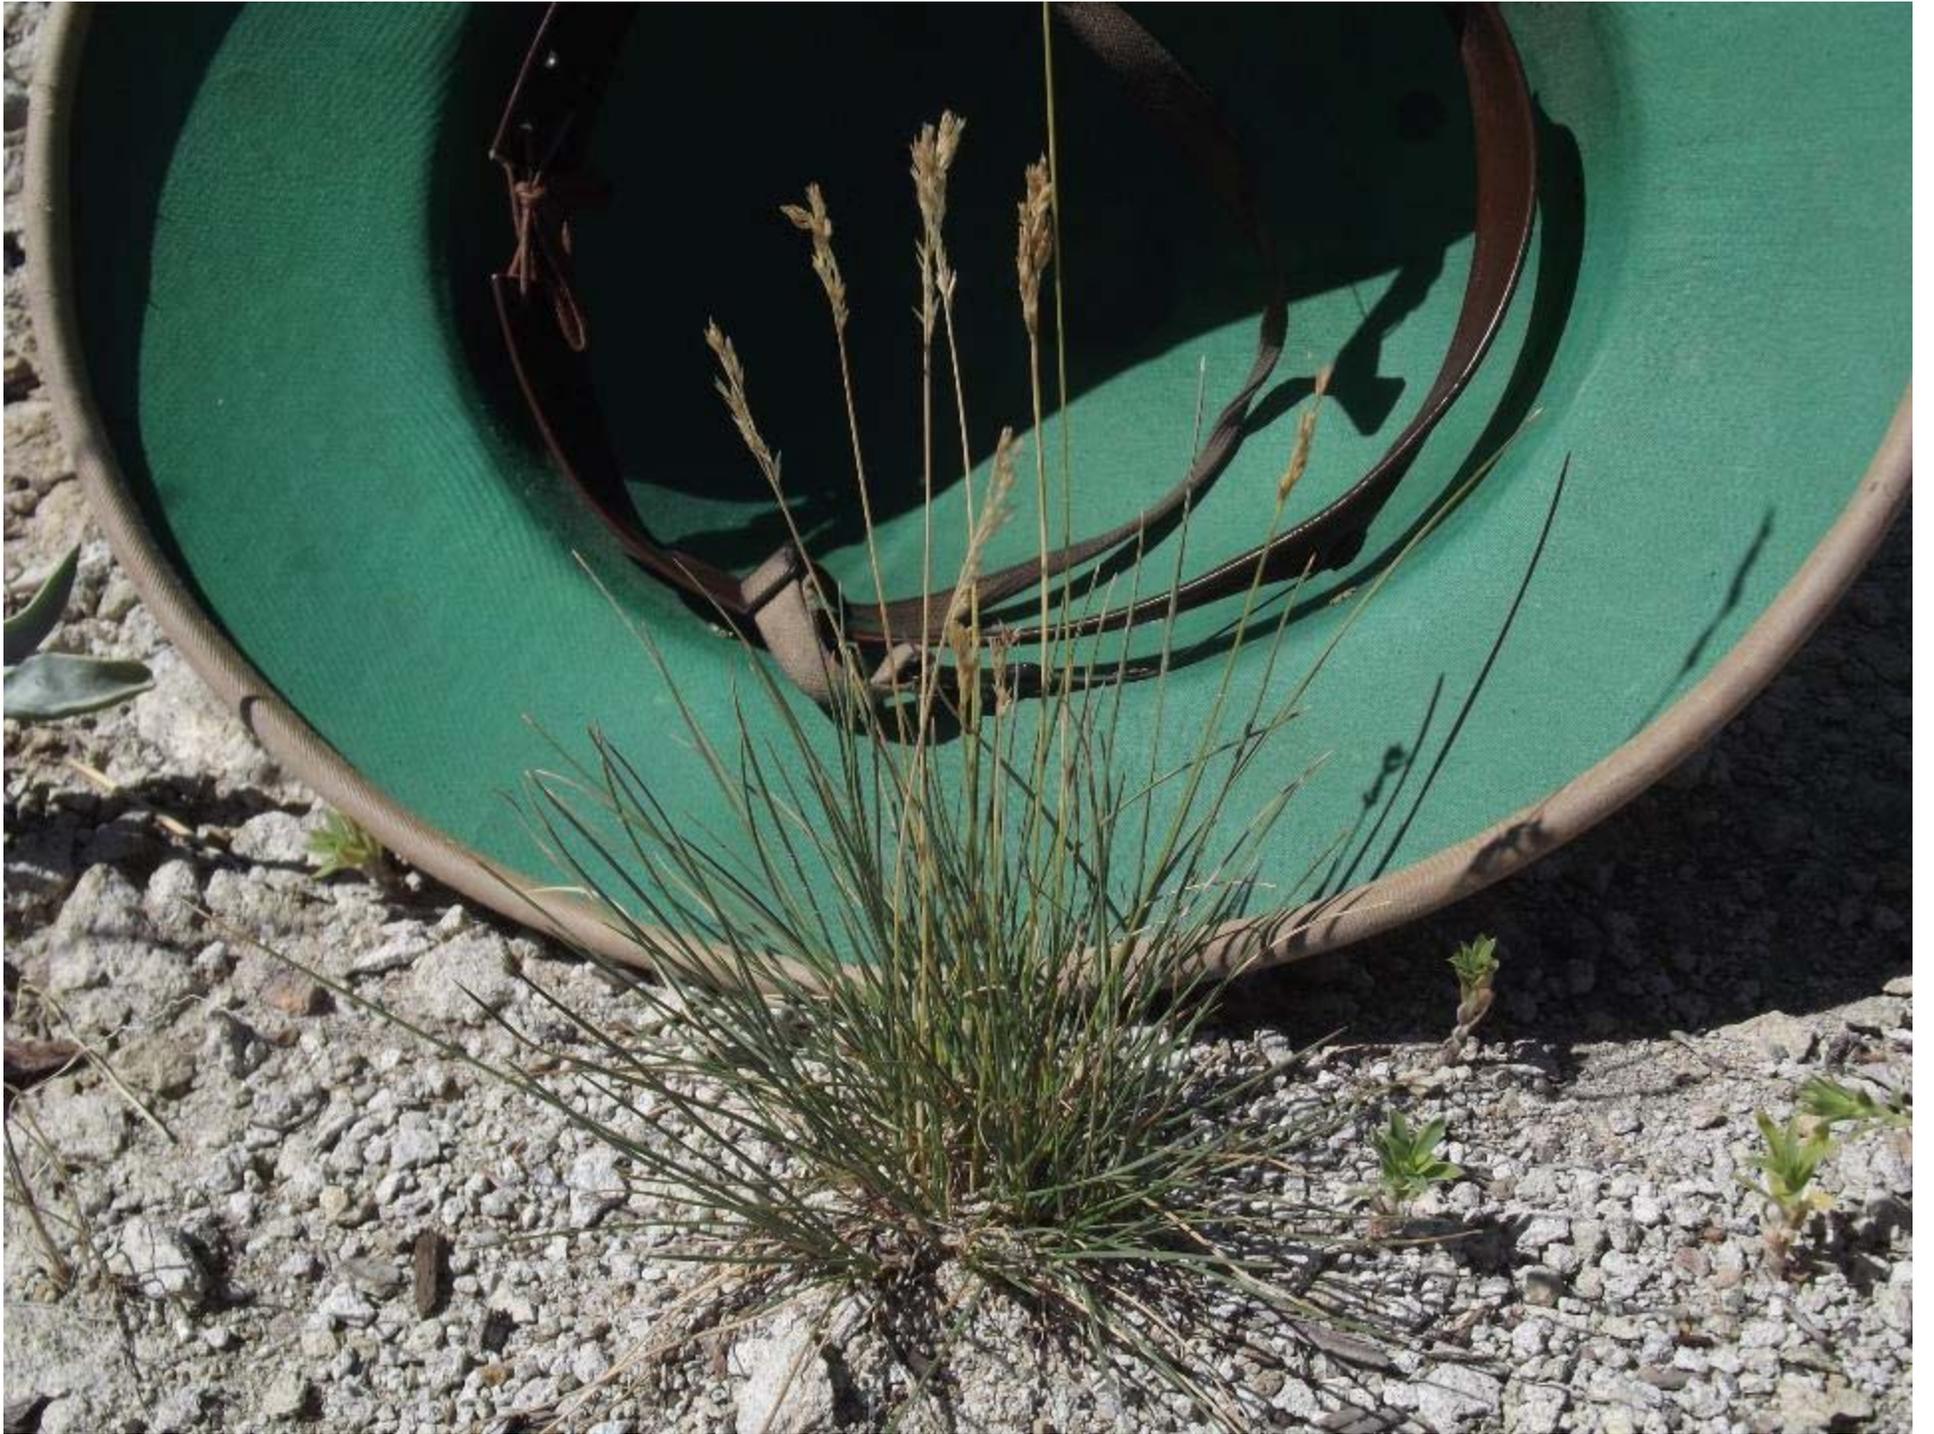
Copperhead Slender
Wheatgrass 29%
relative cover in 2016
PHOTO 2014
