REMEDIATING AND RESTORING SMELTER-DEVASTATED LANDS NEAR ANACONDA, MONTANA

State
owned
area for
remedy
and
restoration

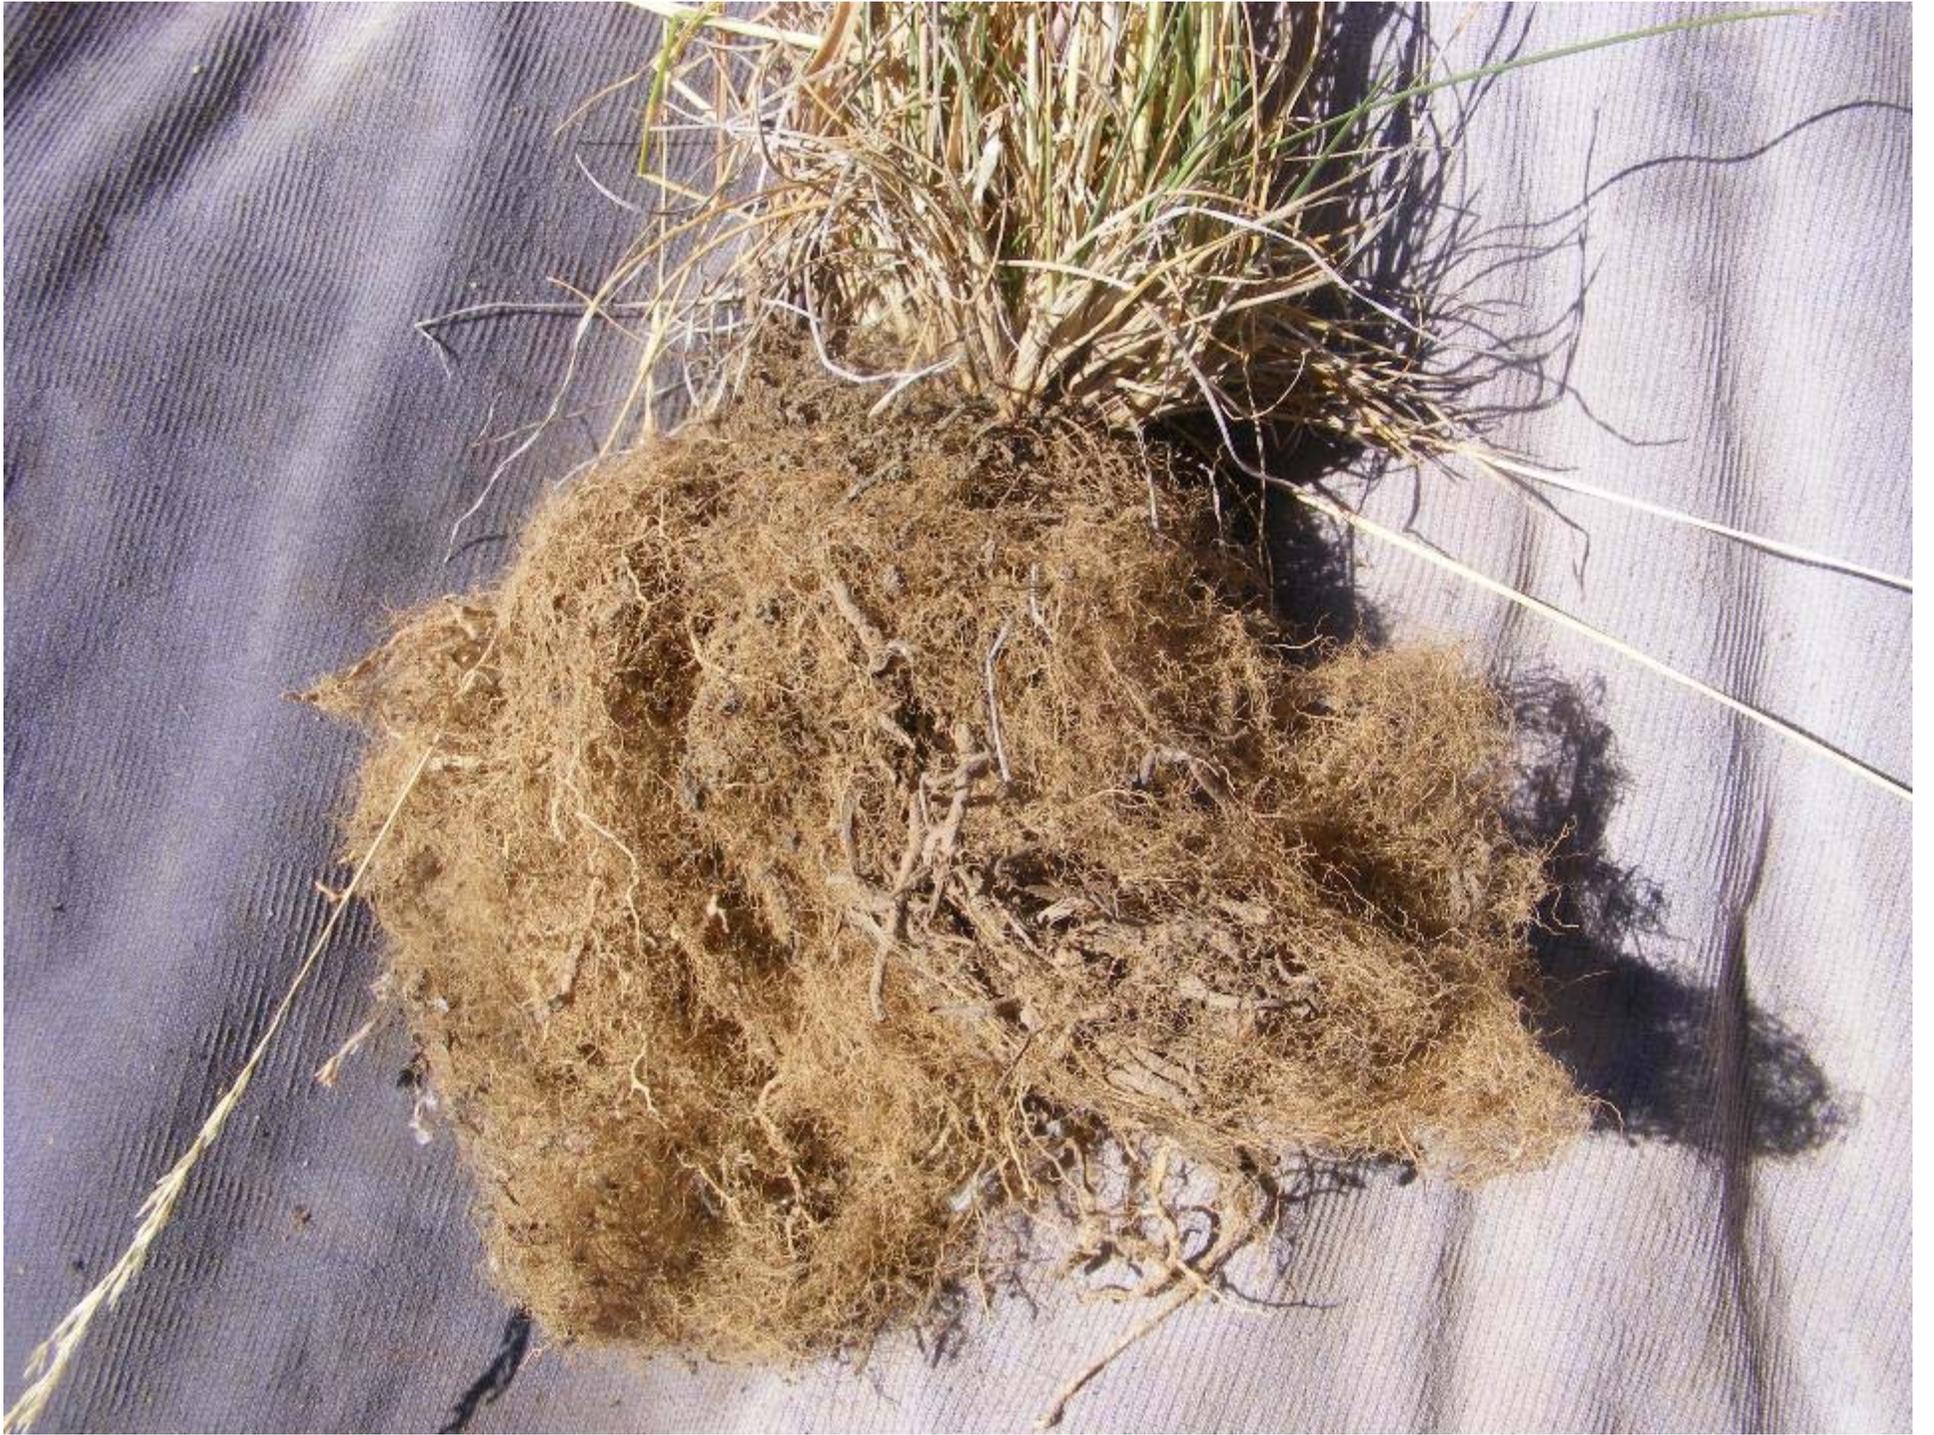
Opportunity
Nevada bluegrass 35%
Relative cover in 2016

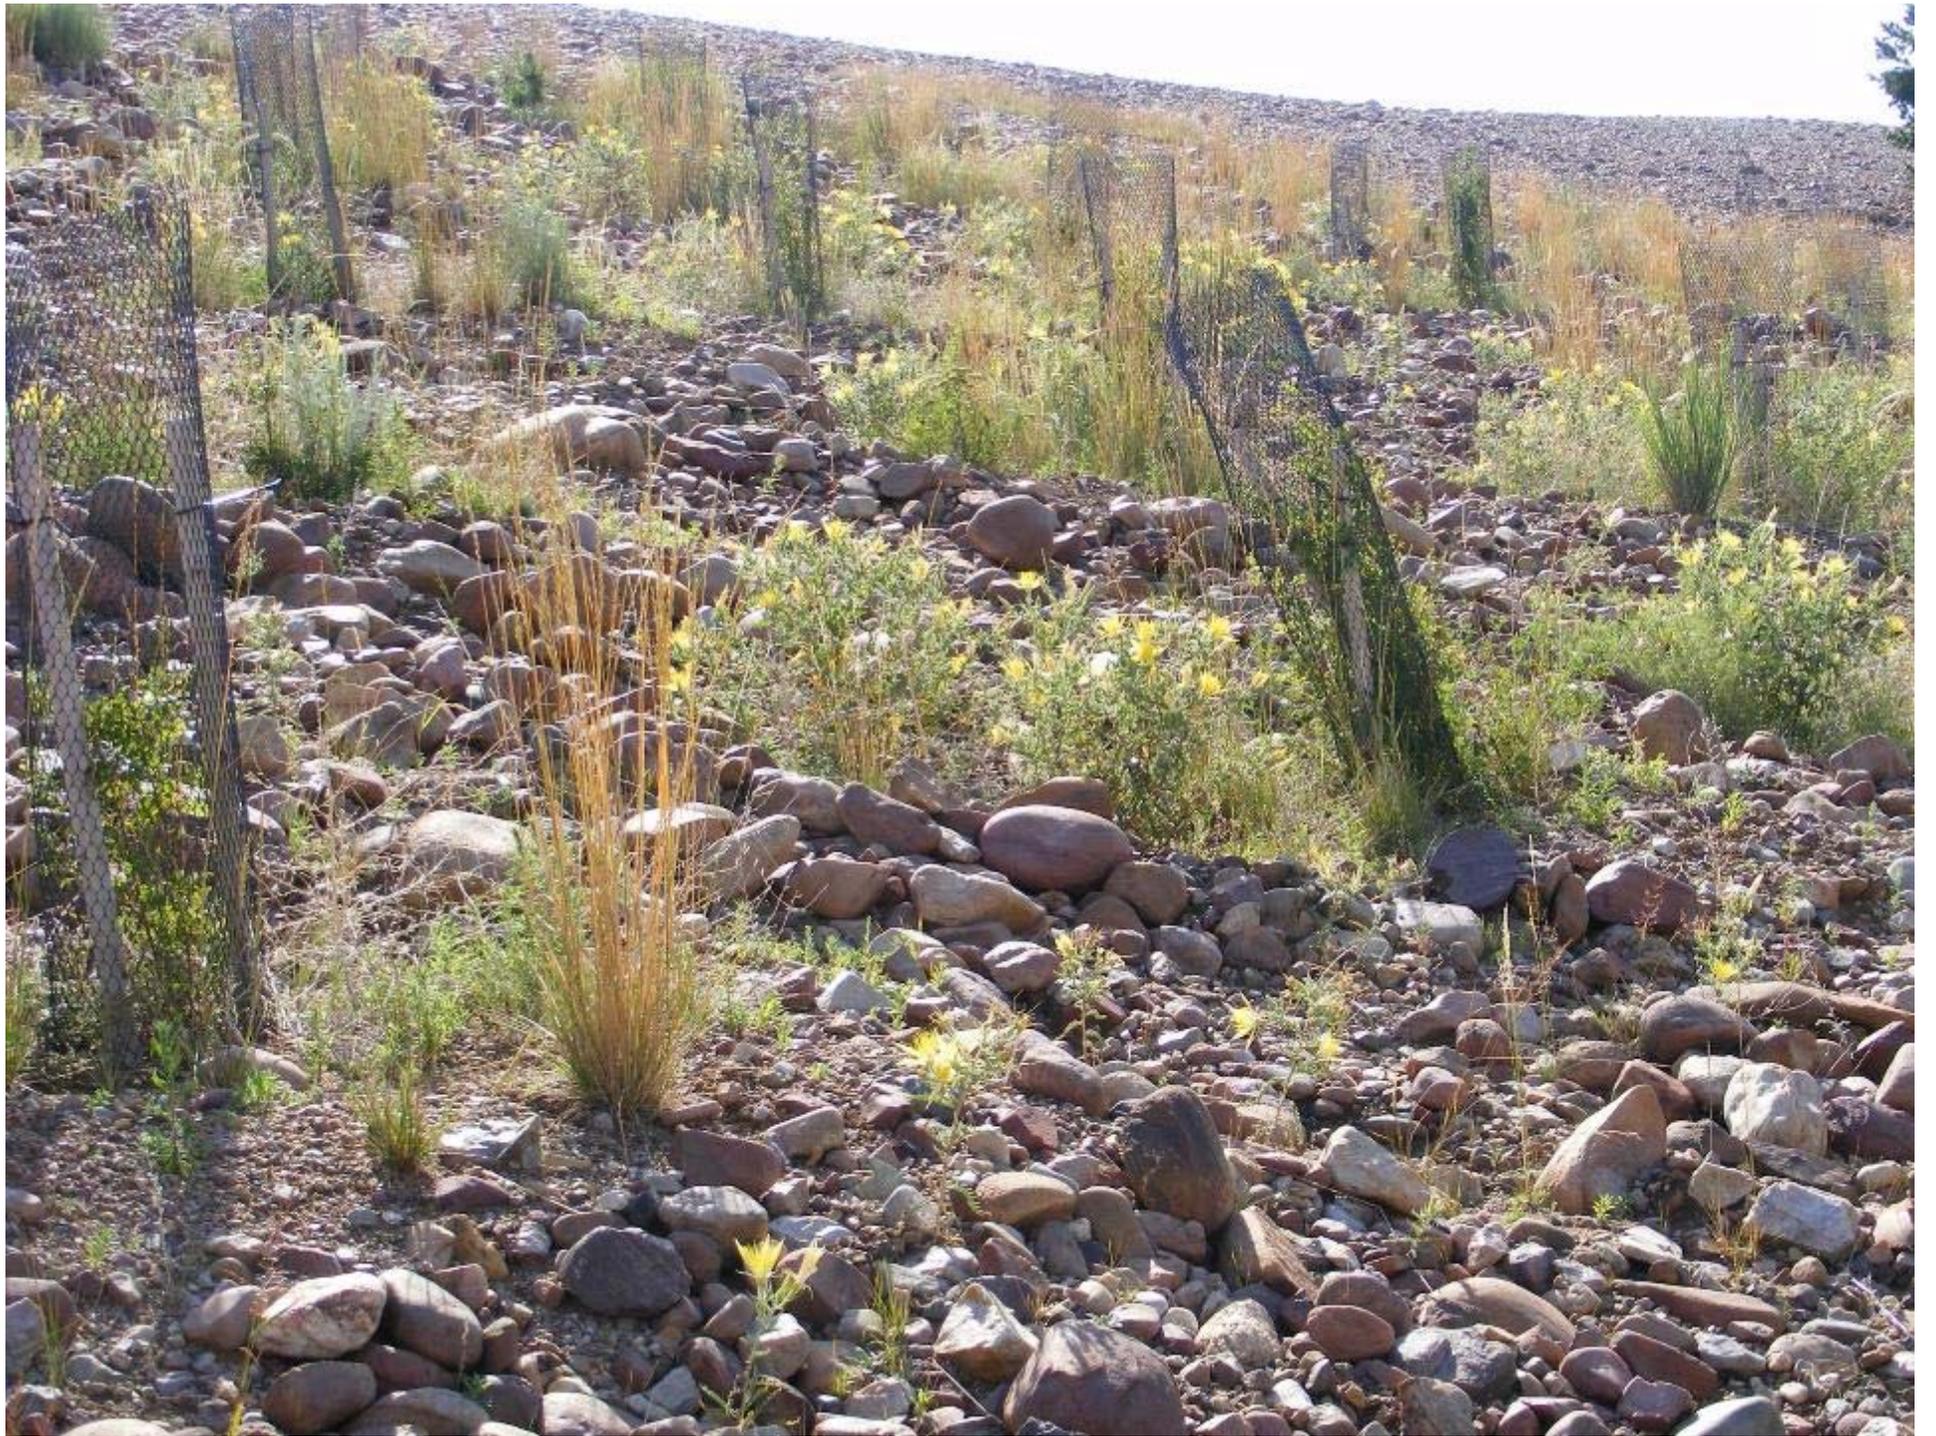
UPLIFTED TERTIARY FLUVIAL DEPOSITS
SIT UNCONFORMABLY ON REWORKED MUDS.
MATRIX ERODED AWAY LEAVING A LAG OF COBBLES.
