# Common Problems at Precious and Base Metal Mines with Sulfide Ores

## Permeable Reactive Barrier for Tailings Dam Drainage Channel

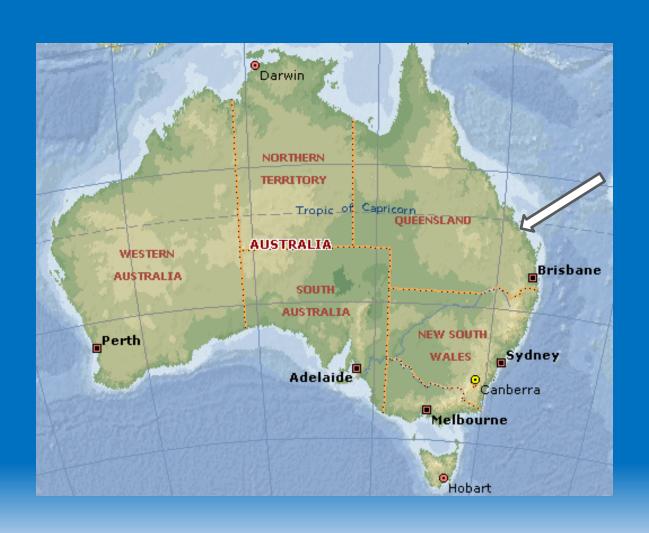
# Queensland Alumina Complex Gladstone, Qld.

### Queensland Alumina Red Mud Handling

- As a fresh water conservation measure, the red mud is piped to the pond in a slurry with seawater.
- The pond is also flushed with tidewater every day.
- As a result the red mud at QAL is neutralized by seawater.

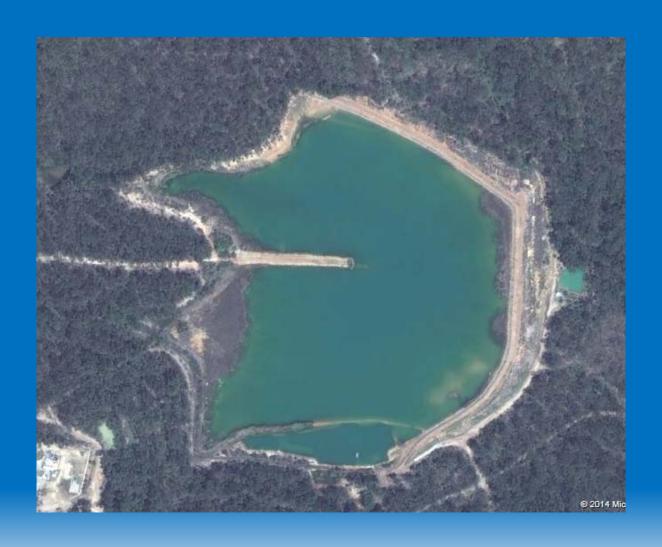
### Tailings Pond Area

### Mount Carrington Mine – Environmental Problems

- Sulfide-rich rock on tailings dam was main source of ARD and metal leaching.
- During dry season, evaporation concentrates metals in water.
- Toe pond was the route followed by discharges of ARD and leached metals to surface water.
- The toe pond was cleaned up first, followed by the drainage to the toe pond from the dam face.

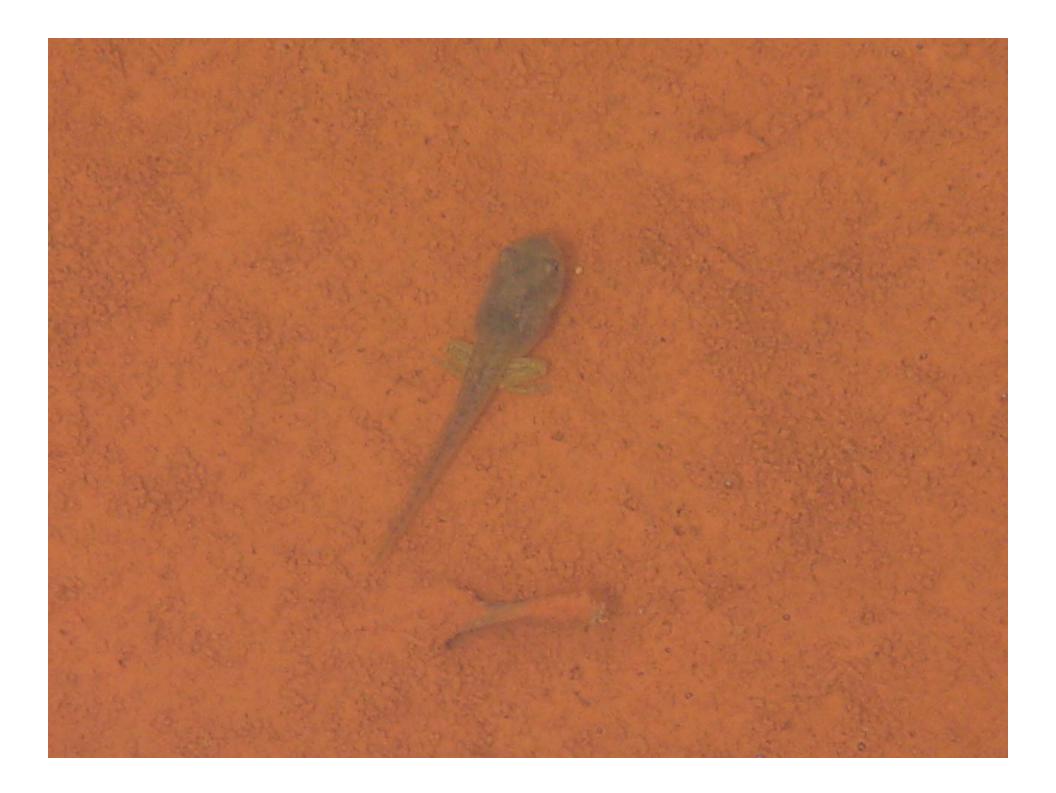
#### Toe Pond Cleanup

- A Bauxsol slurry was applied to the pond (approx. 100 X 100 ft)
- The Bauxsol raised the pond pH from about 3.0 to 8.5 and achieved ANZECC standards for surface water.
- A layer of Bauxsol lined the bottom of the pond, intercepting and cleaning any metalsladen water infiltrating.

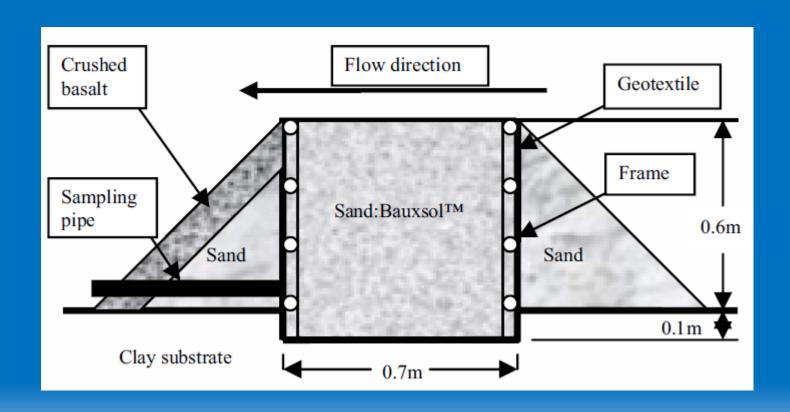
# Permeable Reactive Barrier for Tailings Dam Drainage Channel

- A mixture of 25% Bauxsol and 75% sand was used in the barrier.
- Water residence time in the PRB is about 2 hours 20 minutes.
- PRB effluent meets ANZECC standards.

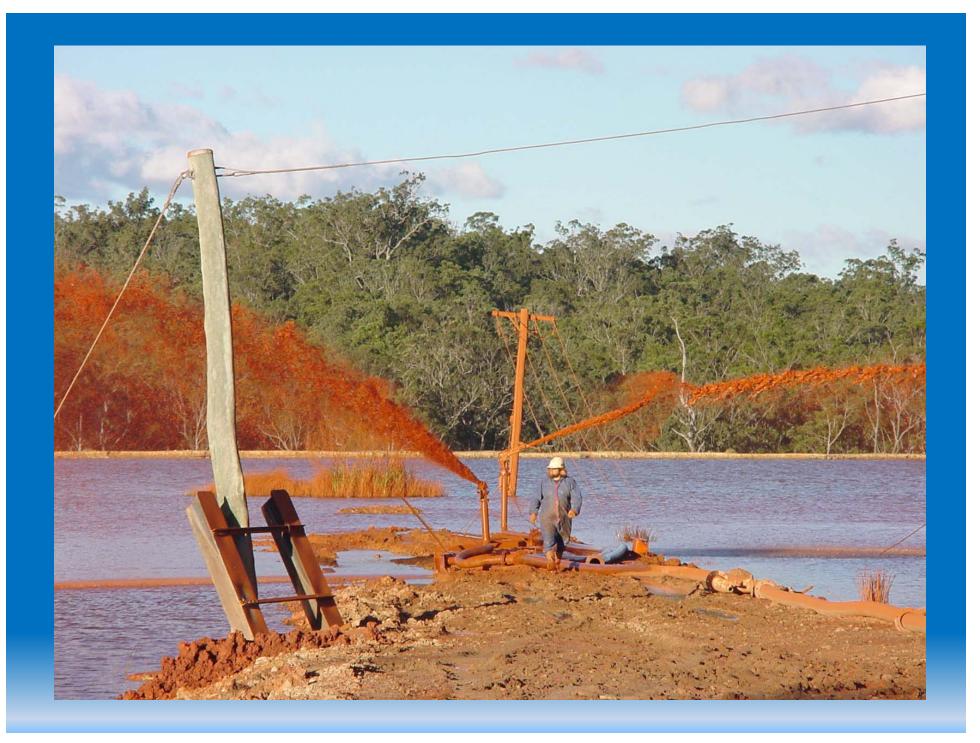
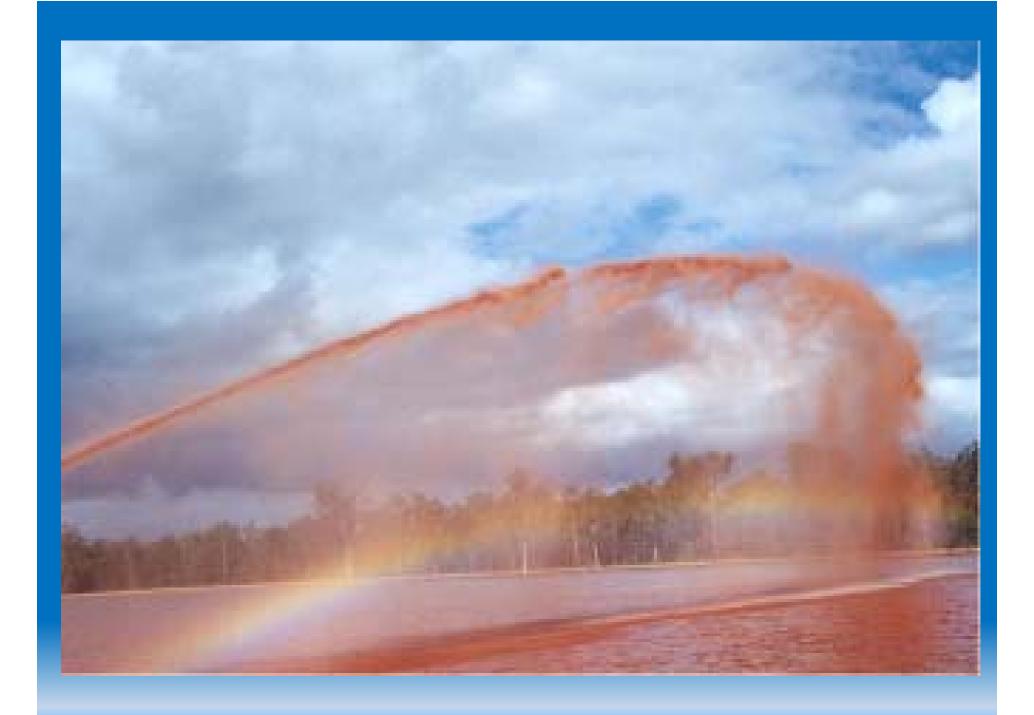
#### **Tailings Pond Cleanup**

- Except for the size of the pond (750 X 1000 ft), the same method was used as in the toe pond.
- Bauxsol slurry was applied using monitors.
- Pond water was suitable for discharge.
- Some water was left in the pond to keep Bauxsol protective blanket and tailings wet.

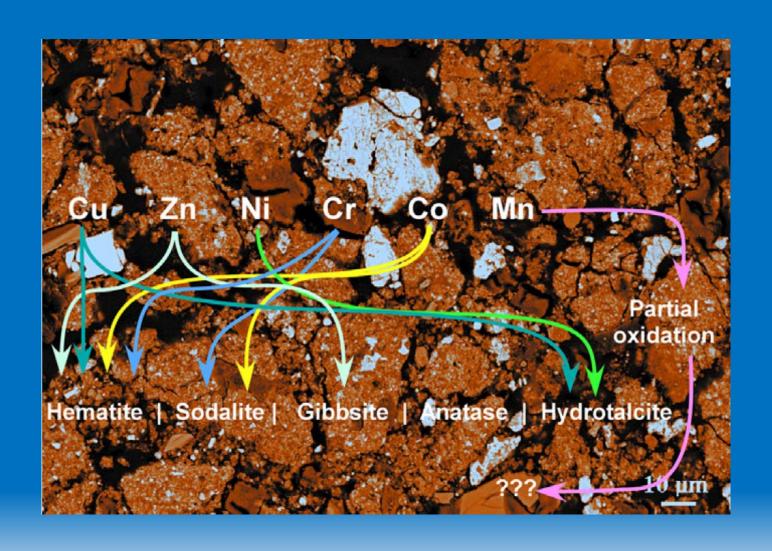
### **Binding of Specific Metals**

- Precipitation of minerals on Bauxsol mineral surfaces
- Substitution in recrystallized minerals
- Ion exchange and adsorption are minor mechanisms.
- Stability increases with time.

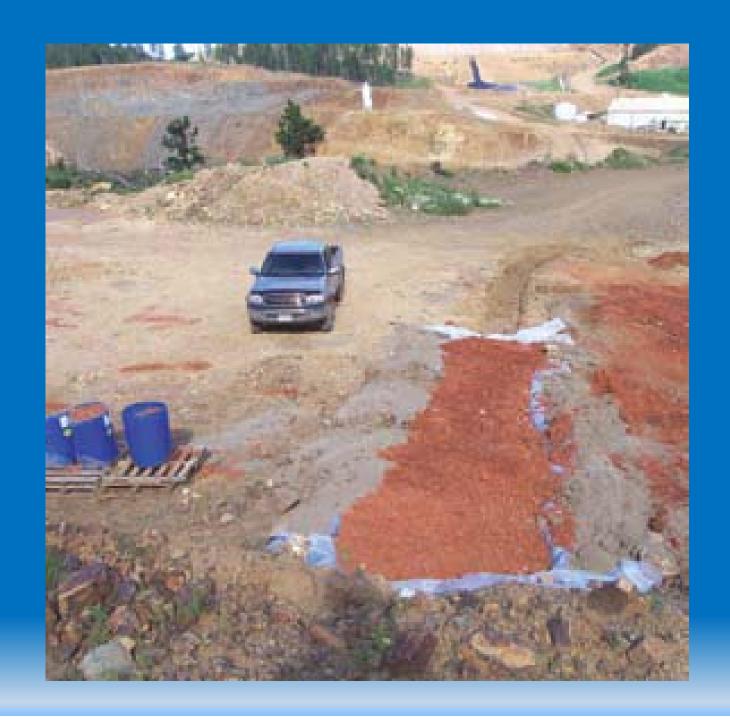
#### Trench Test for Waste Rock Treatment

A lined trench was filled with 20 m³ of a mixture of 90% acid-generating rock and 10% Viromine Acid B Extra<sup>TM</sup>.

Water flowed through this trench and was sampled upstream and downstream.

The test ran from 2001 to 2004.

Control	Result	Result	Result
Analyte - Units	2003	2001	2002	2003
pН	1.93	7.9	7.96	
Acidity (mg/L as CaCO <sub>3</sub> )	49,000	4	<lld (5)<="" th=""><th><lld (5)<="" th=""></lld></th></lld>	<lld (5)<="" th=""></lld>
Alkalinity (mg/L as CaCO <sub>3</sub> )	<lld (5)<="" th=""><th>90</th><th>62</th><th>66</th></lld>	90	62	66
TDS (mg/L)	77,000	11,500	8,300	3,000
Sodium (mg/L)	9,300	2,970	2,990	570
Sulfate (mg/L)	55,000	6,000	5,800	2,200
$\mathbf{Ag}\;(\mu g/L)$	150	<lld (1)<="" th=""><th>1.1</th><th><lld (5)<="" th=""></lld></th></lld>	1.1	<lld (5)<="" th=""></lld>
Al $(\mu g/L)$	1,200,000	<lld (50)<="" th=""><th>10</th><th>66</th></lld>	10	66
As $(\mu g/L)$	35,000	3.1	3.7	<lld (10)<="" th=""></lld>
$Cd \; (\mu g/L)$	630	<lld (1)<="" th=""><th>0.4</th><th><lld (1)<="" th=""></lld></th></lld>	0.4	<lld (1)<="" th=""></lld>
$\text{Co}\left(\mu\text{g/L}\right)$	2,200	1.5	11	<lld (10)<="" th=""></lld>
$\mathbf{Cr}\left(\mu\mathbf{g}/L\right)$	390	<lld (1)<="" th=""><th>12</th><th><lld (10)<="" th=""></lld></th></lld>	12	<lld (10)<="" th=""></lld>

$Cu~(\mu g/L)$	33,000	8.2	7.2	<lld (10)<="" th=""></lld>
Fe $(\mu g/L)$	21,000,000	< LLD (25)	18	120
$\mathbf{Mn}\ (\mu g/L)$	34,000	17	0.3	<lld (10)<="" th=""></lld>
$Ni (\mu g/L)$	1,600	2.1	1.4	<lld (10)<="" th=""></lld>
$\textbf{Pb} \; (\mu g/L)$	390	<lld (2.5)<="" th=""><th>2.9</th><th><lld (10)<="" th=""></lld></th></lld>	2.9	<lld (10)<="" th=""></lld>
Sb $(\mu g/L)$	500	<lld (4)<="" th=""><th>48</th><th><lld (10)<="" th=""></lld></th></lld>	48	<lld (10)<="" th=""></lld>
$\mathbf{V}\left(\mu g/L\right)$	1,700	<lld (1)<="" th=""><th>1</th><th><lld (10)<="" th=""></lld></th></lld>	1	<lld (10)<="" th=""></lld>
Zn (µg/L)	29,000	42	21	<lld (10)<="" th=""></lld>
