Khayyam Mine EE/CA: Investigation Challenges and Risk-Based Justification for No- Action Response Prince of Wales Island, Alaska

By John Bingham, PE

Is No Action Ever a Cleanup Action?

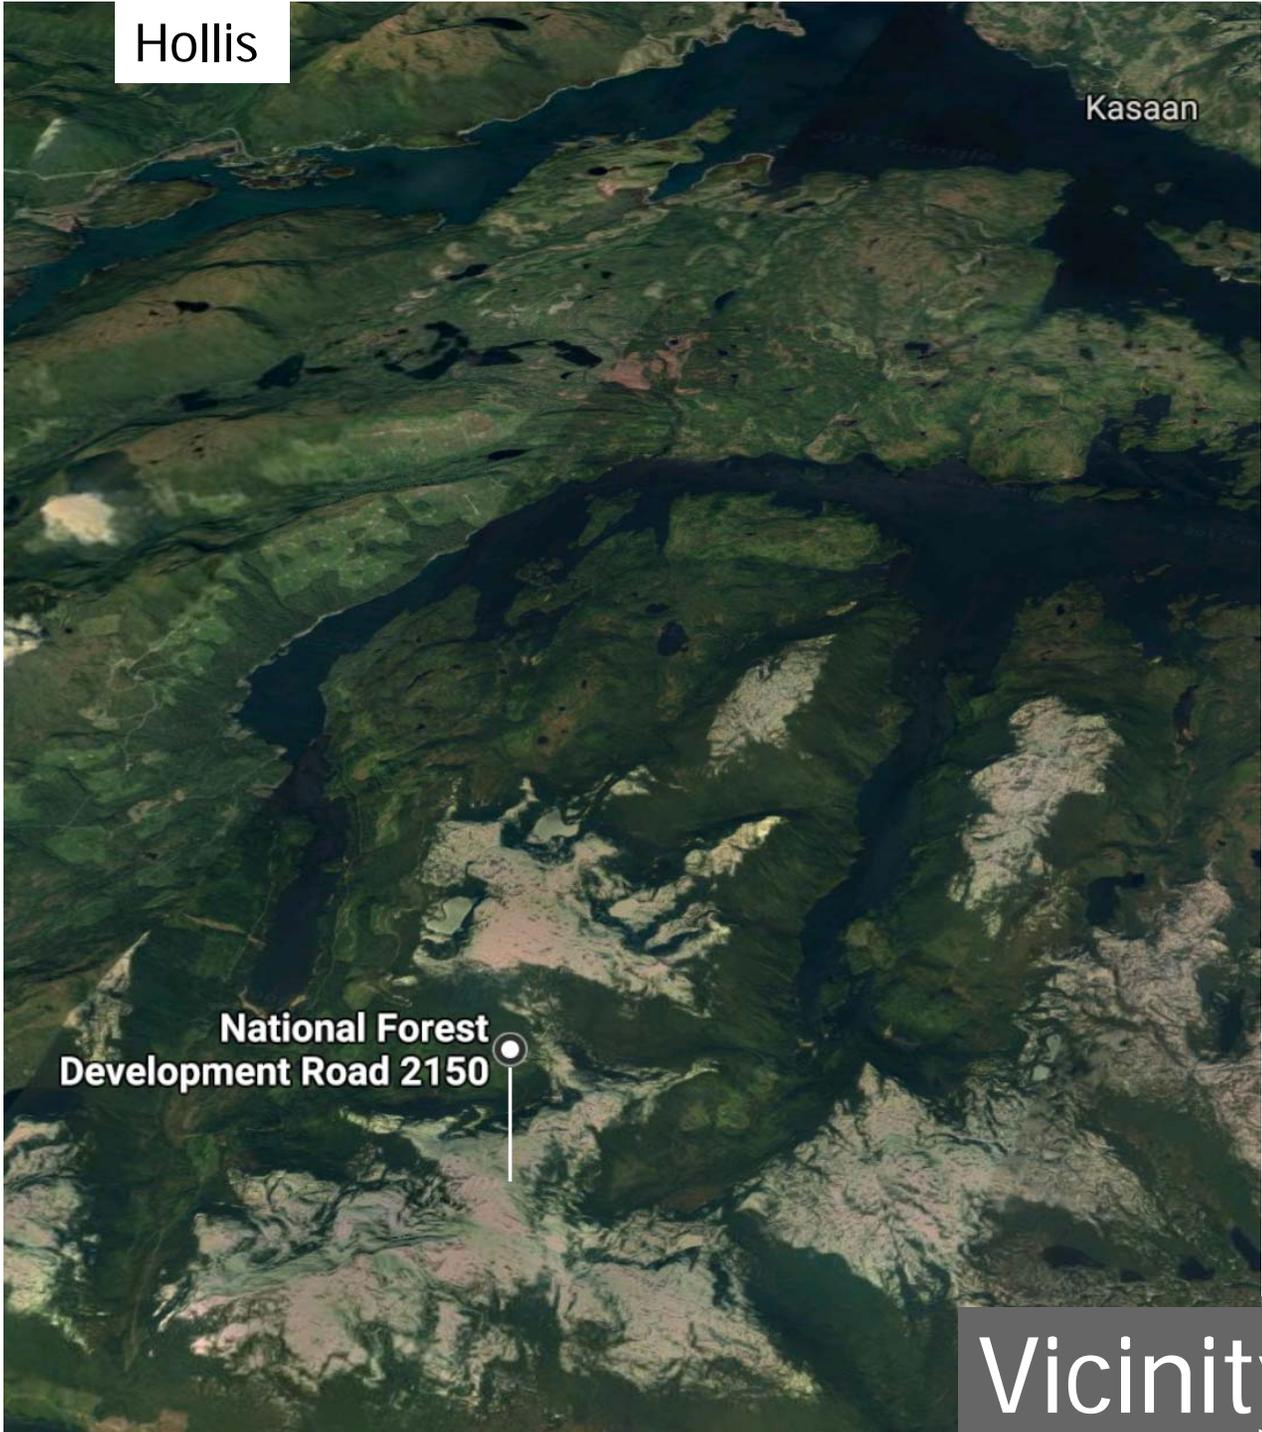
Vicinity Map

48 mi from
Hollis (140
people) on
ditched,
overgrown
logging road &
steep hike

National Forest
Development Road 2150

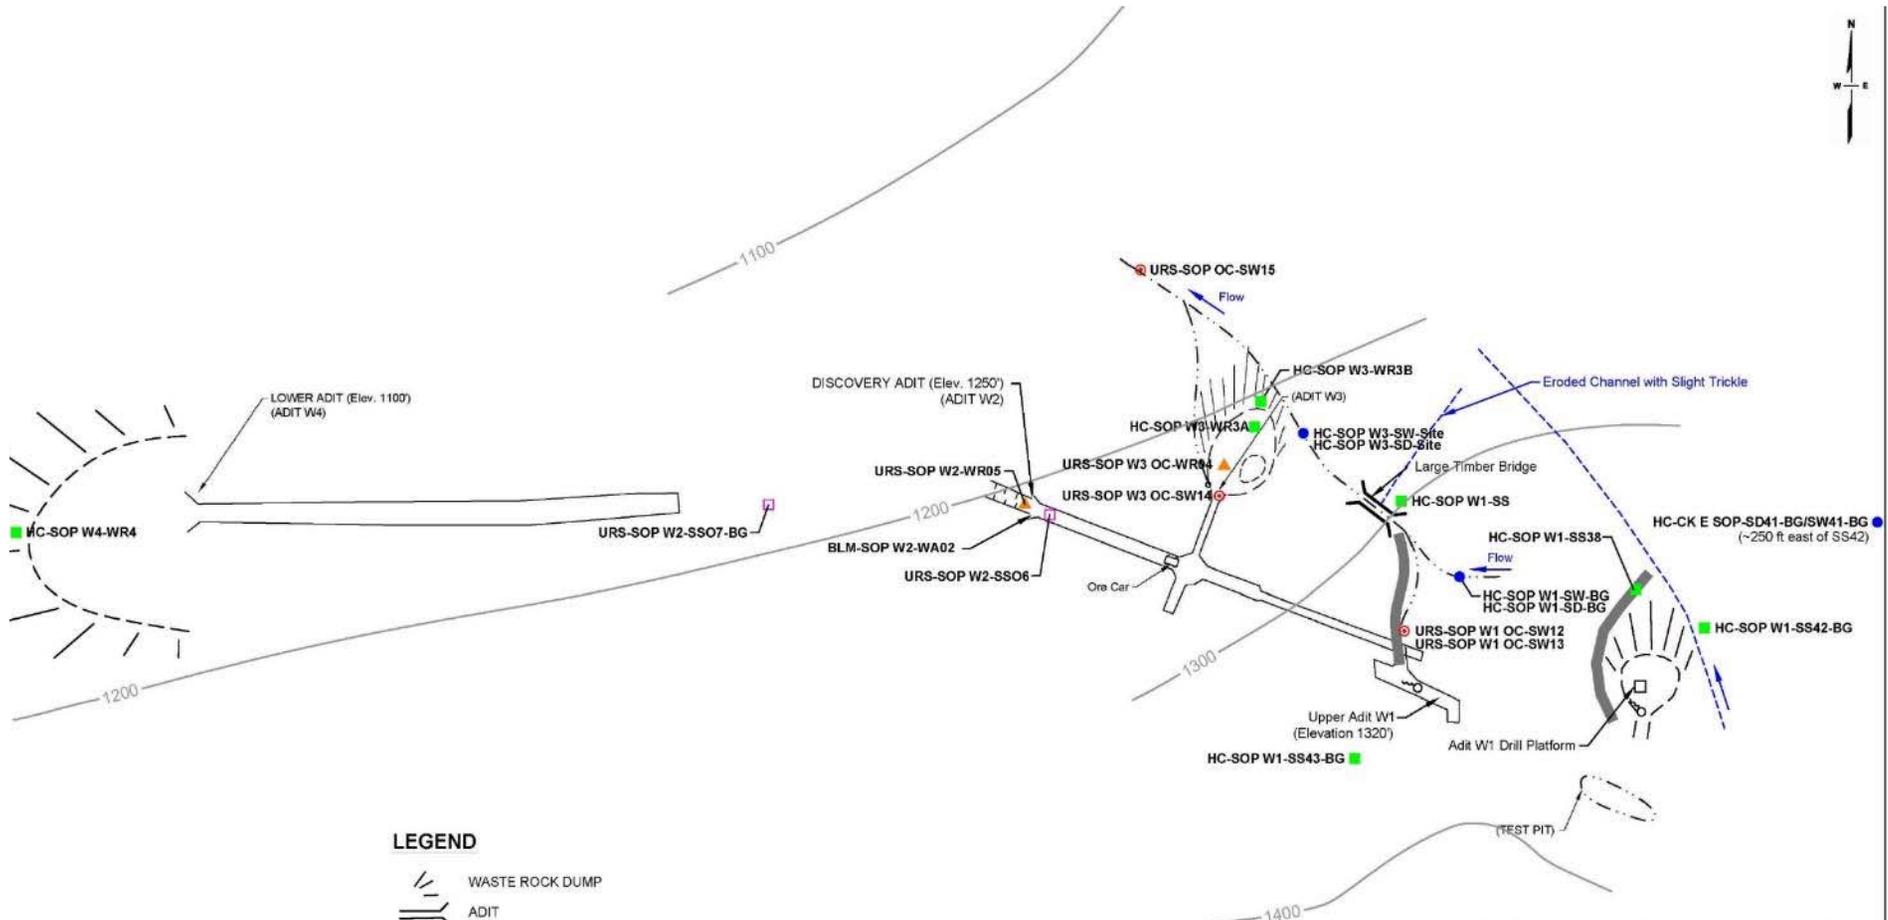
Khayyam Mine Prince of Wales Island, Alaska	
Stumble-On Prospect Site Layout and Sample Locations	
17567-00	2/11
	Figure 4

Note: Sample locations based on location relative to mine features and elevation contours on base map, but base map does not necessarily match Figure 4.

Stumble on Prospect

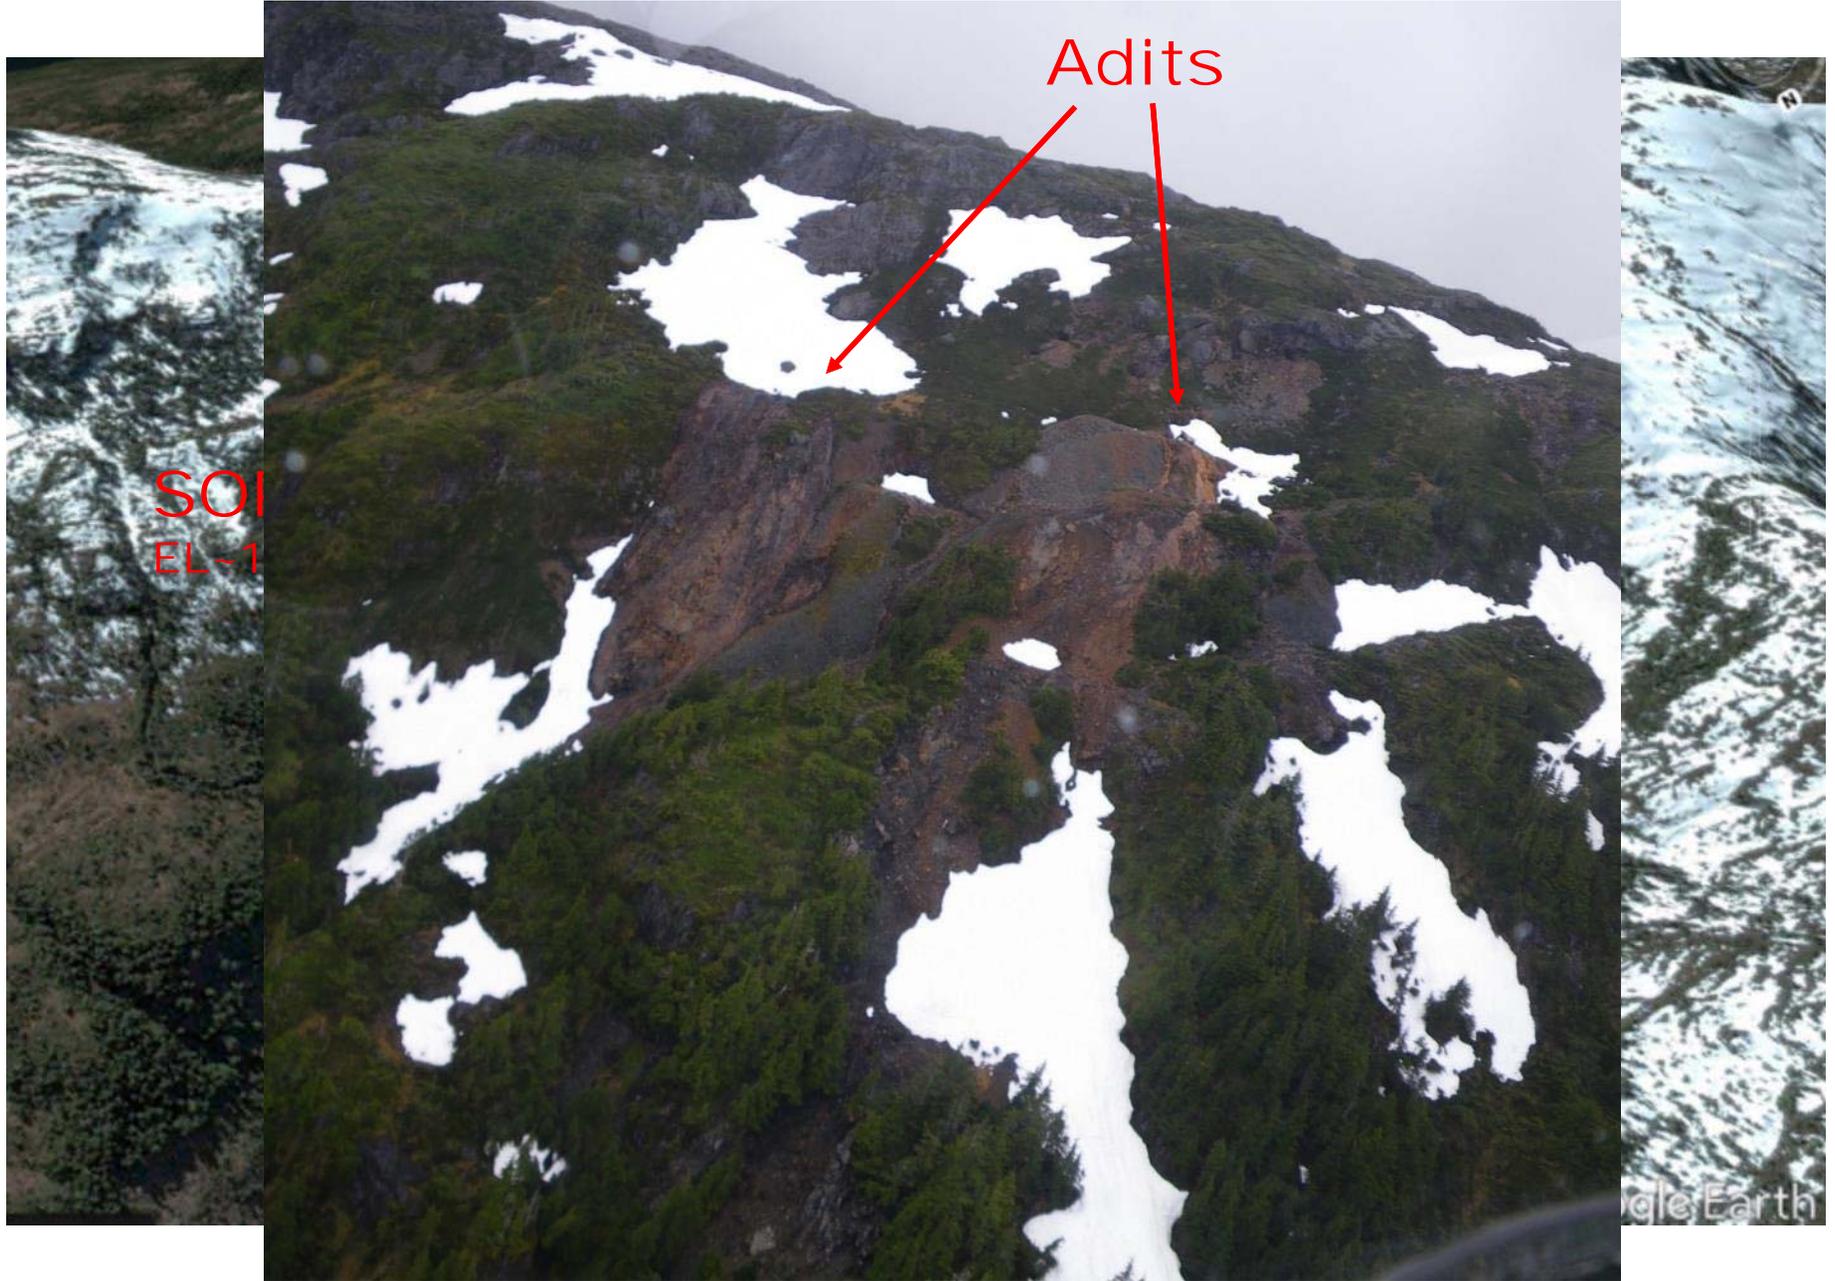
Surface Water Flow Path

- Surface water chemical results:
 - Khayyam Mine, Stumble on Prospect seeps:
 - Elevated metal concentrations > RBSC.
 - Ferric hydroxide precipitate (yellow boy) & field pH (2.8 – 6.7) indicative of AMD
 - Adit seeps mostly infiltrate near adits, but some go to small perennial tributaries of Omar Ck
 - Surface water & groundwater had no human health & ecological receptor complete pathways

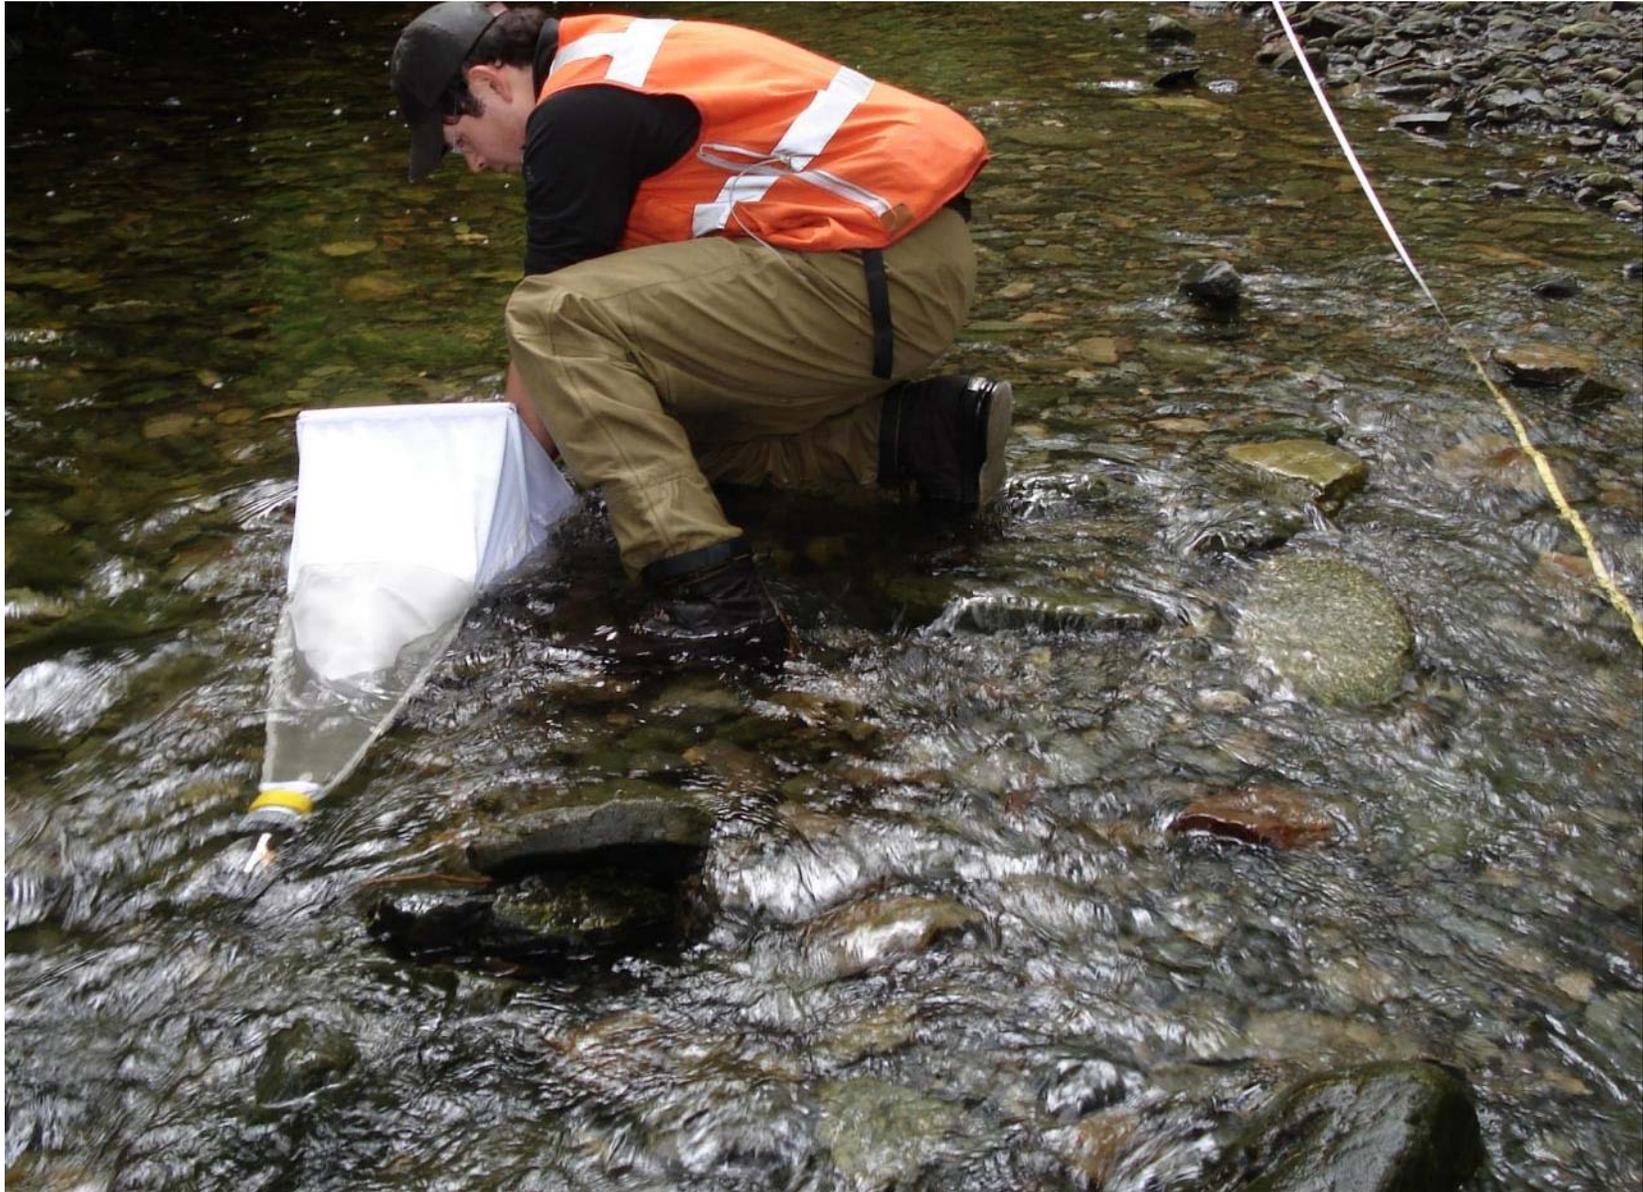
RBP Bug Surveys

- Human Health: no complete pathways for solid media or water
- Ecological:
 - 2 seasons of bug surveys in Omar Ck & reference creeks showed no adverse impacts to aquatic receptors despite some elevated metal concentrations in SW
 - Potentially complete pathways were identified for exposure of ecological receptors to solid media

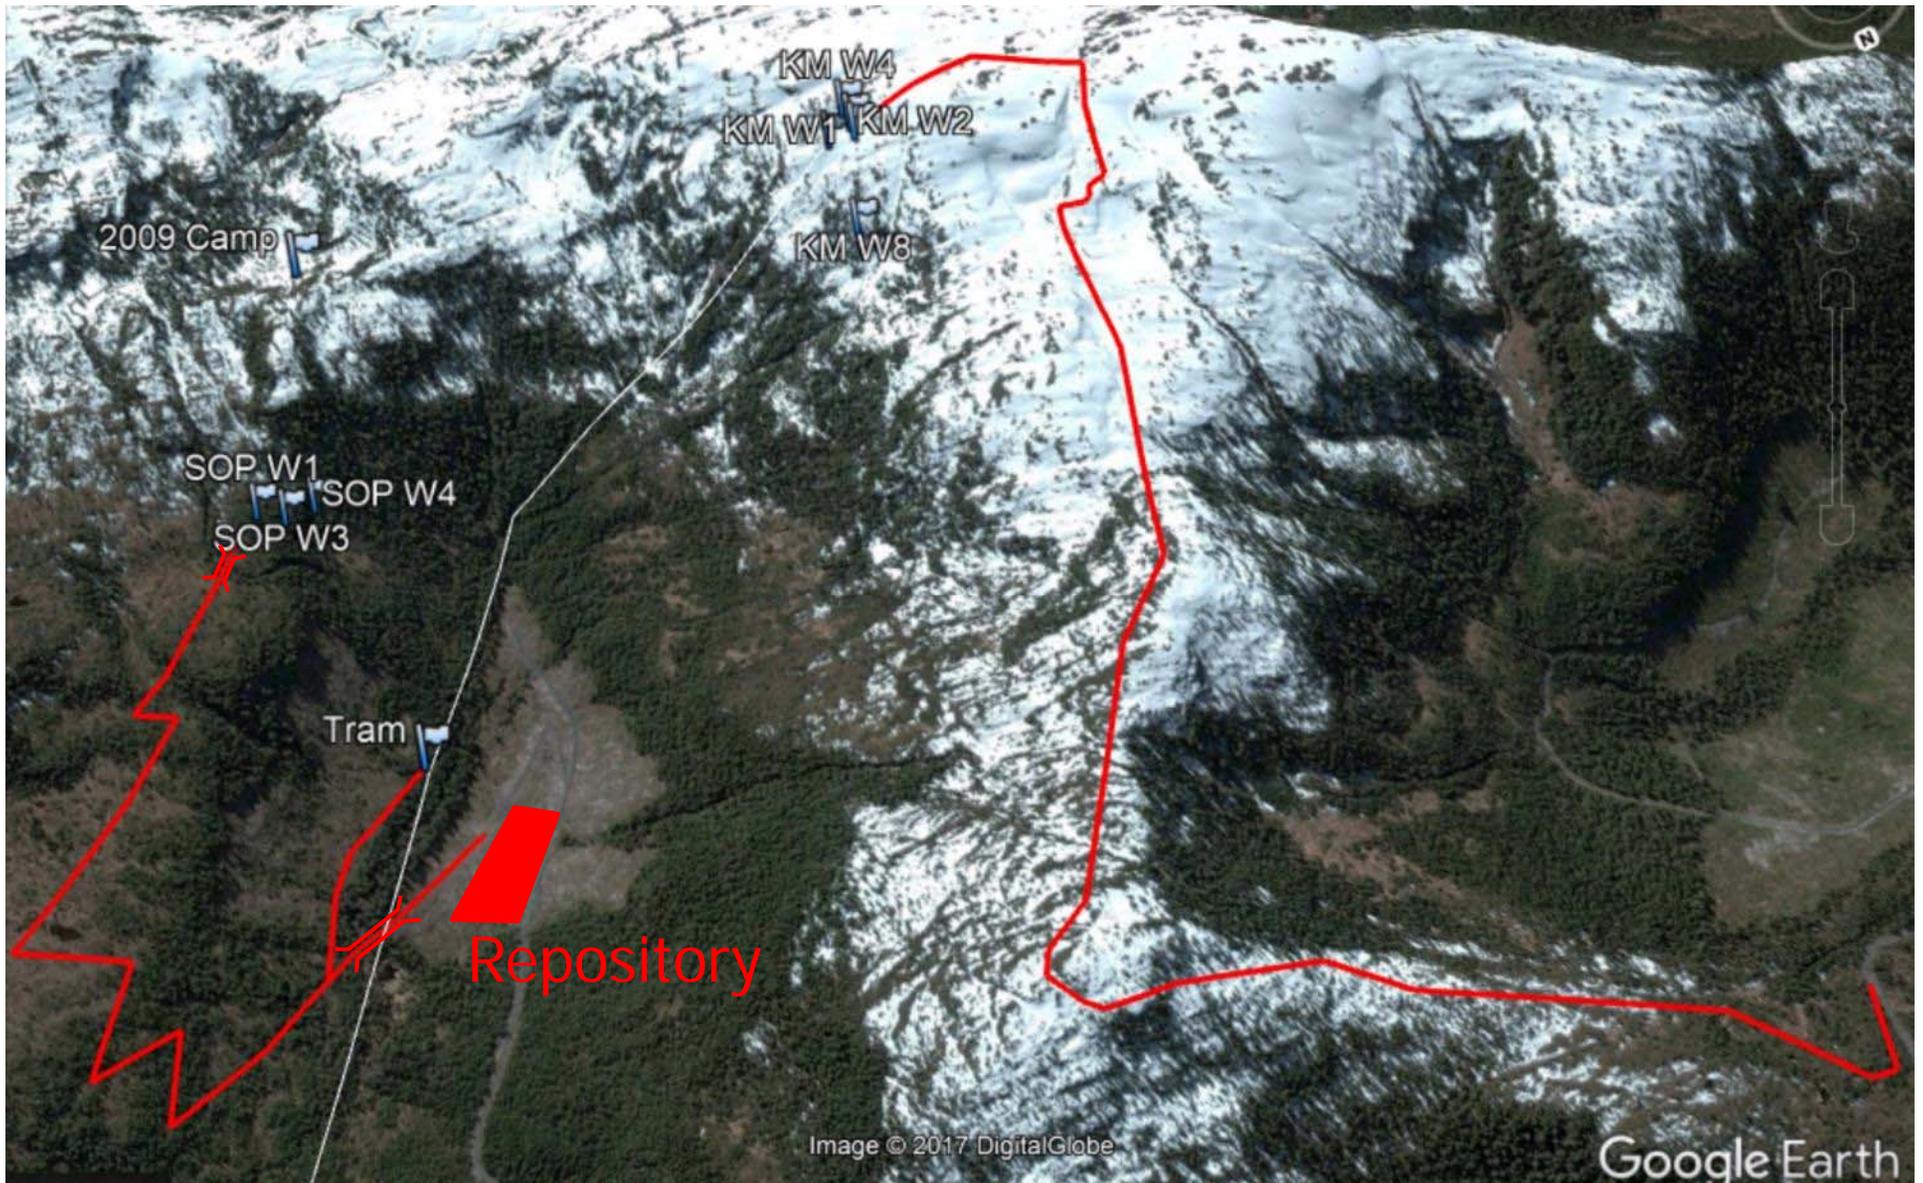
Cleanup Action Impacts

- Alts. 2, 3, & 4 are not recommended:
 - Alts. 2, 3, & 4 cost >> Alt. 1, & provide marginal risk reduction
 - Alts. 2, 3, & 4 address elevated metal concentrations in wastes, but have >> env. risk from construction impacts to sensitive habitat & marginal risk reduction
 - Logging ~17 acres
 - ~3.5mi. new roads, staging, cut/fill slope
 - Long re-establishment
 - Temporary creek crossings in sensitive habitat
 - Potential const. release
