# Belt #1 Repairs

Fort Knox Mine – Alaska

Kris VanLuchene PE - Tim White PE

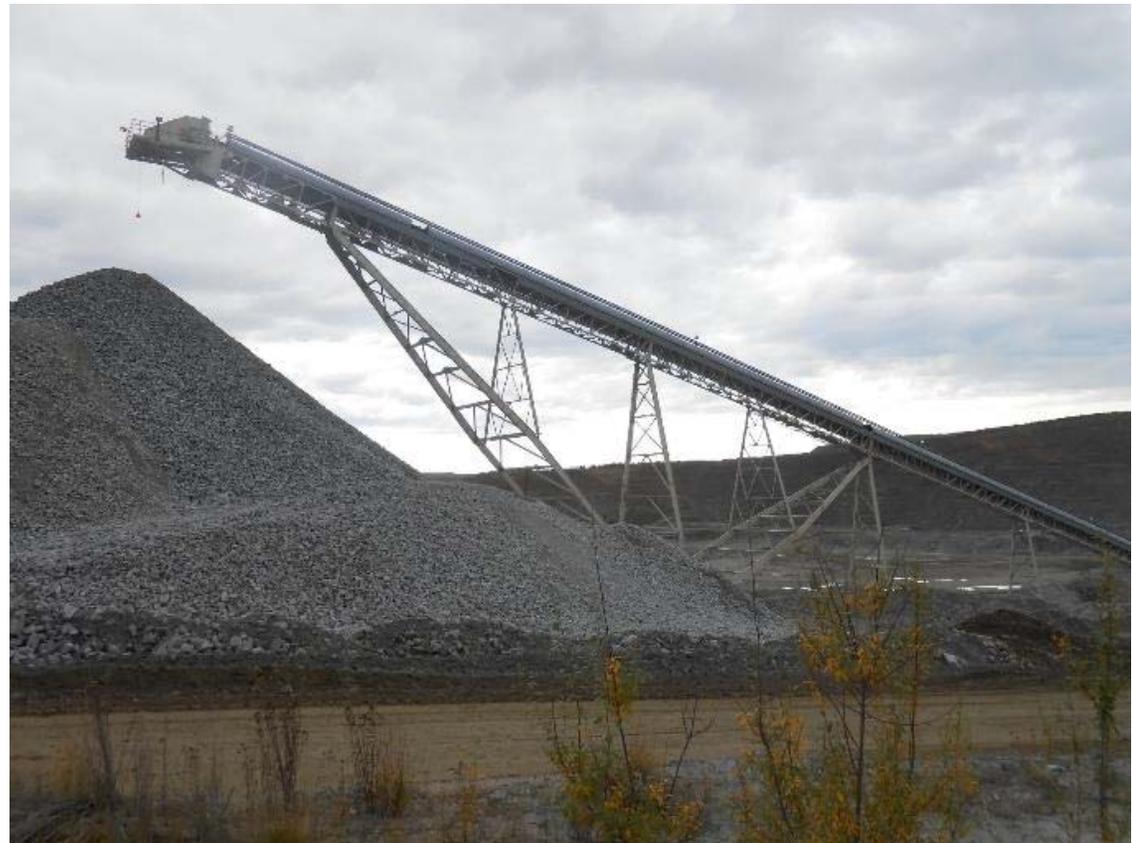
# Support Design Considerations

- Downtime
- Ease of installation
- Functionality
- Downtime
- Cost
- Toughness
- DOWNTIME

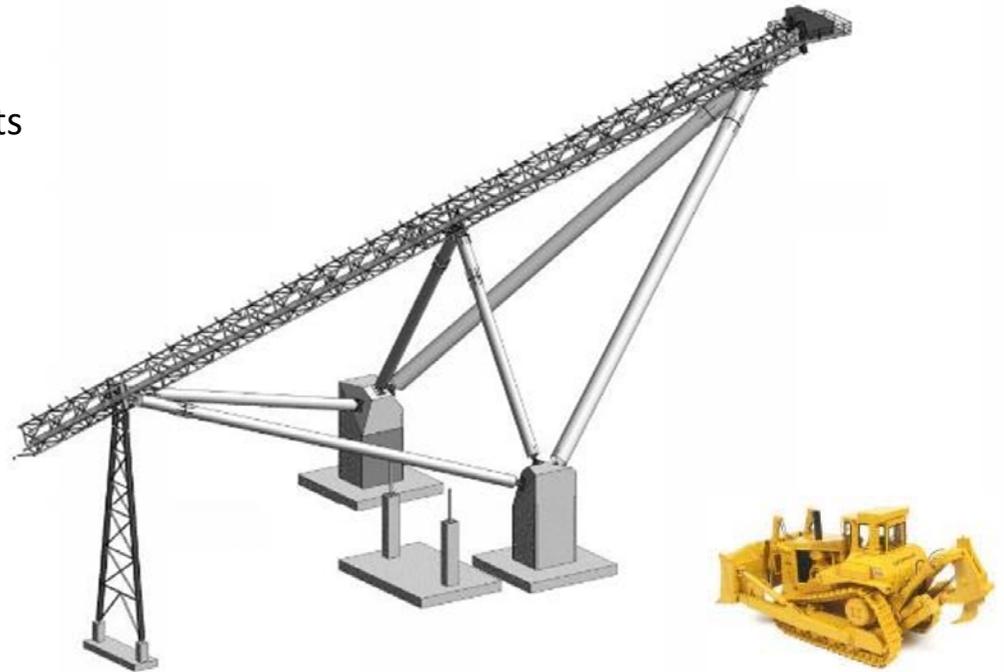
# The Details...

- Unique Loading Concerns
- Truss Reinforcing for New Support Points
- Complicated Geometry
- Truss Misalignment
- Load Transfer – Existing to New
- Downtime
  - Existing Truss to Remain in Place
  - Installation around Existing
  - Few New Elements
  - Maximum Field Adjustment
- Avoid Future “D-10” Earthquakes

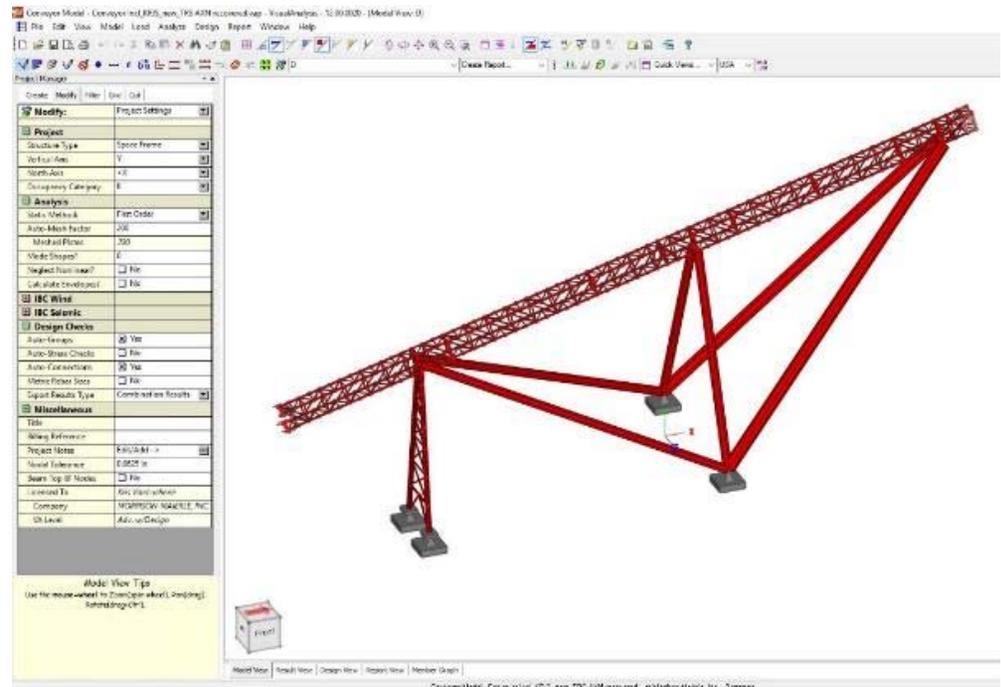
# Design

- 20.5 k Head Pulley and Enclosure
- Belt Tension Loading (up to 200 k)
- Long. Support of System Back to Drive Tower
- 1'-6" Misalignment at Head Pulley
- Pattern Loading of Conveyed Material
- 209 Load Cases

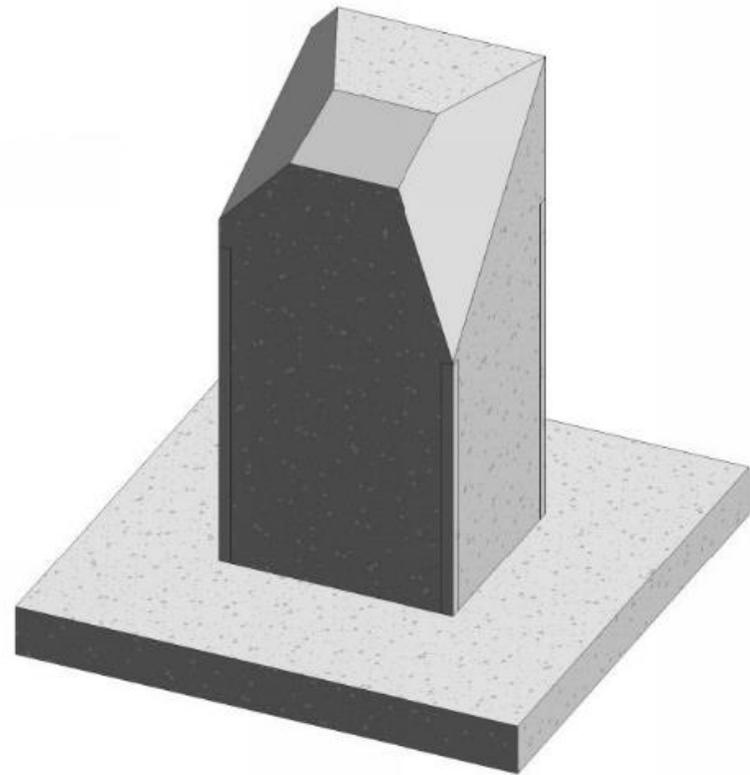
# Foundations

- 30' x 30' x 3' Spread Footings
- 14' x 12' x 29' Tall Piers
  - Geometry set by connecting supports.
- Rock / Eqpt. Protection
  - Large Size
  - Additional Clear
  - Additional Tie Reinforcement
  - Protection Plates
  - Cast In Angles

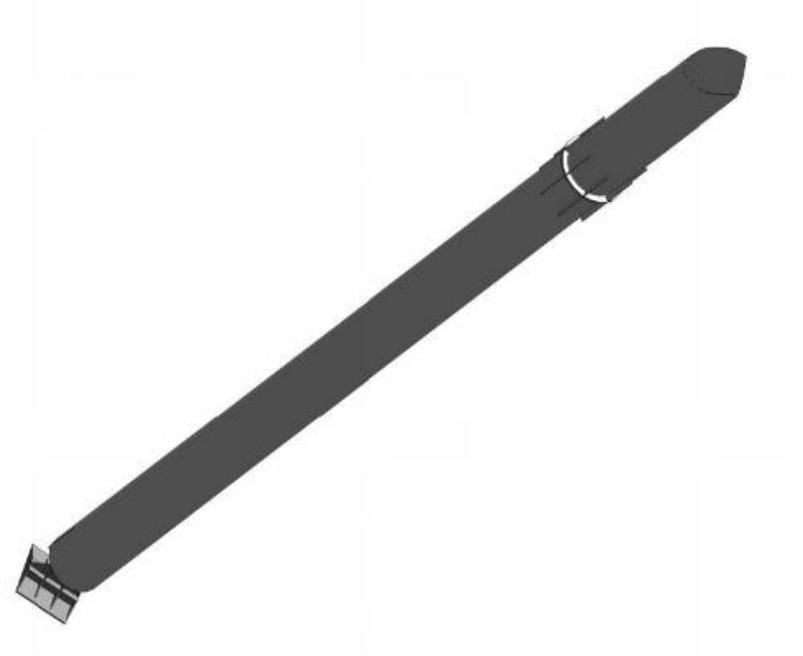
# Struts

- Middle and Rear Struts – 42” Dia. Tubes
  - Up to 130 ft. Long
- Front Struts – 60” Dia. Tubes
  - Around 145 ft. Long
- Pinned Base and Flanged, Bolted Top

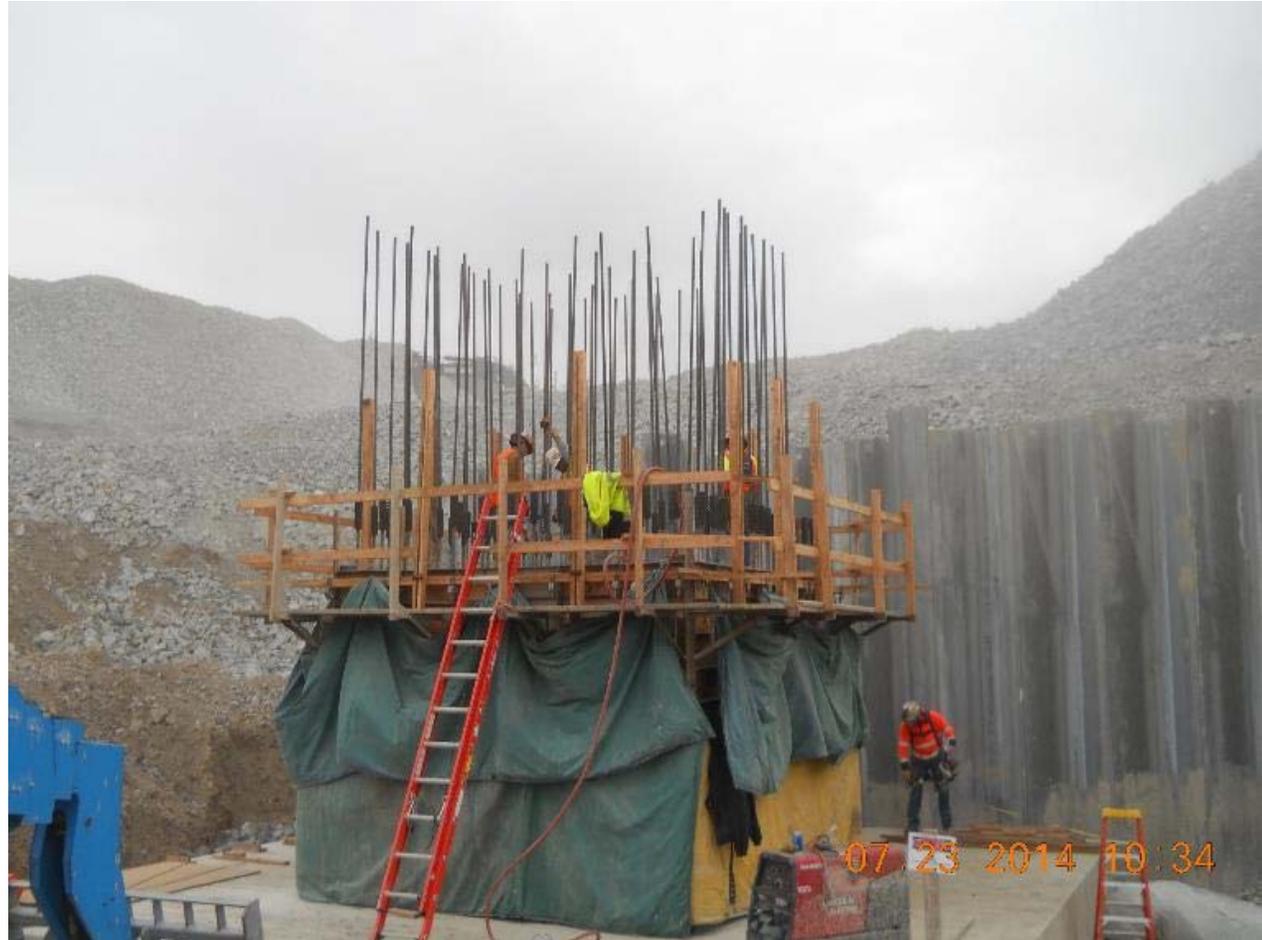
# Foundations

- Mass concreting
  - Initially intended to cool internal temp.
  - In the end, raised external temp. and monitored  $\Delta T$

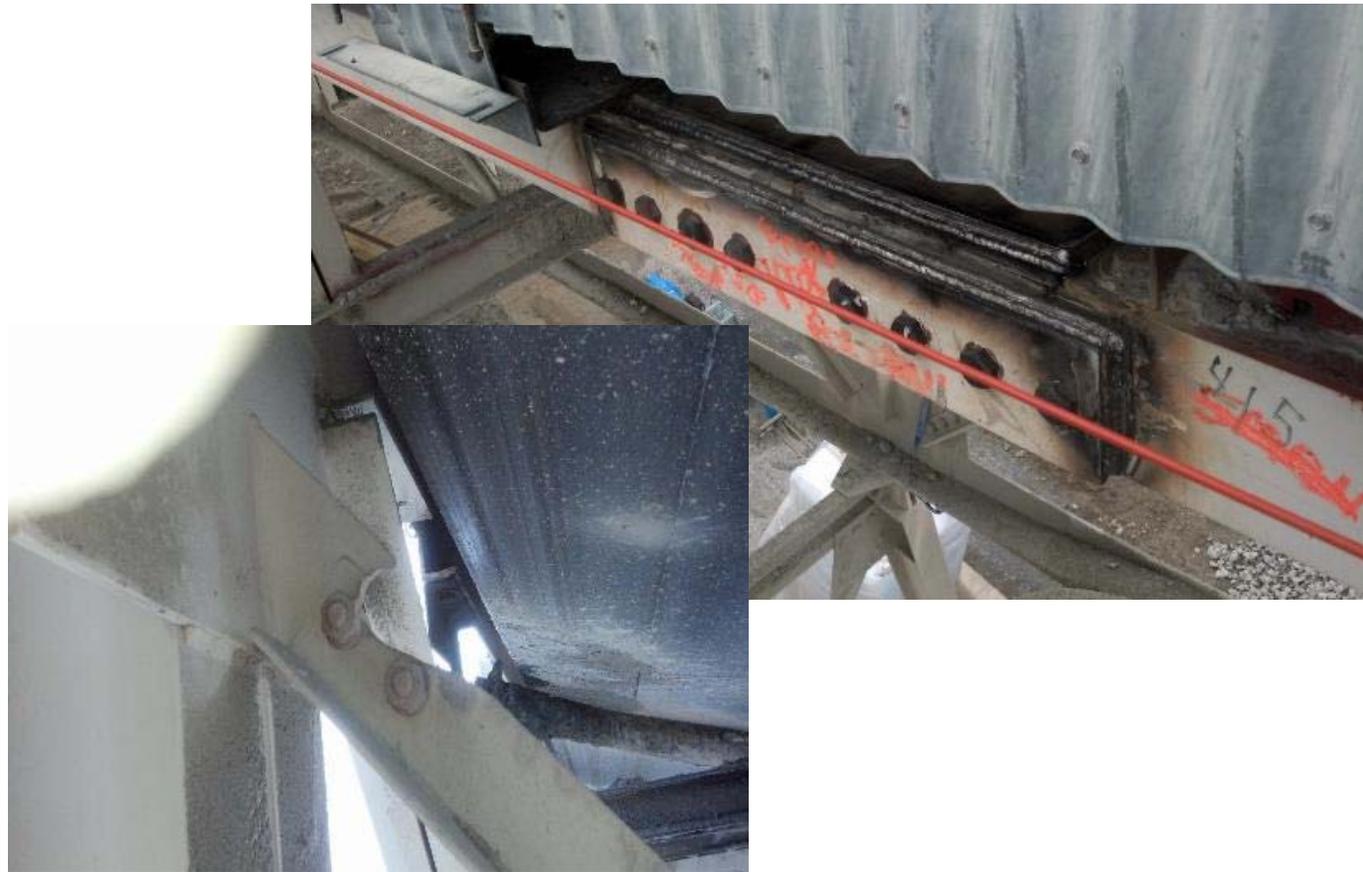
# Conveyor Shutdown 1 (3-days)

- 12hr day shifts
- Truss cleaning
- Truss reinforcement
- Bolt and conn. insp.

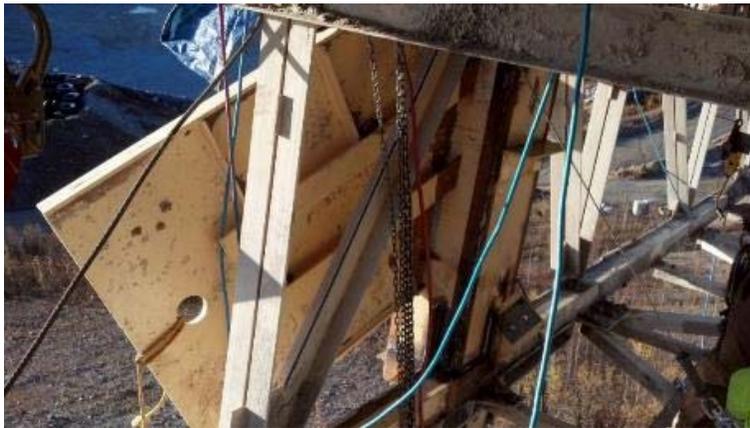
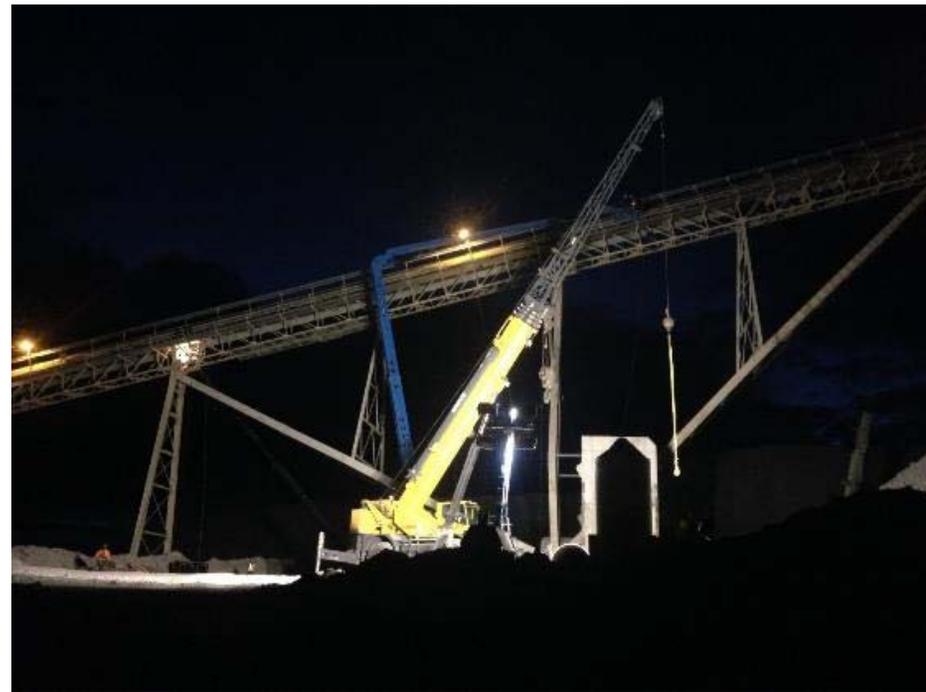
# The Big Shutdown (10 days)

- 2 – 12hr shifts
- 3 MMI personnel (2-Engineers, 1-RPR)
  - On the fly means and methods analysis
  - Concurrent mine maintenance work
- 2 CWIs

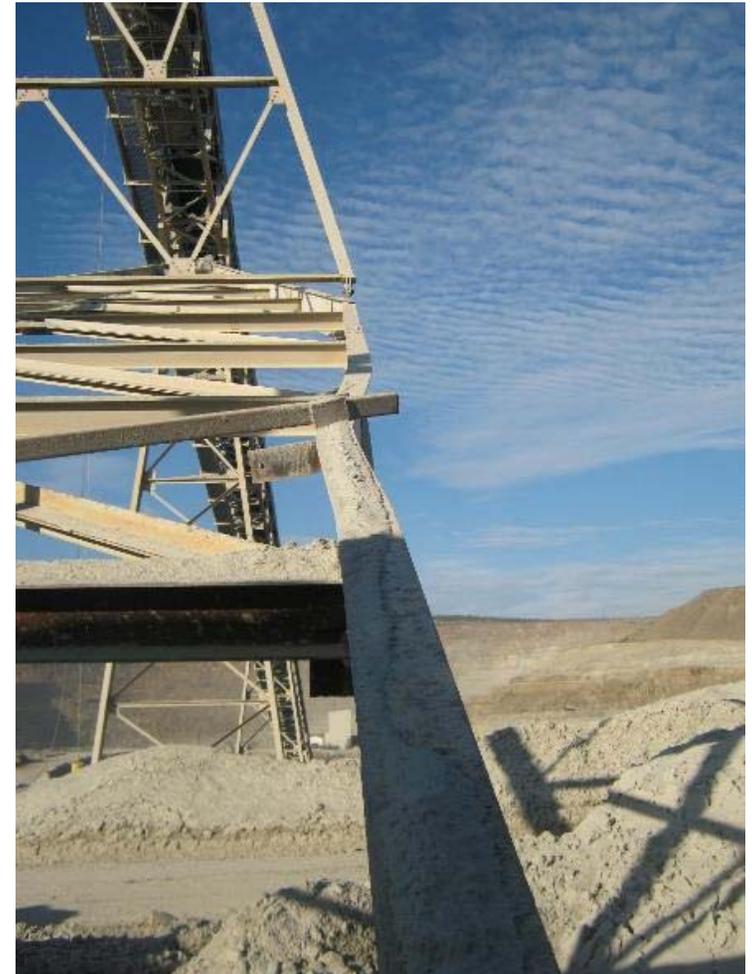
# Post Down Capacity

- Additional weight added to structure
- Structurally deficient supports not repaired
- Complete structural analysis not possible
  - Members out of alignment
  - Unidentified supports
  - Deficient welds

- Use Historical Loading Data to Limit future Loads
- Ft. Knox provided info. on past snow loading
  - Observed Snow Depths
- Morrison Maierle Researched Past Wind Loading
  - Historical Data from nearby weather stations
- Produced Tonnage Matrix

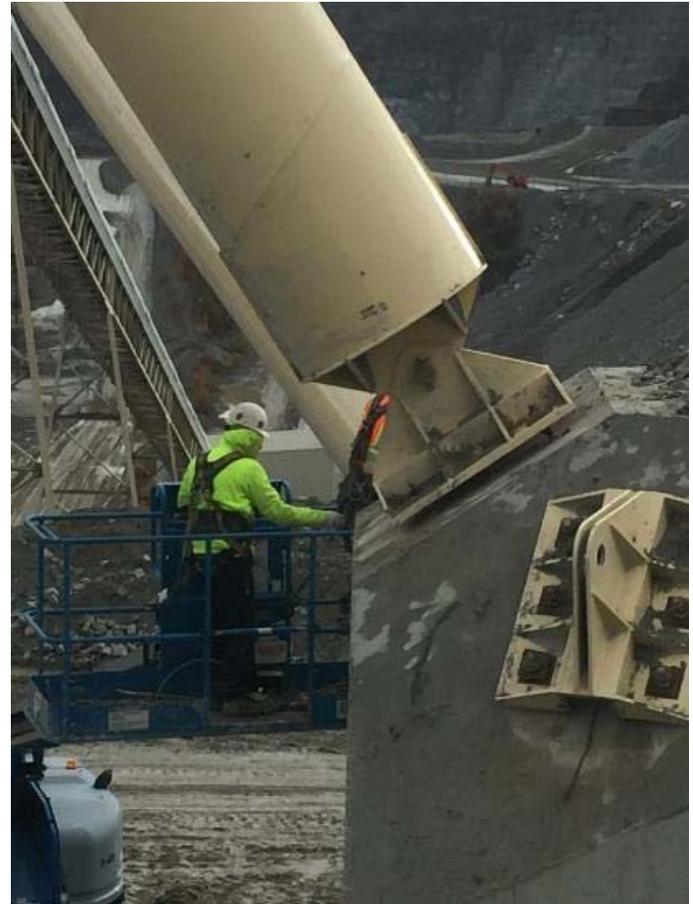
# Construction Team Coordination

- Erection Sequencing
  - Head Pulley Removal
- Pre-Loading New Structure
  - Minimize “Unsprung” Forces in Existing Members
  - Enerpac Jacks Below Strut Base Plates
  - Pre-Determined Jacking Forces
