RILEY PASS URANIUM MINES

Uranium Mining Riley Pass, North Cave Hills, 1962-1964

Riley Pass Reclamation Approach

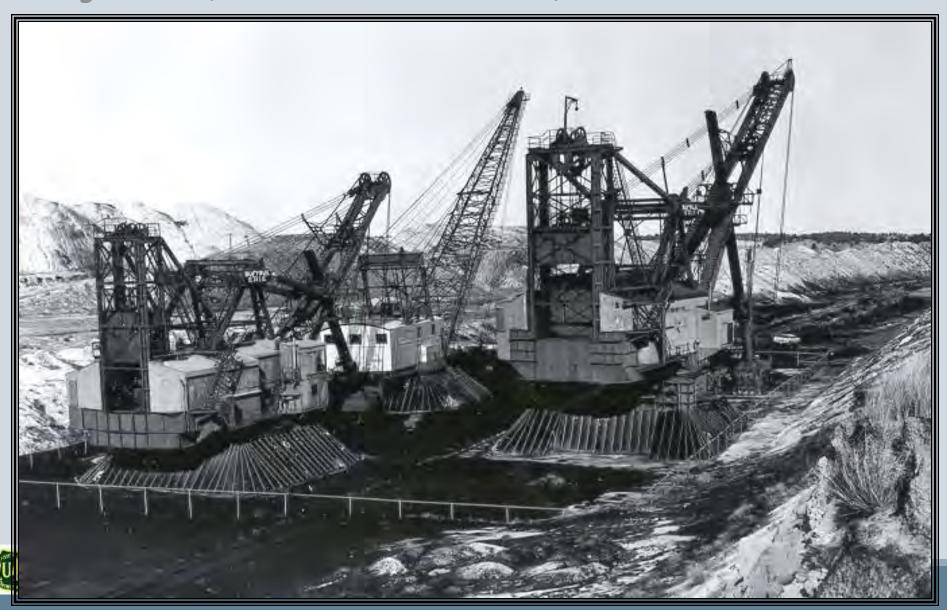
Overburden pushed off the outer edges of the pits, highwalls and spoils material with exposed radioactive material

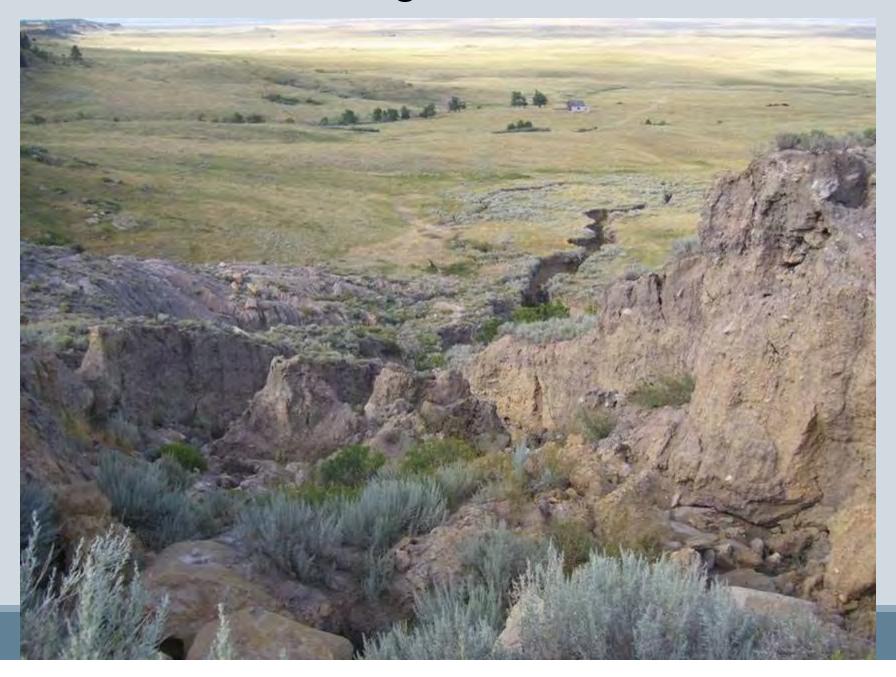
Northeast Drainage Channel – Bluff B

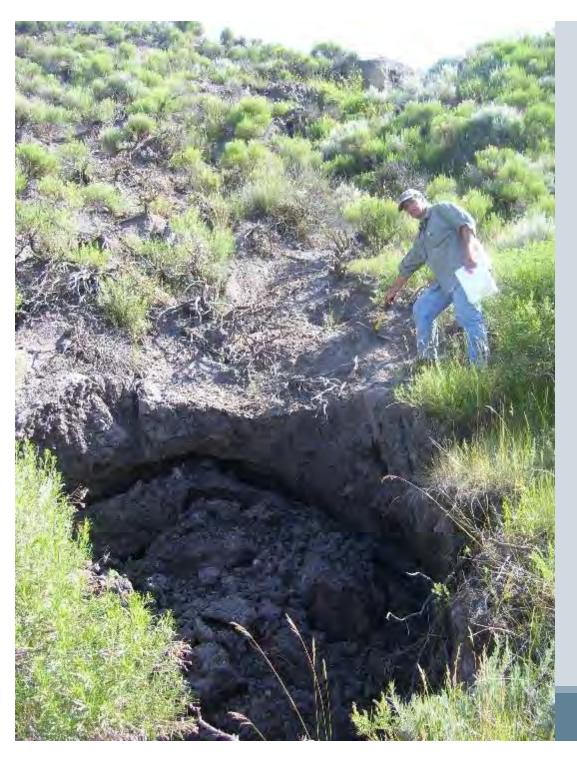
Soil piping throughout spoils material

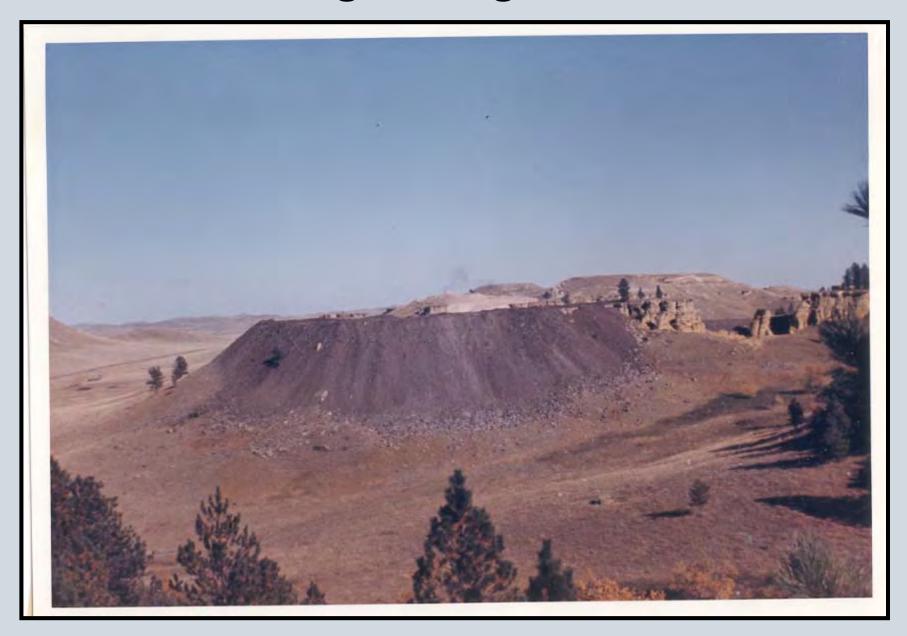
Bluff G – During Mining - 1964

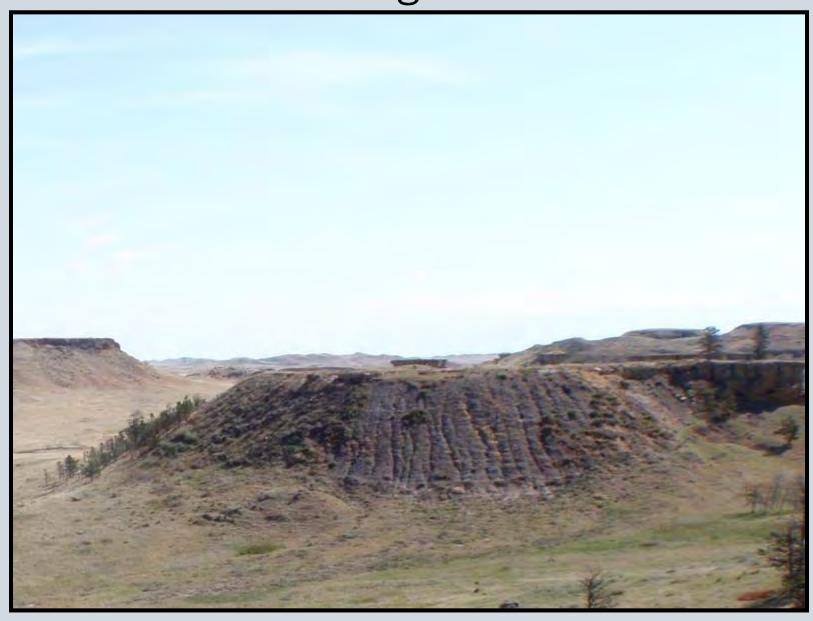
Bluff G – Post Mining - 2012

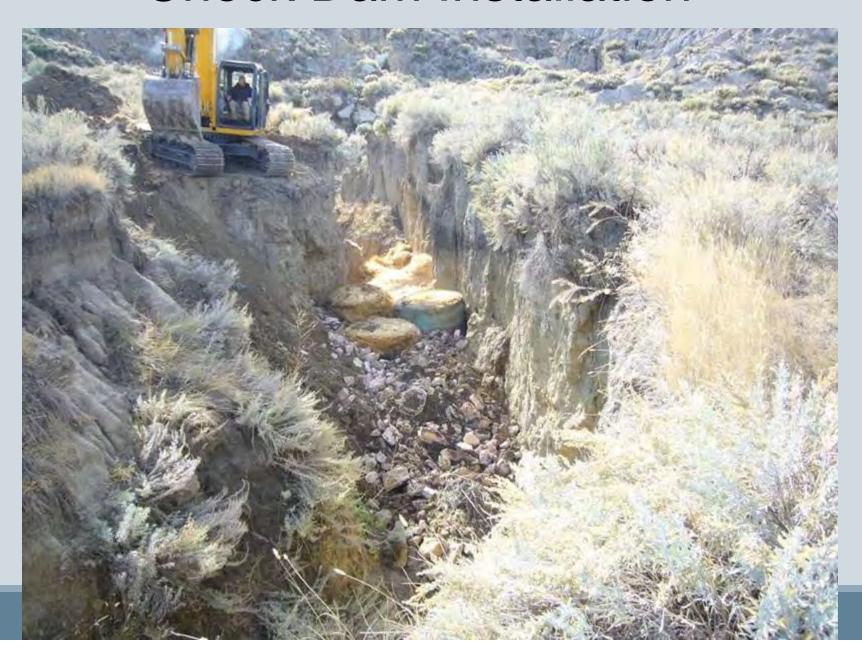
Check Dam Installation

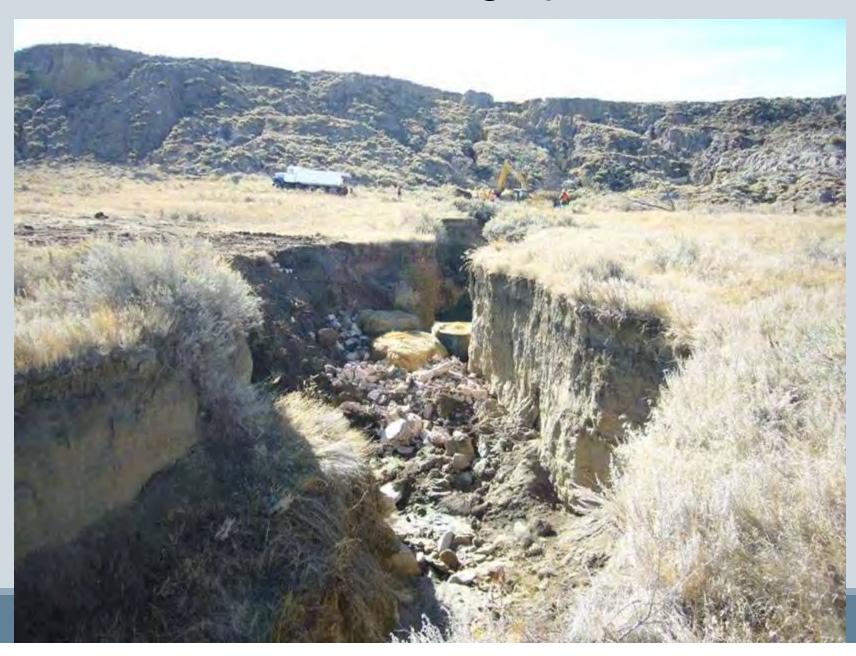
Check Dam looking upstream

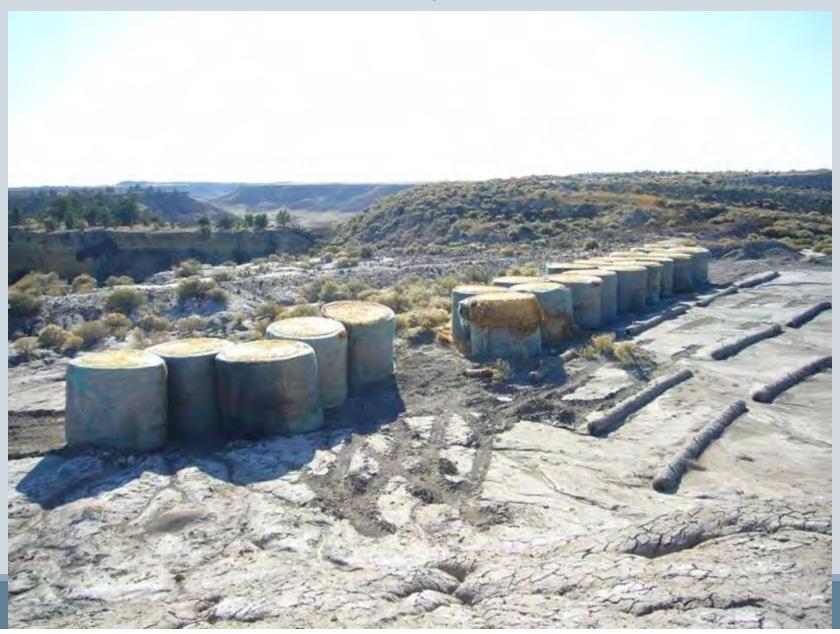
Bluff Top Drainage Control

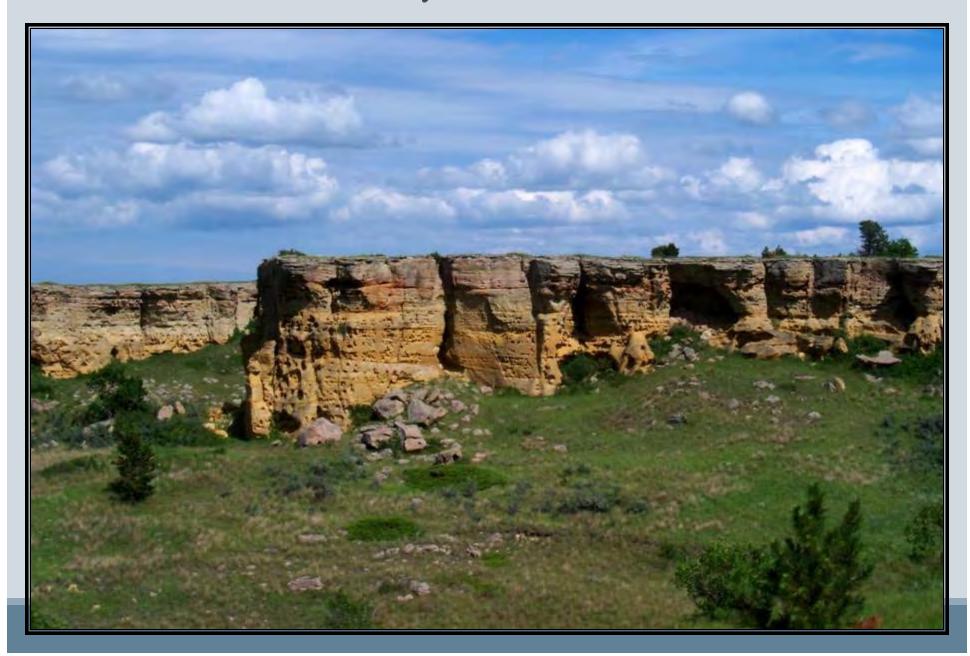
Sandstone Cliffs, Fort Union Formation

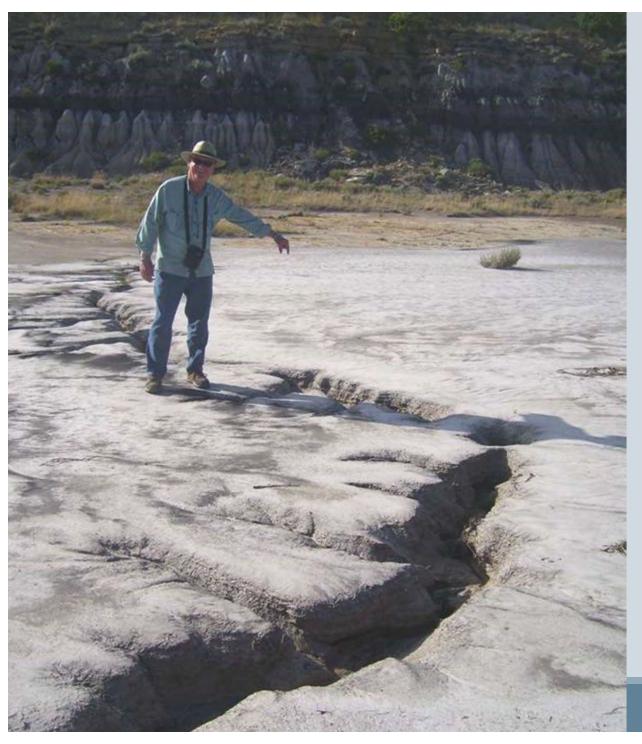
Fractures in Basal Sandstone

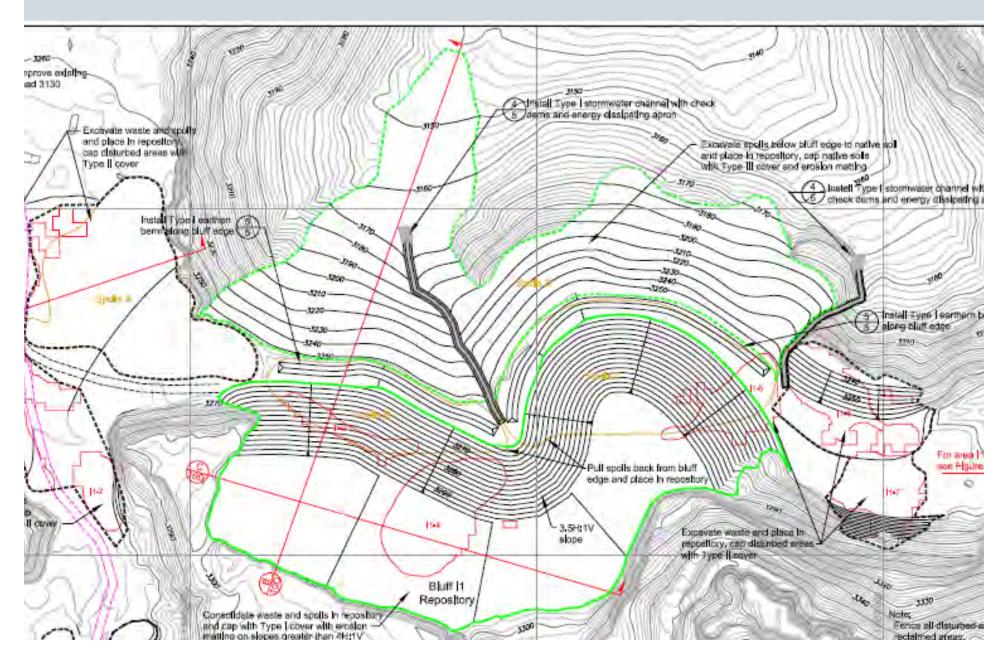
Traditional Reclamation Design

- Constant uniform slopes
- *Rock lined ditches
- Terraces
- Erosion Control structures, such as rock basins and check dams

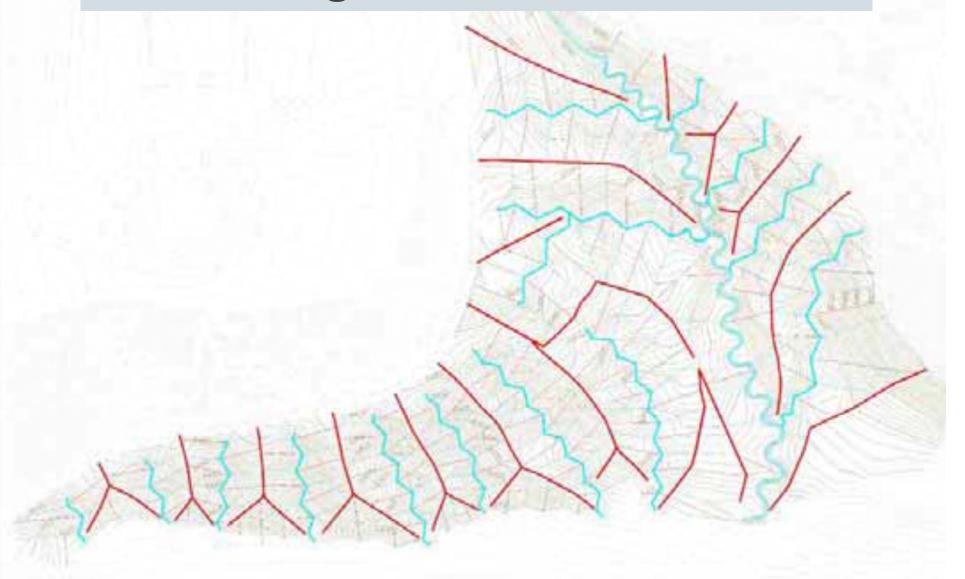
Natural Regrade™ Reclamation

- Natural channel morphology
- Small drainage basins
- Increased diversity of slope aspects and habitat
- Stable configuration of slopes

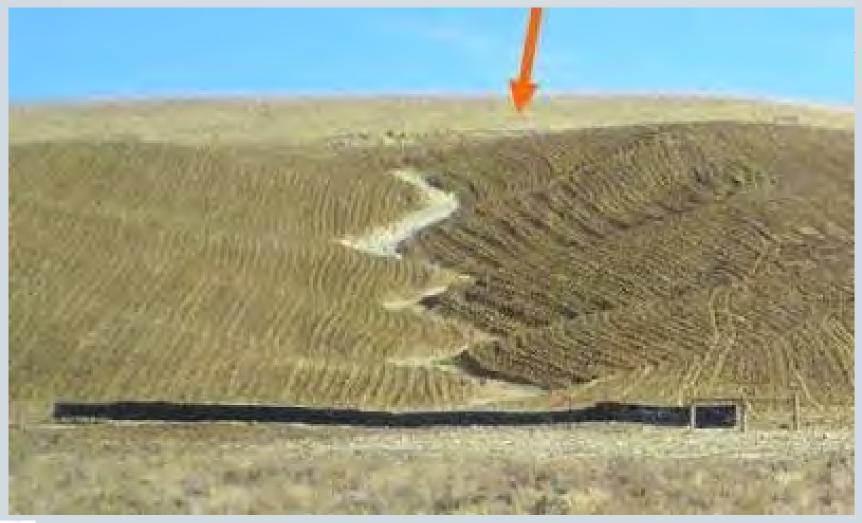
Natural Regrade™ Reclamation

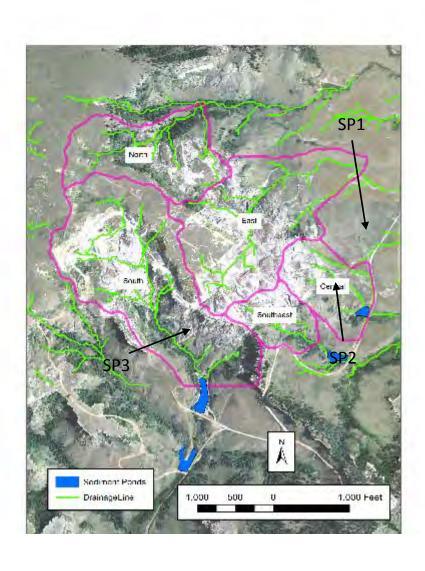
Bluff B Watershed Delineation

North (Pete's Creek)

East (Pete's Creek)

Central (Sediment Pond "SP1")

Southeast (Sediment Pond "SP2")

Watershed ID	Drainage Area		
	(mi²)	(km²)	[acres]
North	0.067	0.17	42.6
East	0.113	0.29	72.2
Southeast	0.025	0.07	16.2
Central	0.039	0.10	25.0
South	0.147	0.38	94.0

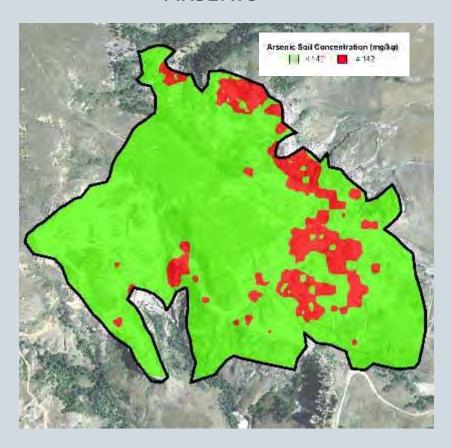
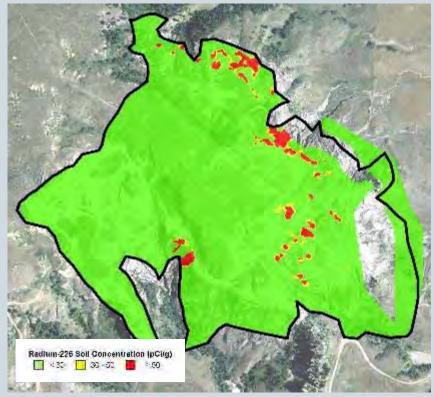
Bluff B

ARSENIC

RADIUM-226

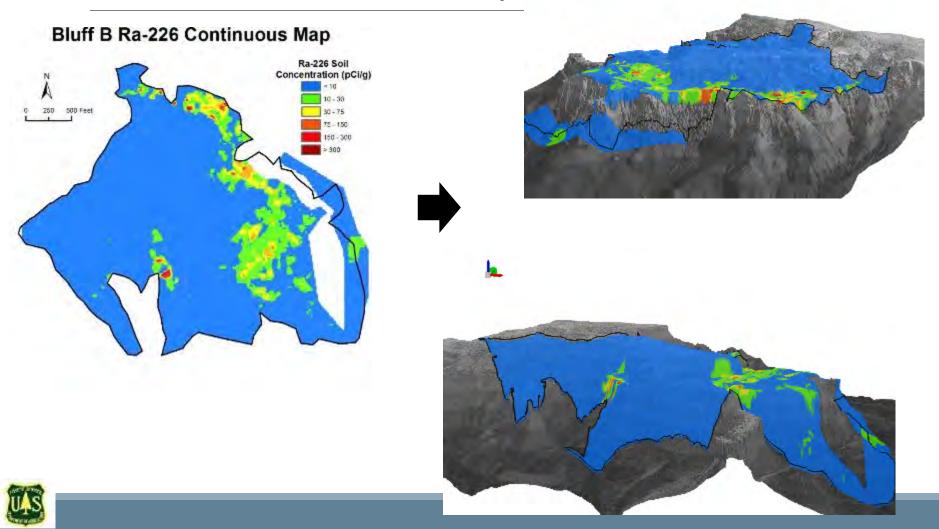
Radium-226 Map -:-----

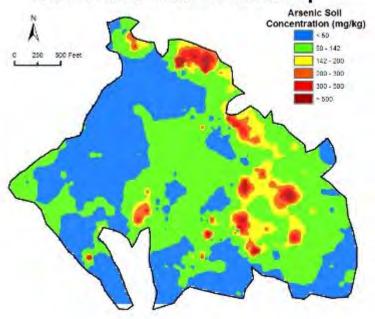
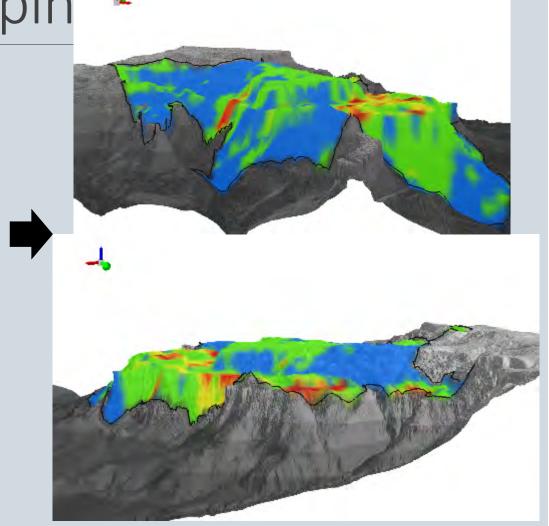
Bluff B Arsenic Continuous Map

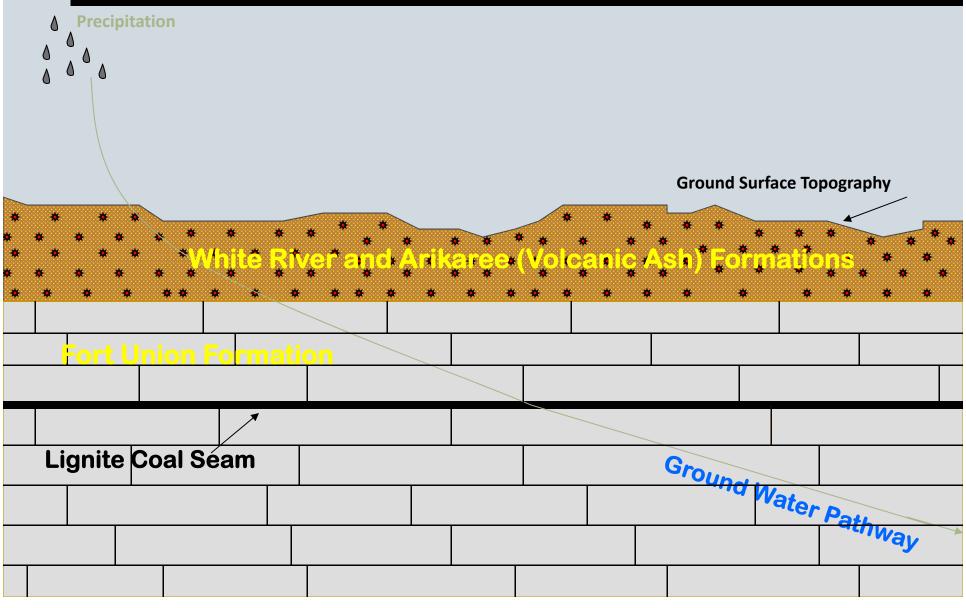
Regional Geology and Uranium Transportation Model
