STILLWATER
MINING COMPANY

Knight Piésold
CONSULTING

Embankment Underdrain for Nitrogen Source Reduction

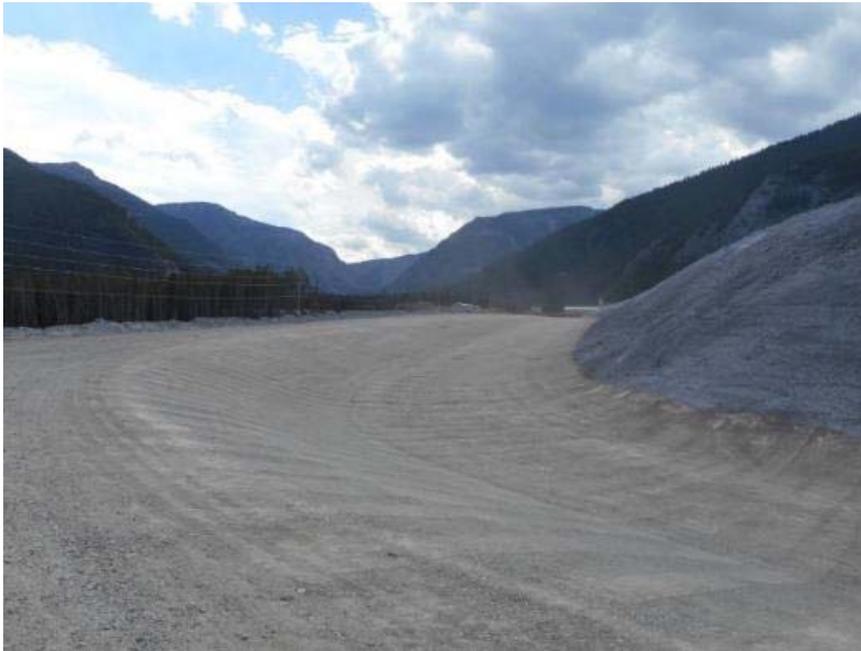
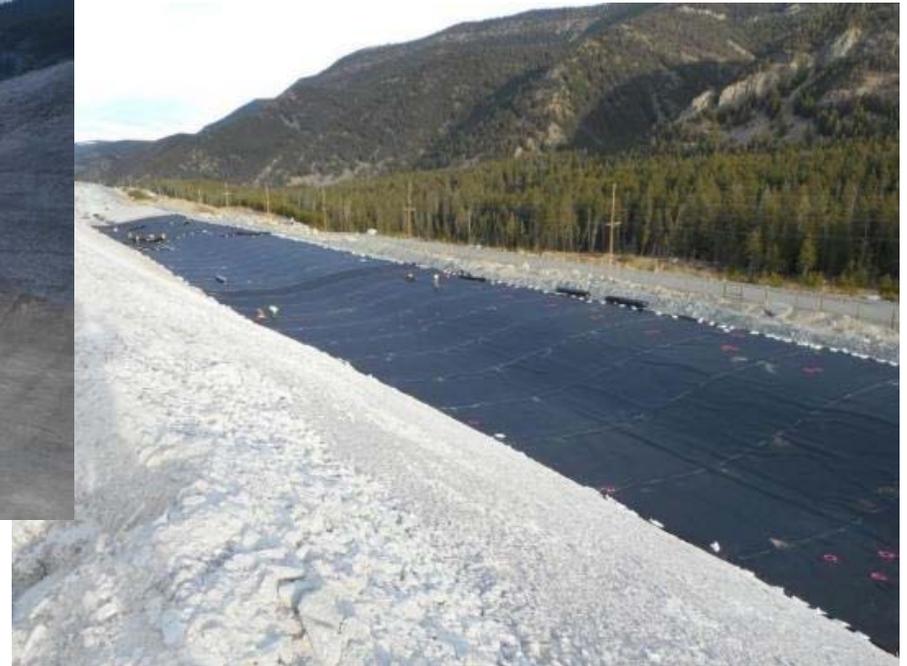
Underdrain Shaping, Subgrade Preparation, and Geosynthetics Installation

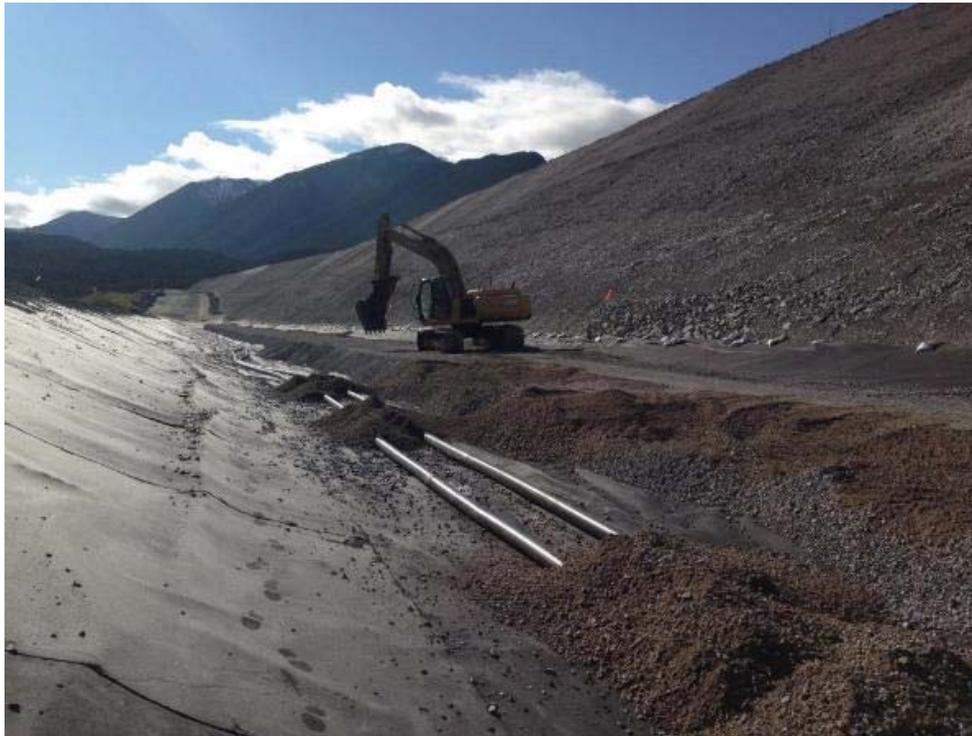
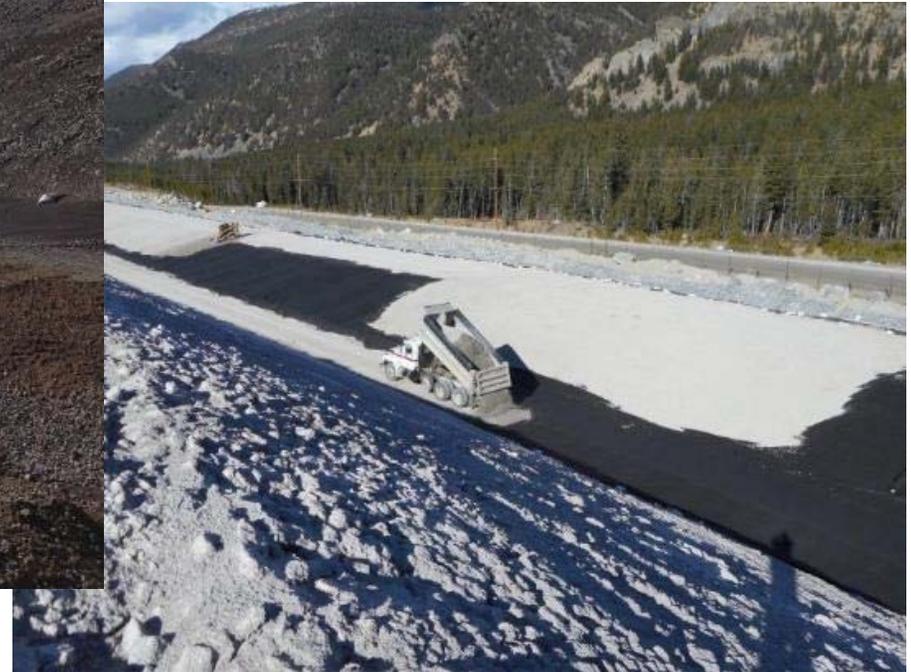
Drainage Layer Installation

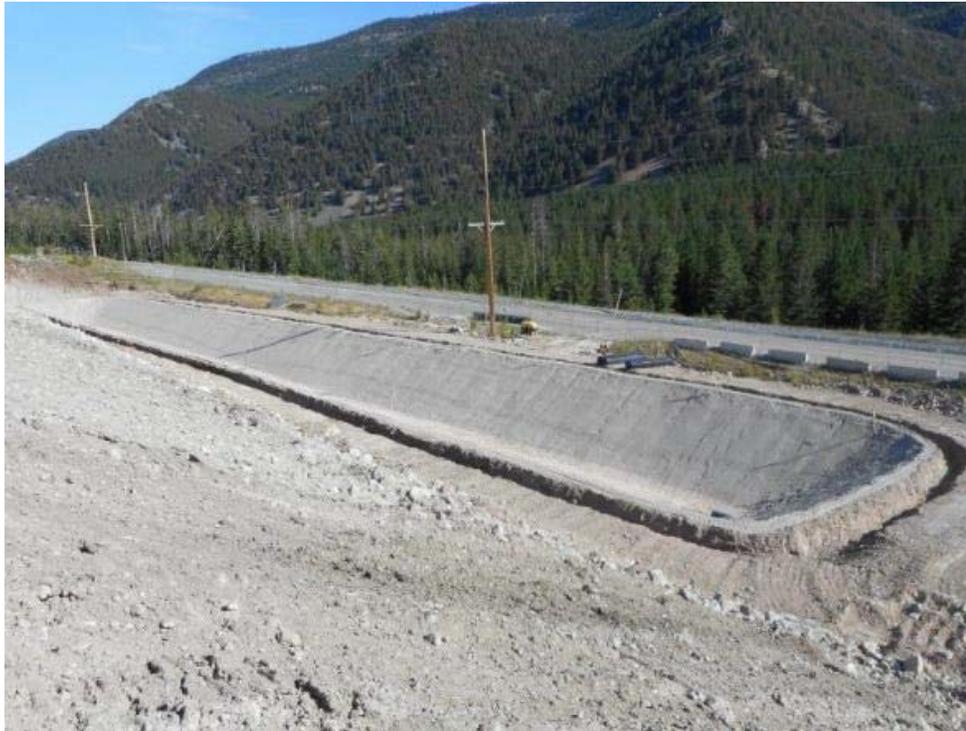
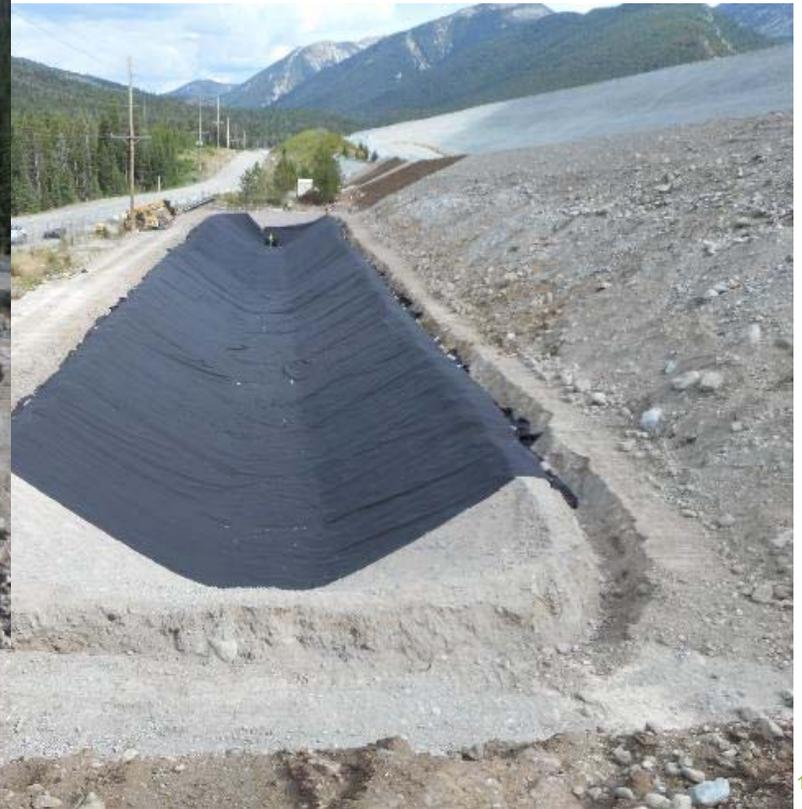
Collection Sump

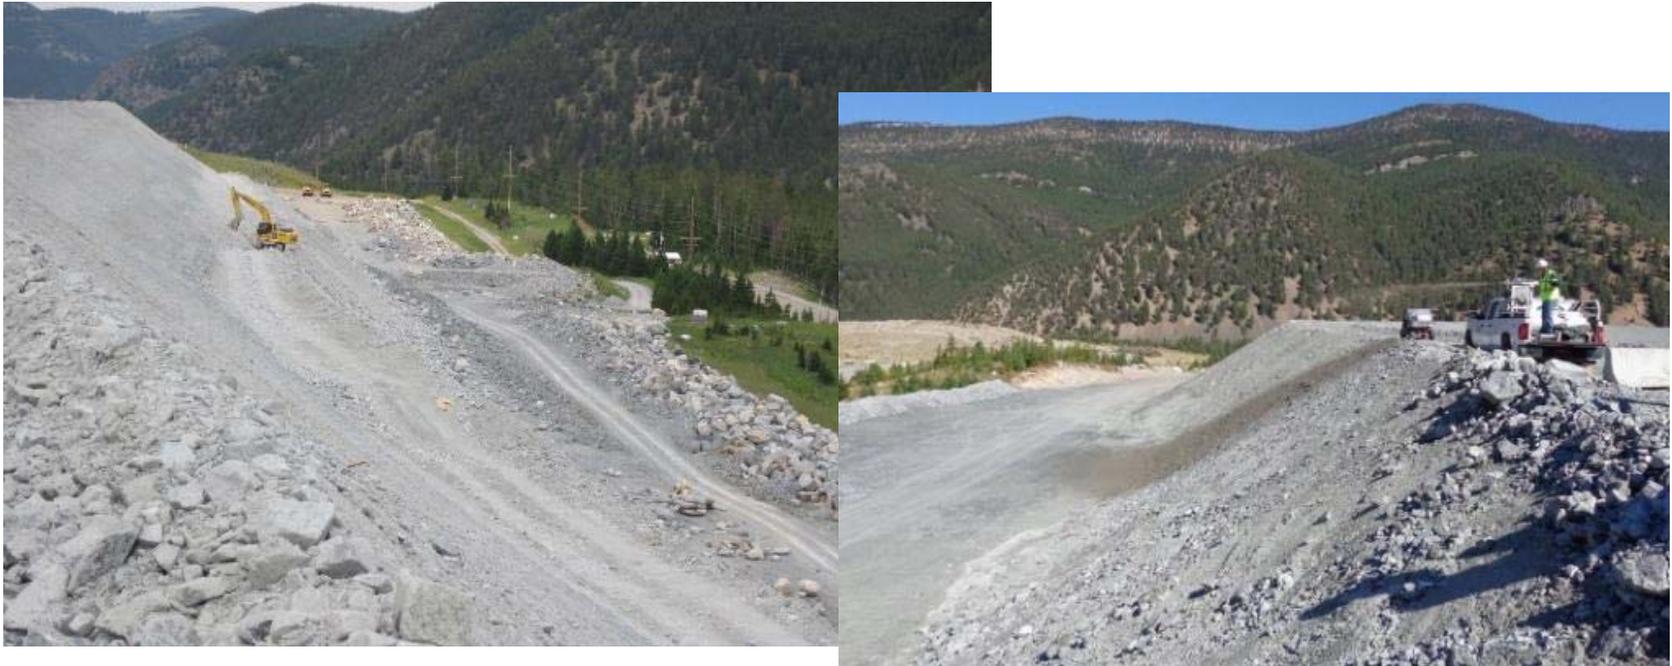
Embankment Trimming and Posi-Shell® Application

- Interim measures to reduce infiltration into the embankment ROM rockfill
- Downstream slope of the Stage 3 embankment trimmed and compacted

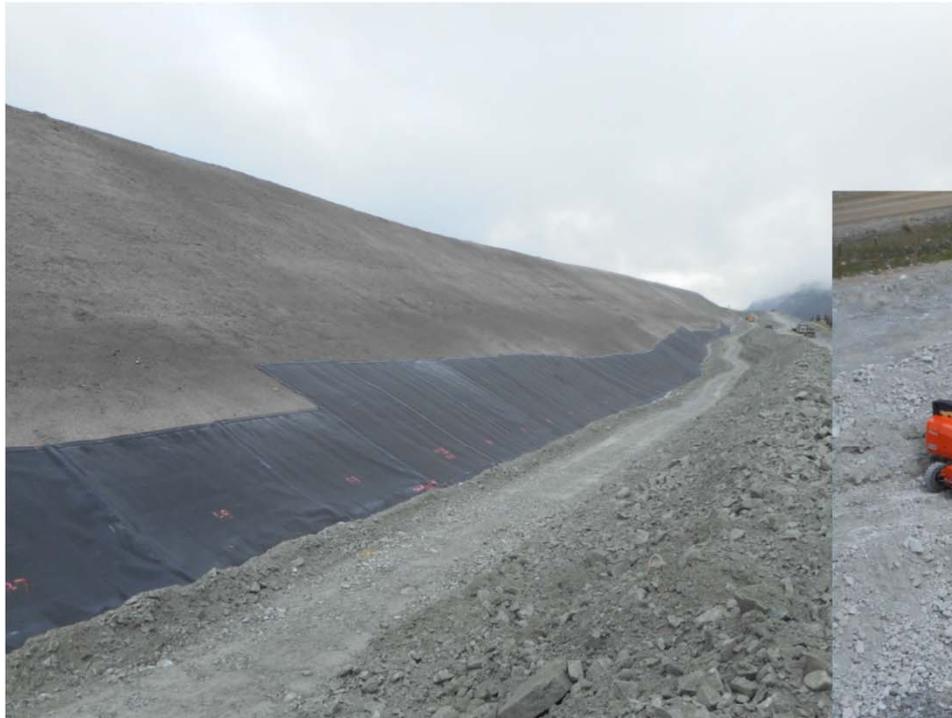
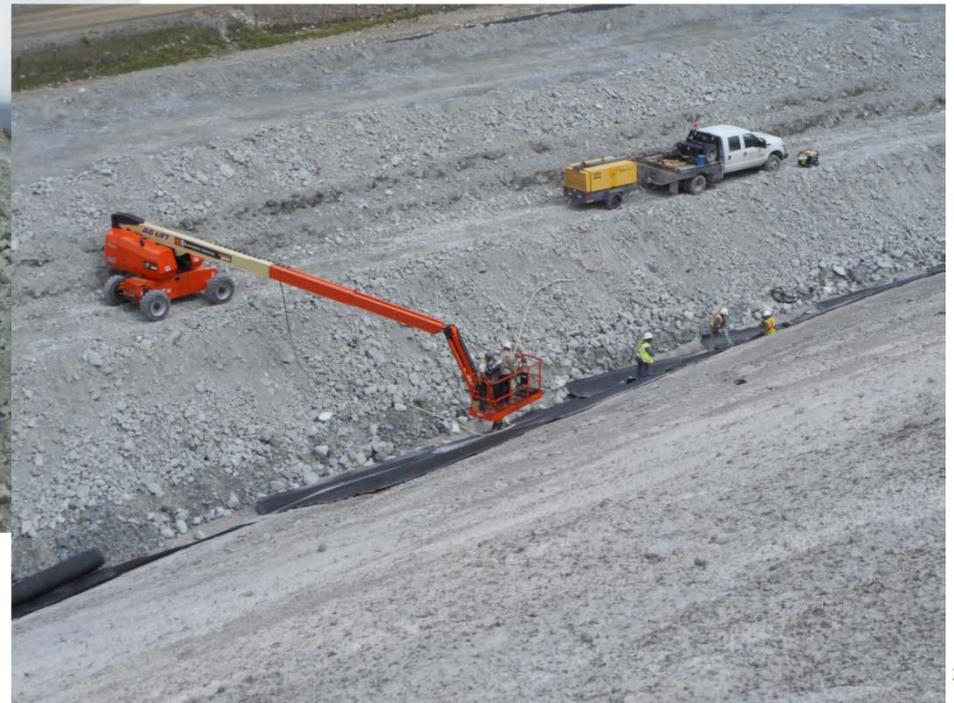
Phase 1 Downstream Slope Geomembrane Installation

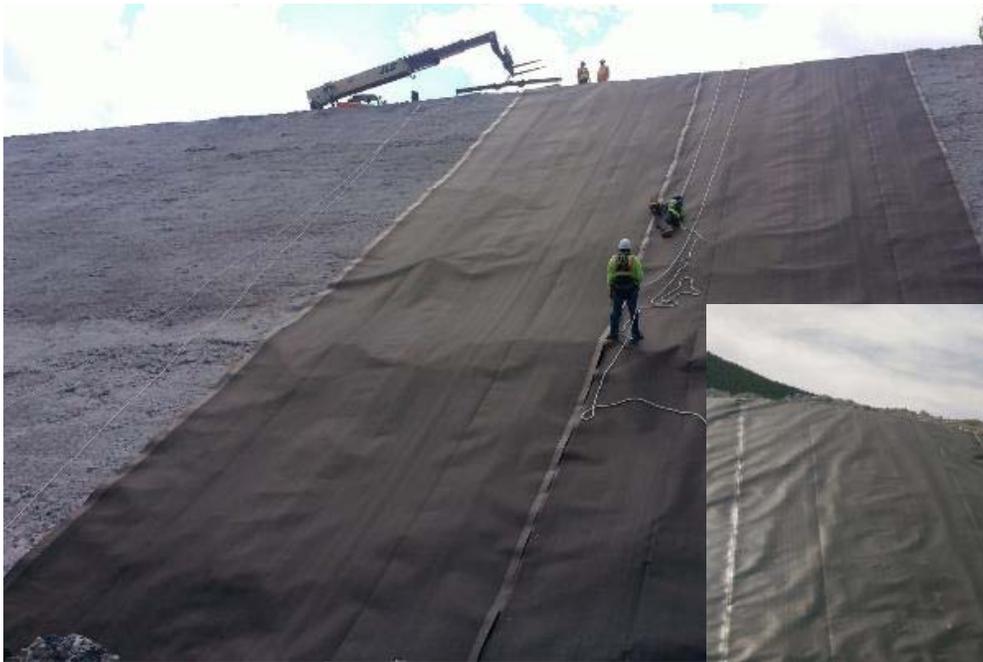
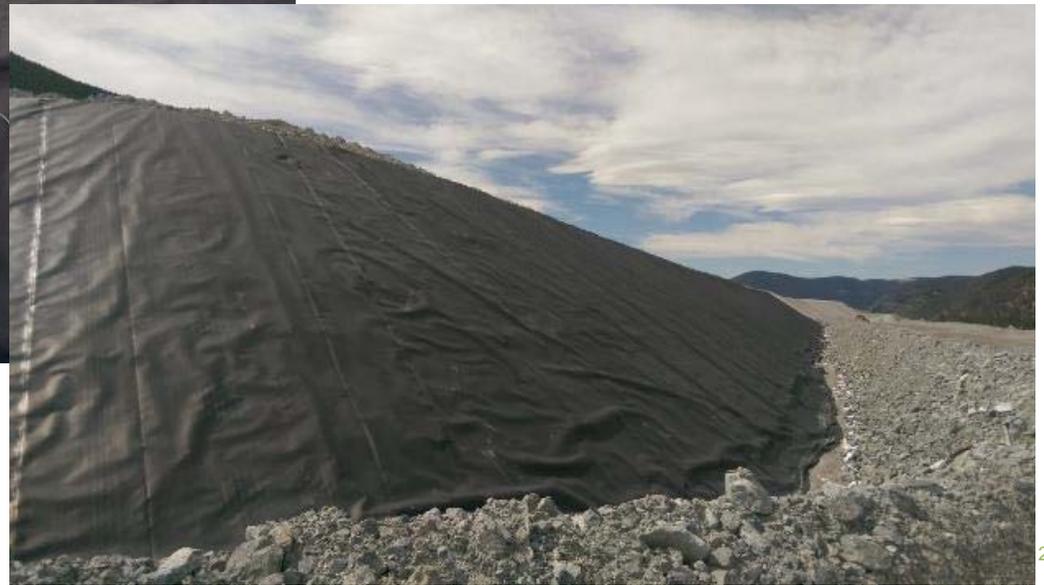
Phase 2 Downstream Slope Geomembrane Installation

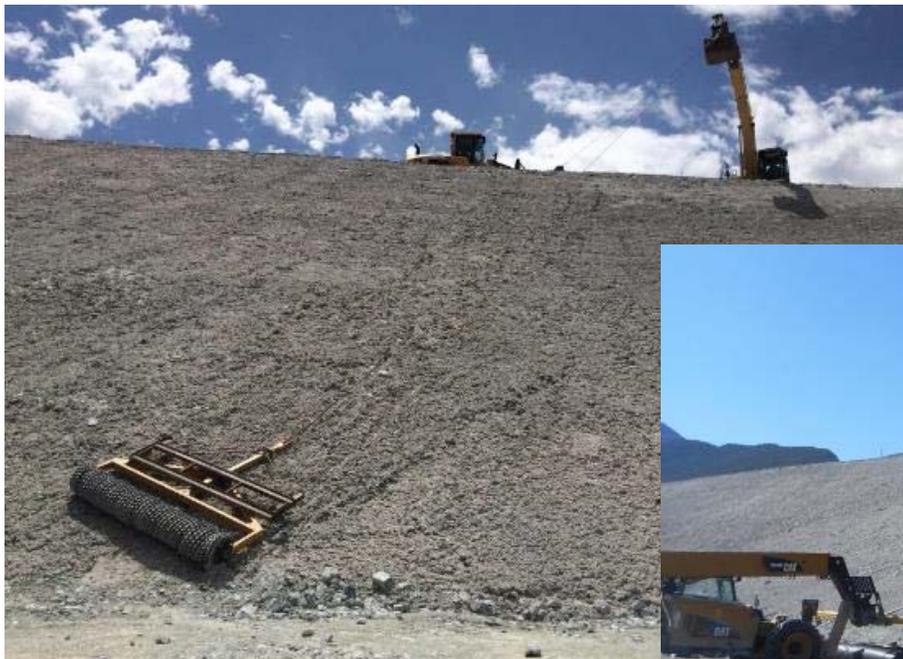
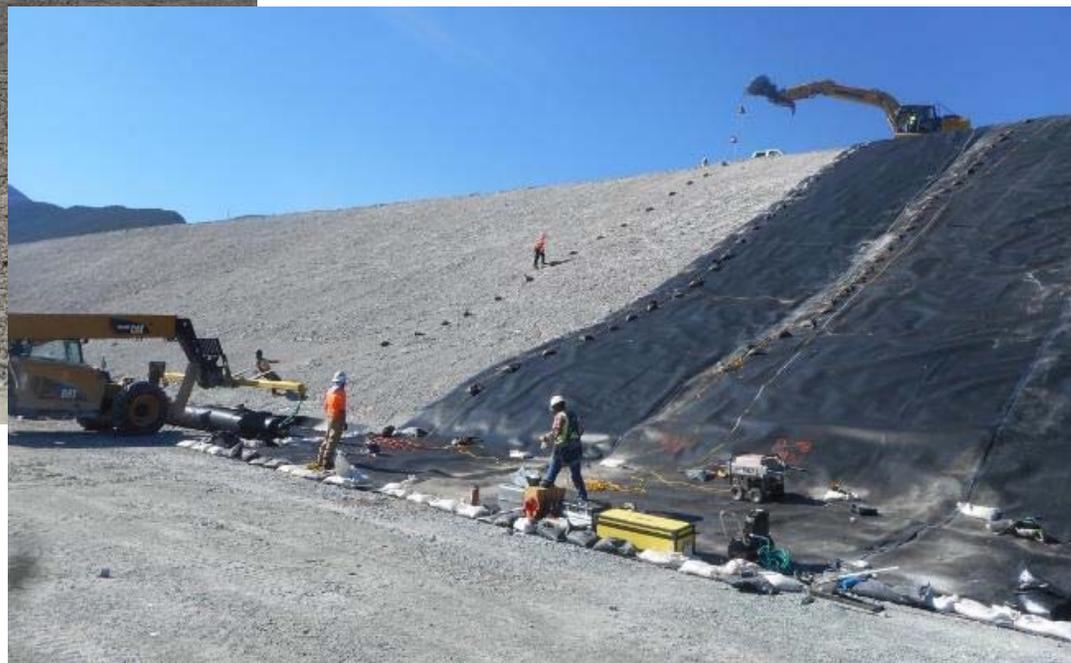
Phase 3 Downstream Slope Geomembrane Installation
