## Kingston Generating Facility Flyash Impoundment Failure.

Michael J. Gobla, P.E.

U.S. Department of the Interior  
Bureau of Reclamation

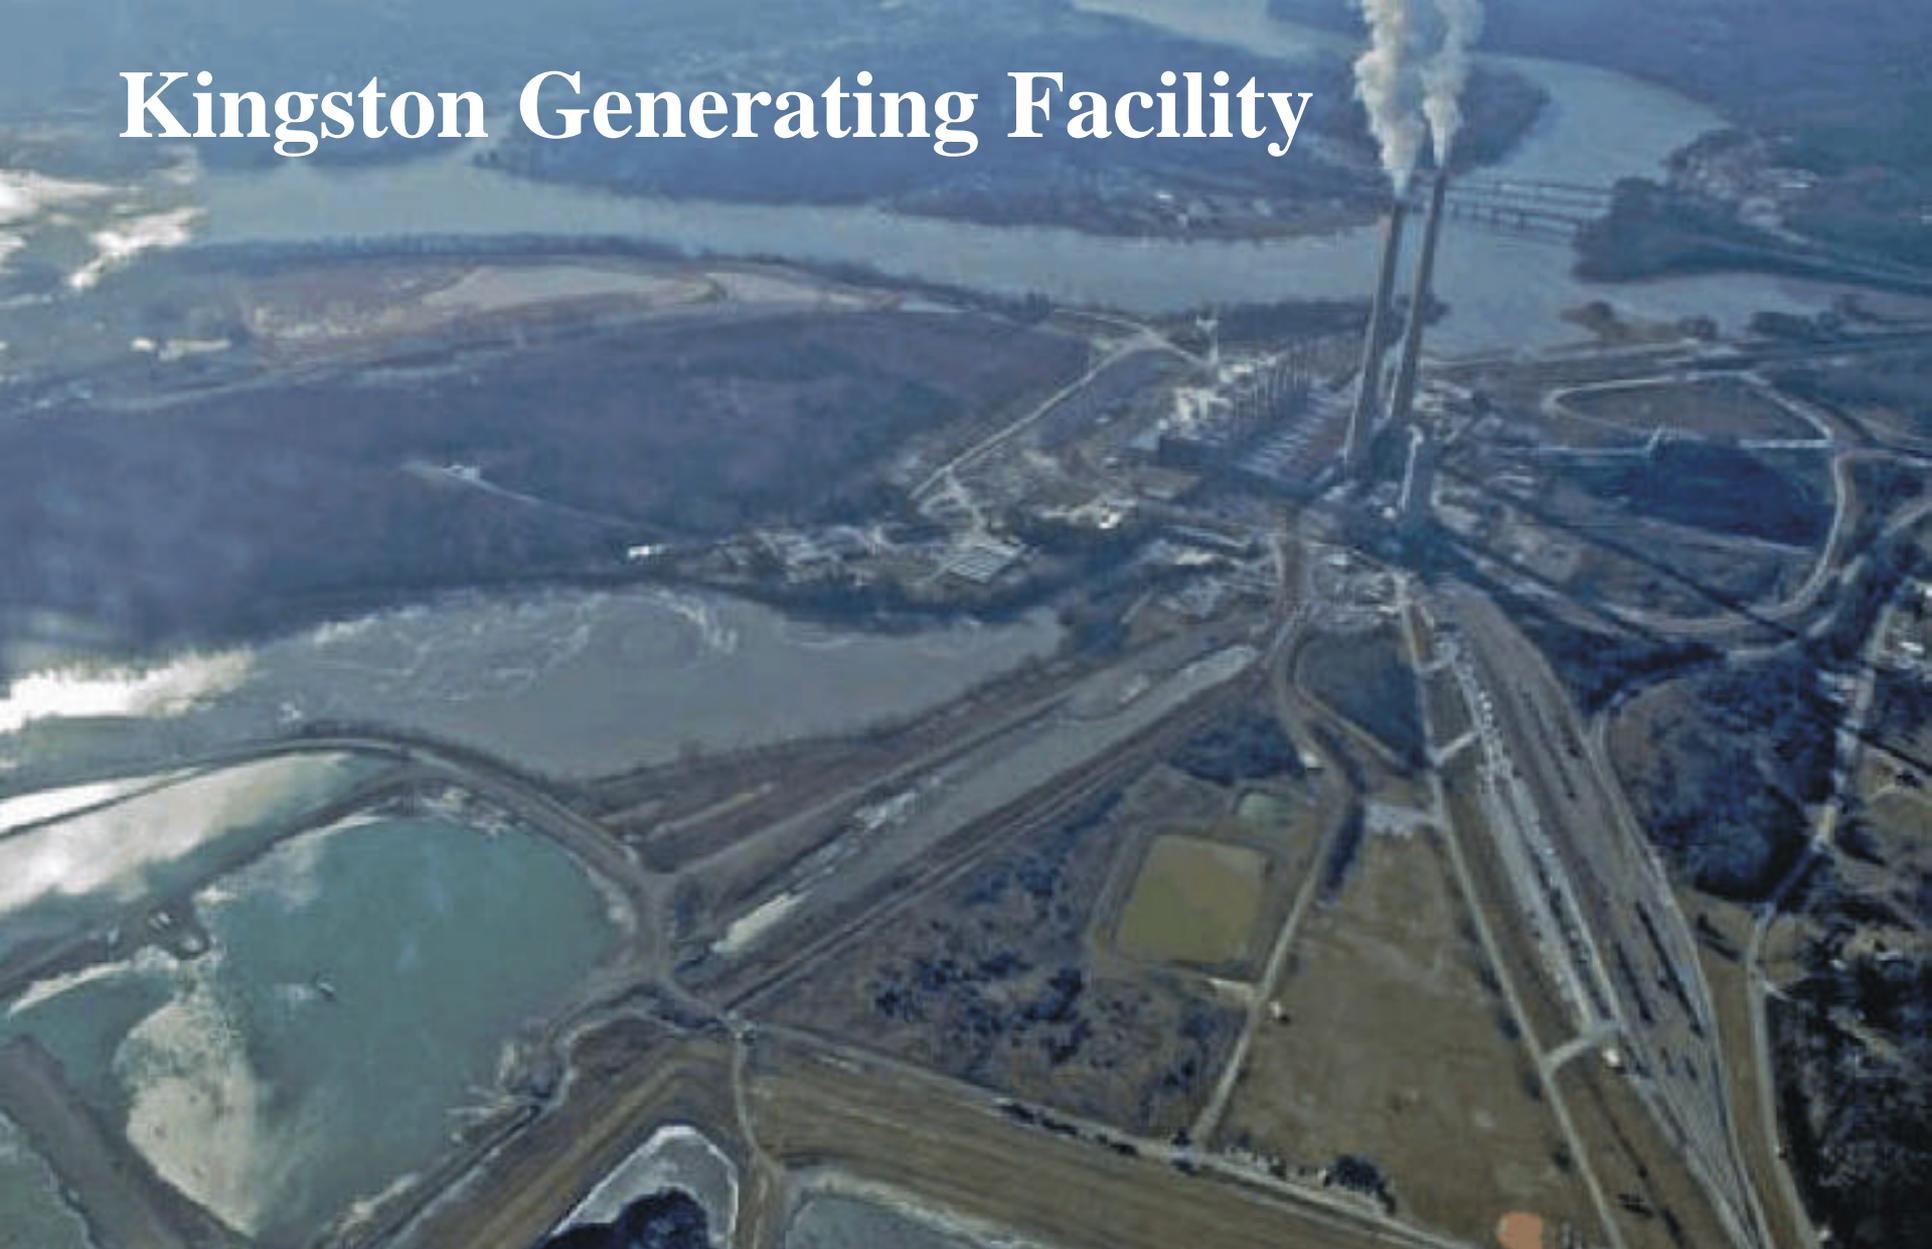
An aerial photograph of the Kingston Generating Facility. The facility is a large industrial complex with a prominent tall smokestack emitting a plume of white smoke. The facility is situated near a river and several large circular water treatment tanks. The surrounding area is a mix of industrial structures, roads, and some greenery.

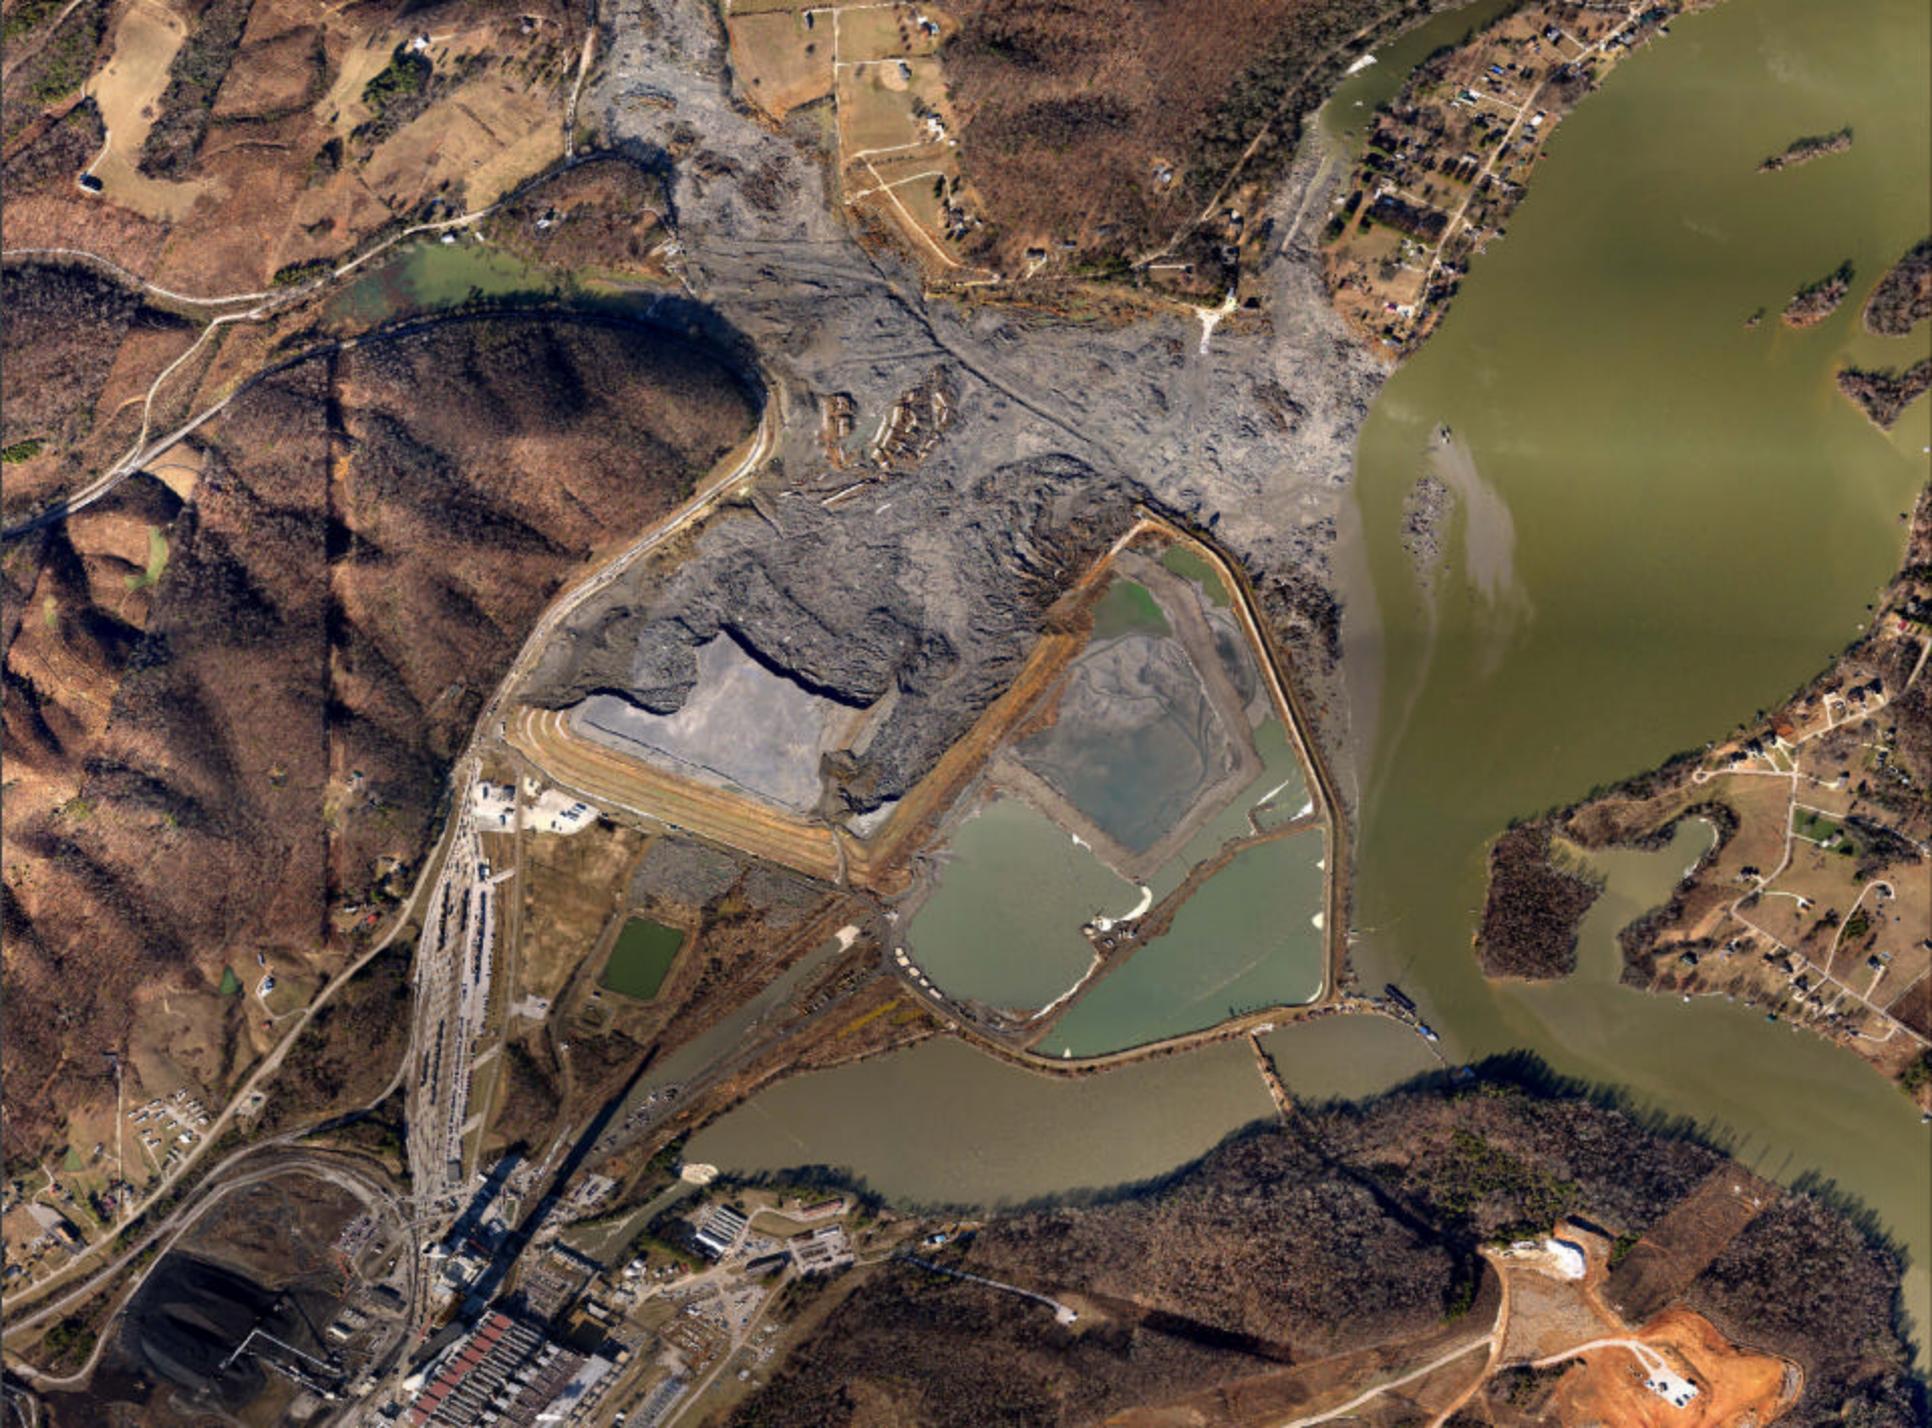
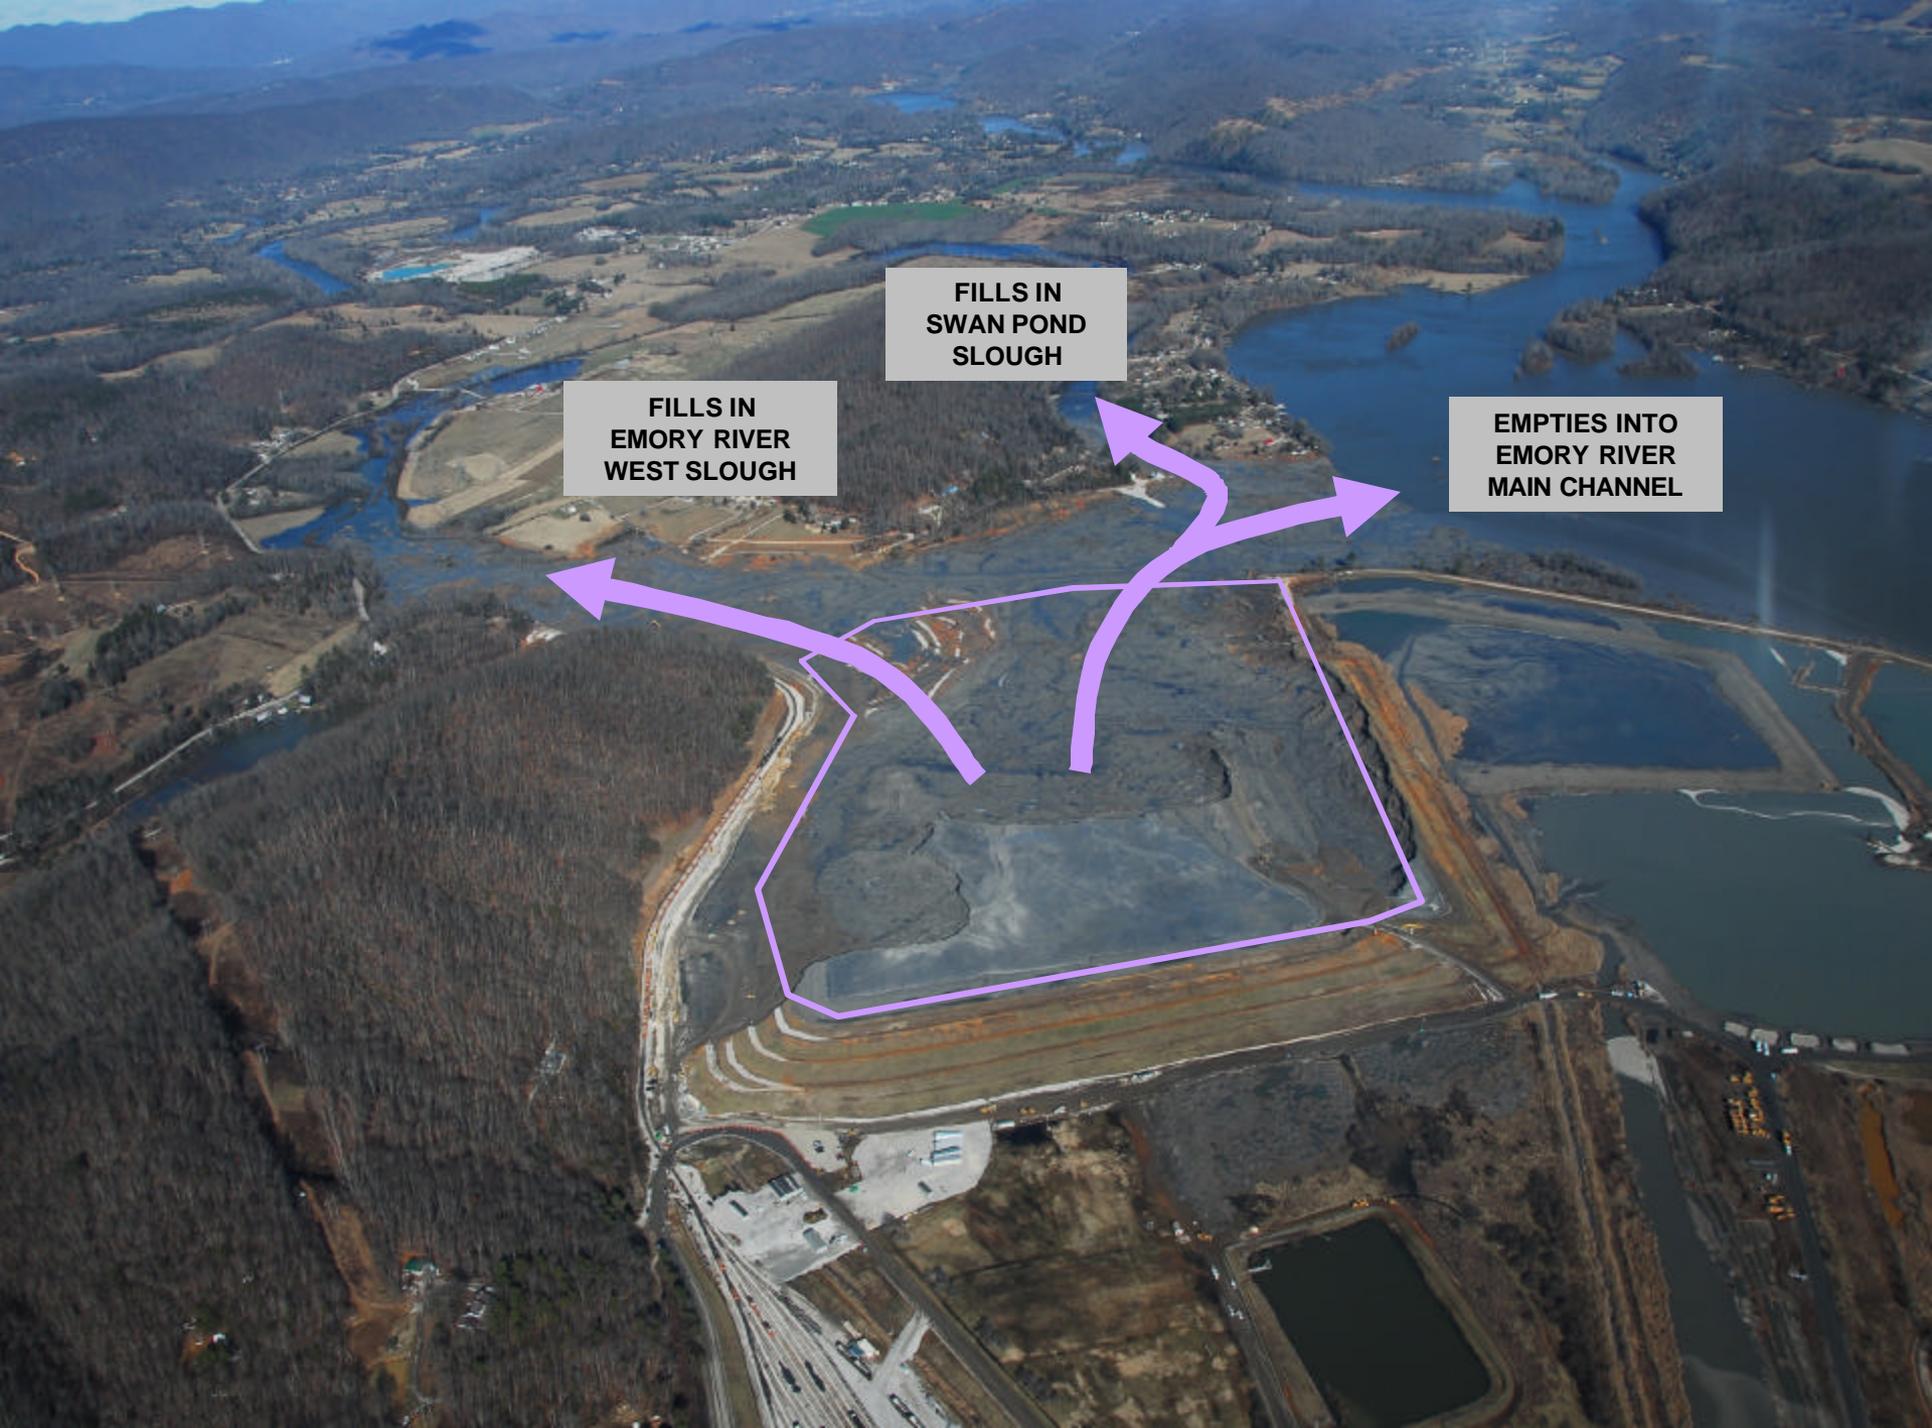
**FILLS IN  
SWAN POND  
SLOUGH**

**FILLS IN  
EMORY RIVER  
WEST SLOUGH**

**EMPTIES INTO  
EMORY RIVER  
MAIN CHANNEL**

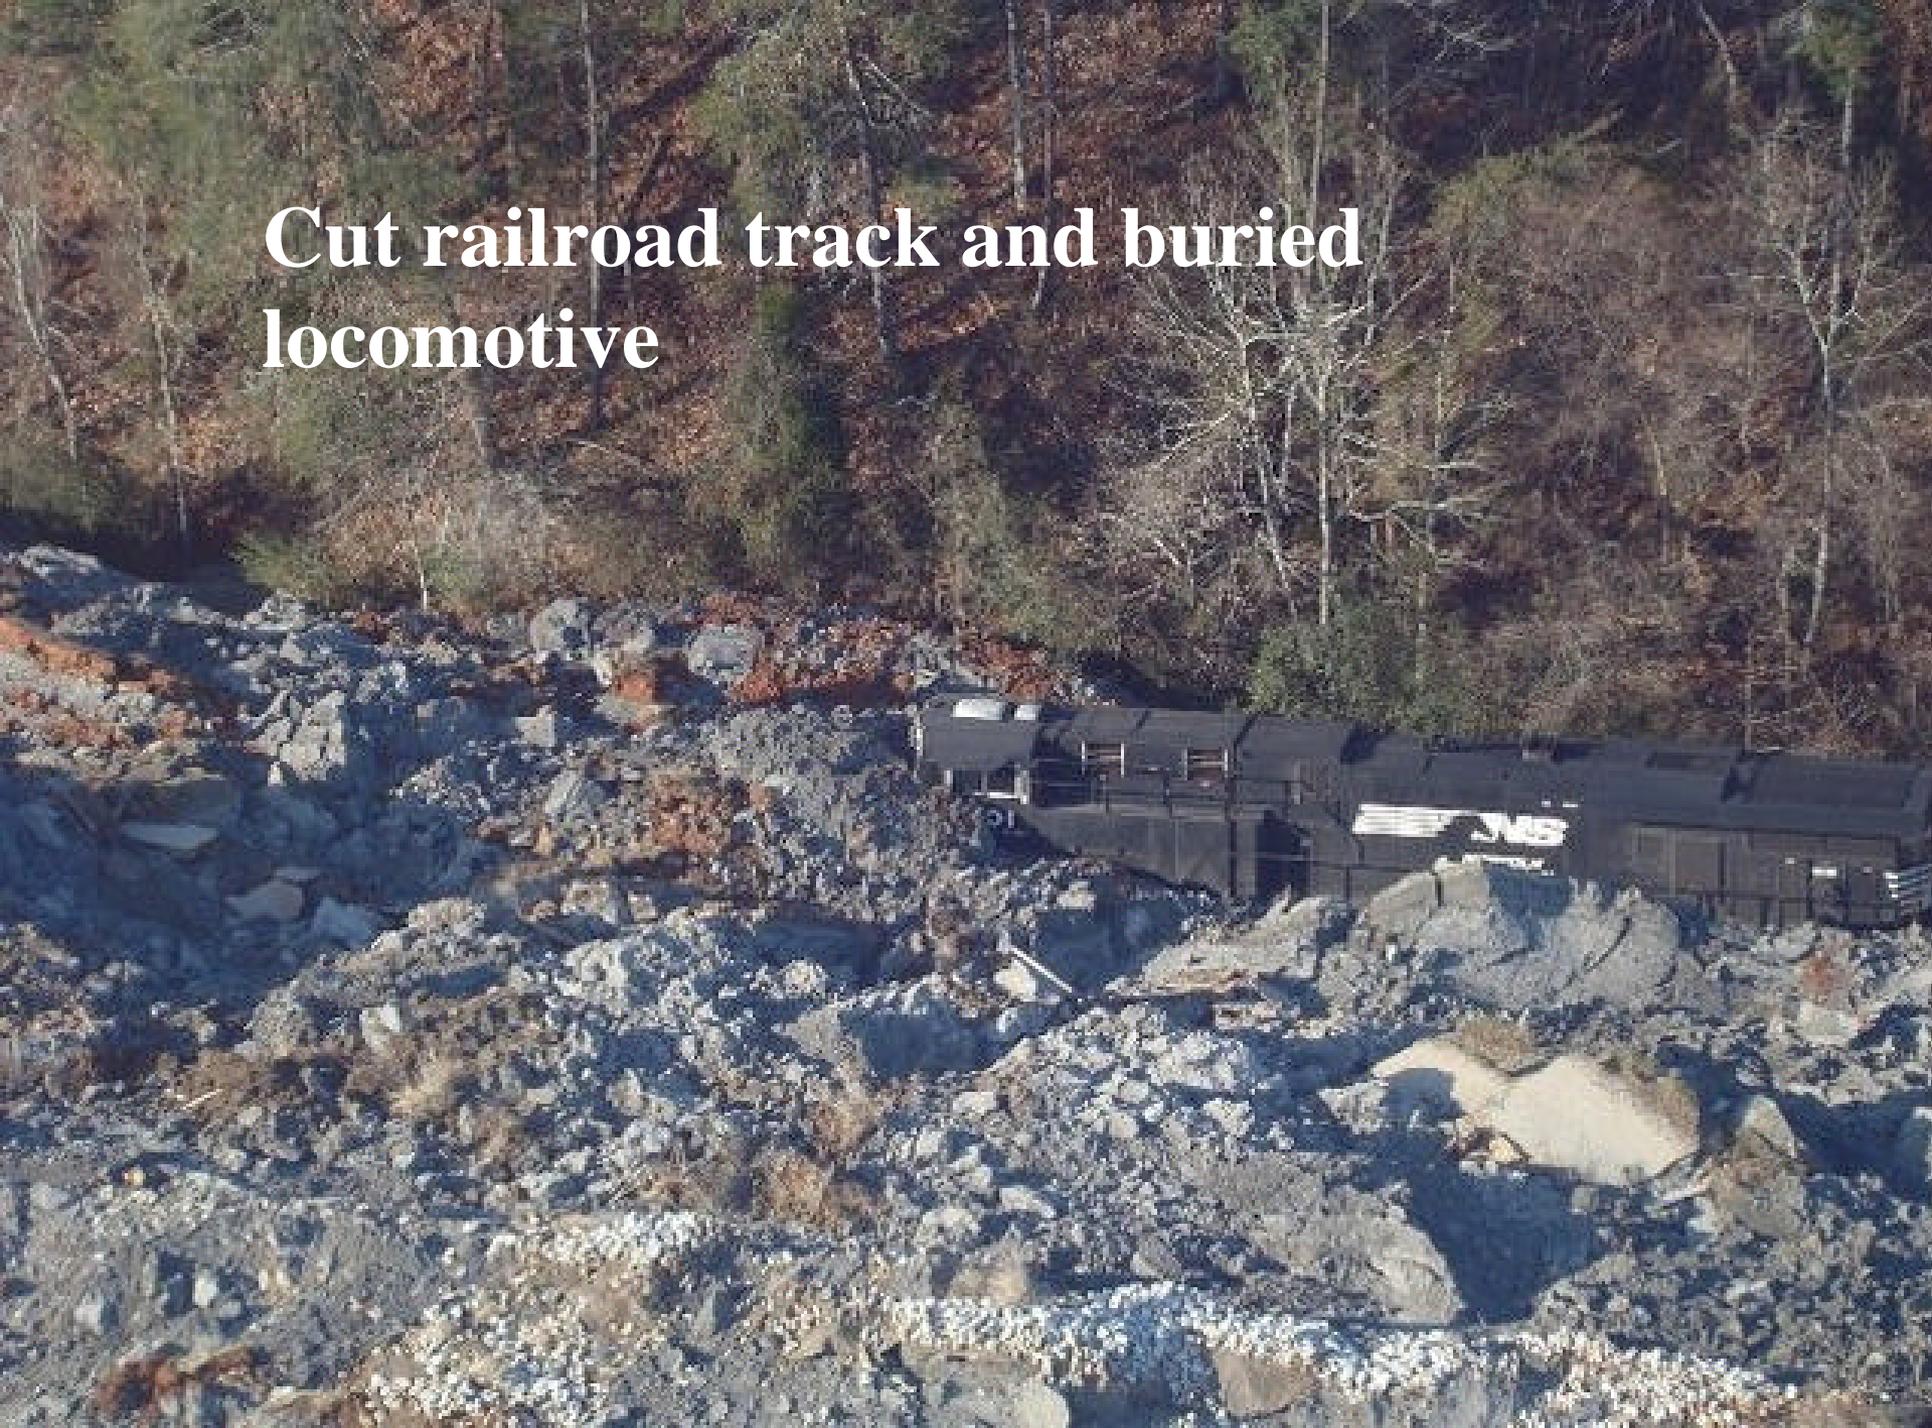
**Road, power line, water and sewer lines disrupted.**

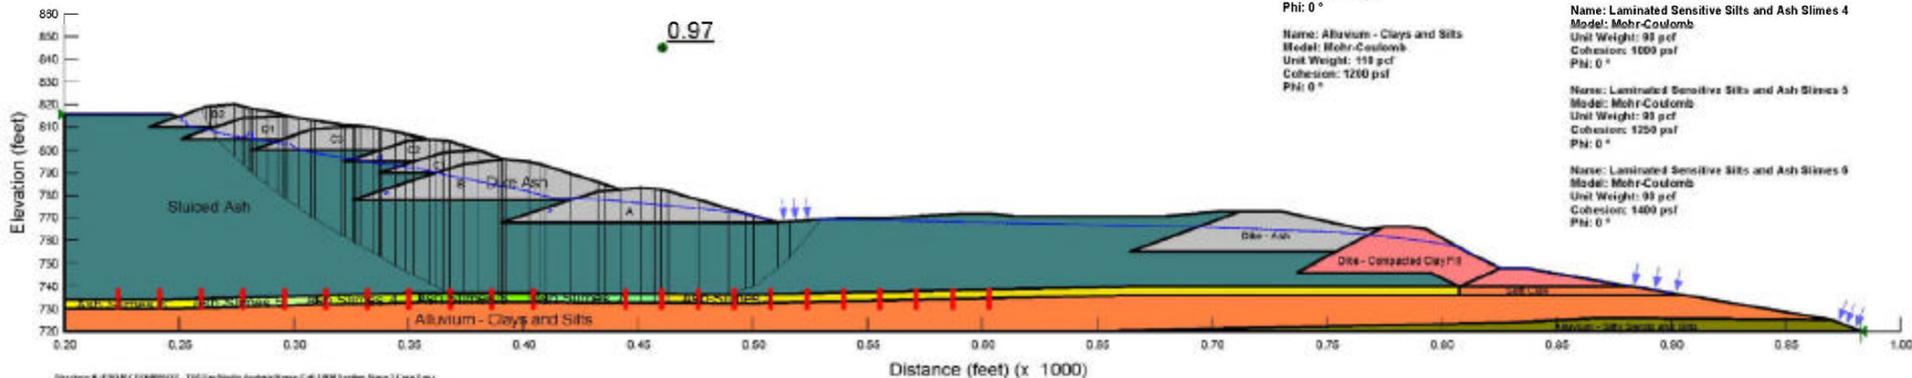
Geology & Foundation Engineering - TVA Kingston Analysis - Case 2 - Northwest Section Stage 2 Case 2.gpr

Title: TVA - Kingston RCA  
 Comments: Slope Stability Analysis for Cell 2 Northwest Section Stage 2 Case 2 (Low Bound Strength of Ash Slimes)  
 Method: Morgenstern-Price  
 Analysis Sluiced Ash Undrained Condition  
 Block Specified Failure Surface

Name: Ash - Dike  
 Model: Mohr-Coulomb  
 Unit Weight: 107 pcf  
 Unit Wt. Above Water Table: 102 pcf  
 Cohesion: 600 psf  
 Phi: 37 °

Name: Dike - Compacted Clay Fill  
 Model: Mohr-Coulomb  
 Unit Weight: 120 pcf  
 Cohesion: 600 psf  
 Phi: 15 °

Name: Ash - Sluiced  
 Model: S=(overburden)  
 Unit Weight: 107 pcf  
 Tau/Sigma Ratio: 0.3  
 Minimum Strength: 0

Name: Soft Clay  
 Model: Mohr-Coulomb  
 Unit Weight: 110 pcf  
 Cohesion: 600 psf  
 Phi: 0 °

Name: Alluvium - Clays and Silts  
 Model: Mohr-Coulomb  
 Unit Weight: 119 pcf  
 Cohesion: 1200 psf  
 Phi: 0 °

Name: Alluvium - Silty Sands and Silts  
 Model: Mohr-Coulomb  
 Unit Weight: 130 pcf  
 Cohesion: 600 psf  
 Phi: 30 °

Name: Laminated Sensitive Silts and Ash Slimes 1  
 Model: Mohr-Coulomb  
 Unit Weight: 90 pcf  
 Cohesion: 600 psf  
 Phi: 0 °

Name: Laminated Sensitive Silts and Ash Slimes 2  
 Model: Mohr-Coulomb  
 Unit Weight: 90 pcf  
 Cohesion: 700 psf  
 Phi: 0 °

Name: Laminated Sensitive Silts and Ash Slimes 3  
 Model: Mohr-Coulomb  
 Unit Weight: 90 pcf  
 Cohesion: 800 psf  
 Phi: 0 °

Name: Laminated Sensitive Silts and Ash Slimes 4  
 Model: Mohr-Coulomb  
 Unit Weight: 93 pcf  
 Cohesion: 1000 psf  
 Phi: 0 °

Name: Laminated Sensitive Silts and Ash Slimes 5  
 Model: Mohr-Coulomb  
 Unit Weight: 93 pcf  
 Cohesion: 1250 psf  
 Phi: 0 °

Name: Laminated Sensitive Silts and Ash Slimes 6  
 Model: Mohr-Coulomb  
 Unit Weight: 93 pcf  
 Cohesion: 1400 psf  
 Phi: 0 °

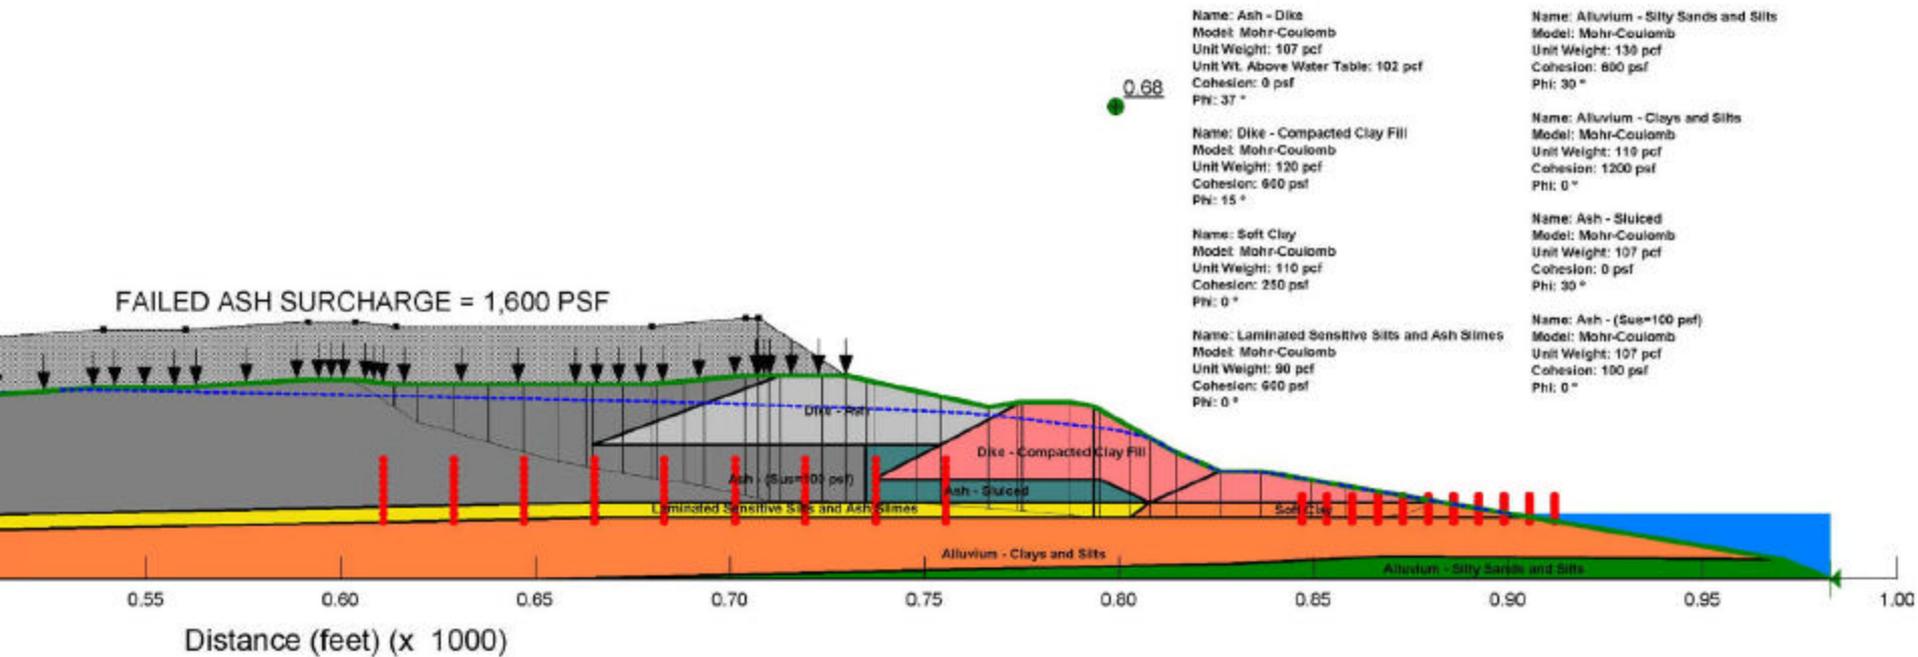
Directory: K:\PROJECTS\60095742 - TVA\GeoStudio Analysis\Name: Cell 2 NW Section - Stage 3 Post-Failure.gsz

Title: TVA - Kingston RCA  
 Comments: Stability Analysis for Cell 2 Northwest Section Stage 3 Post-Failure Case 1  
 Method: Morgenstern-Price  
 Block Specified Failure Surface

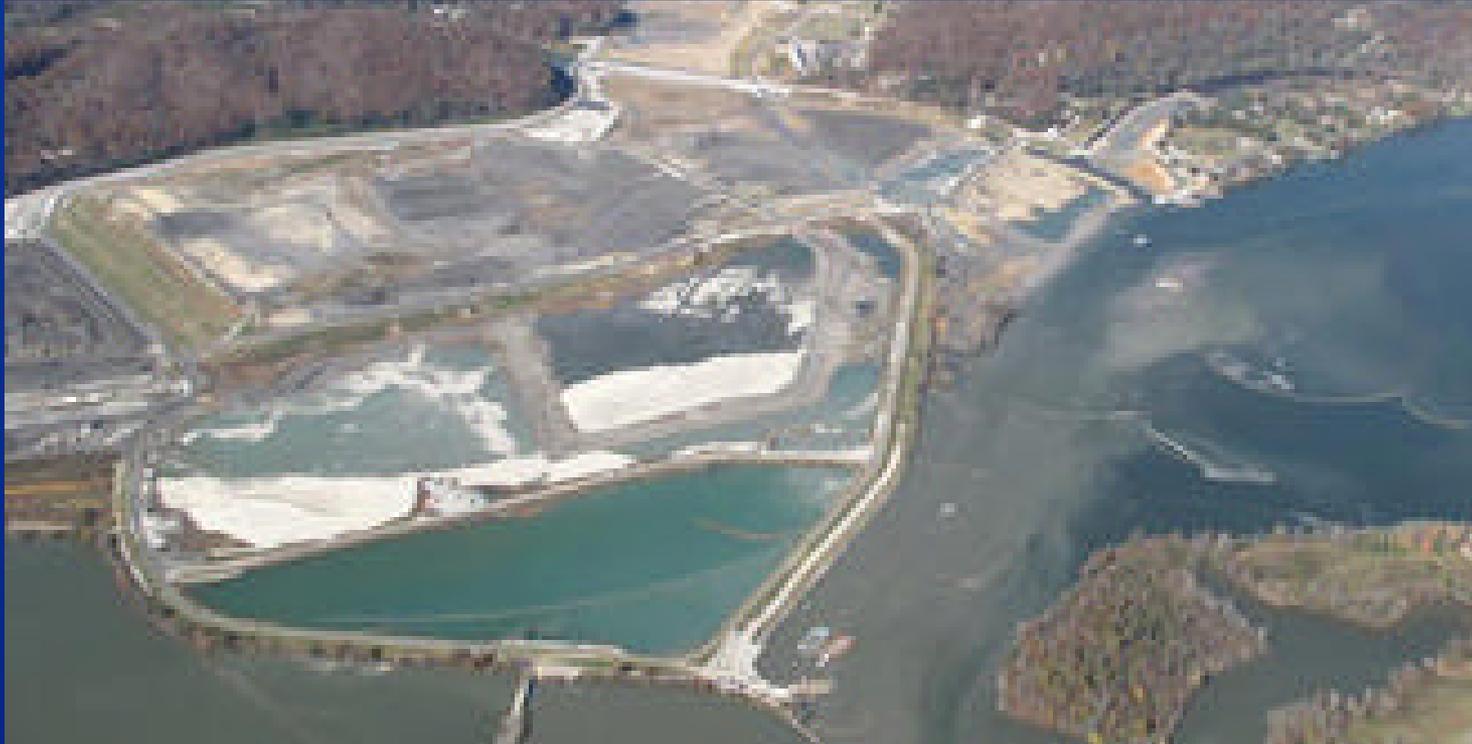
It took that long to design the buttress which is filter sand, fine gravel, coarse gravel, and riprap.

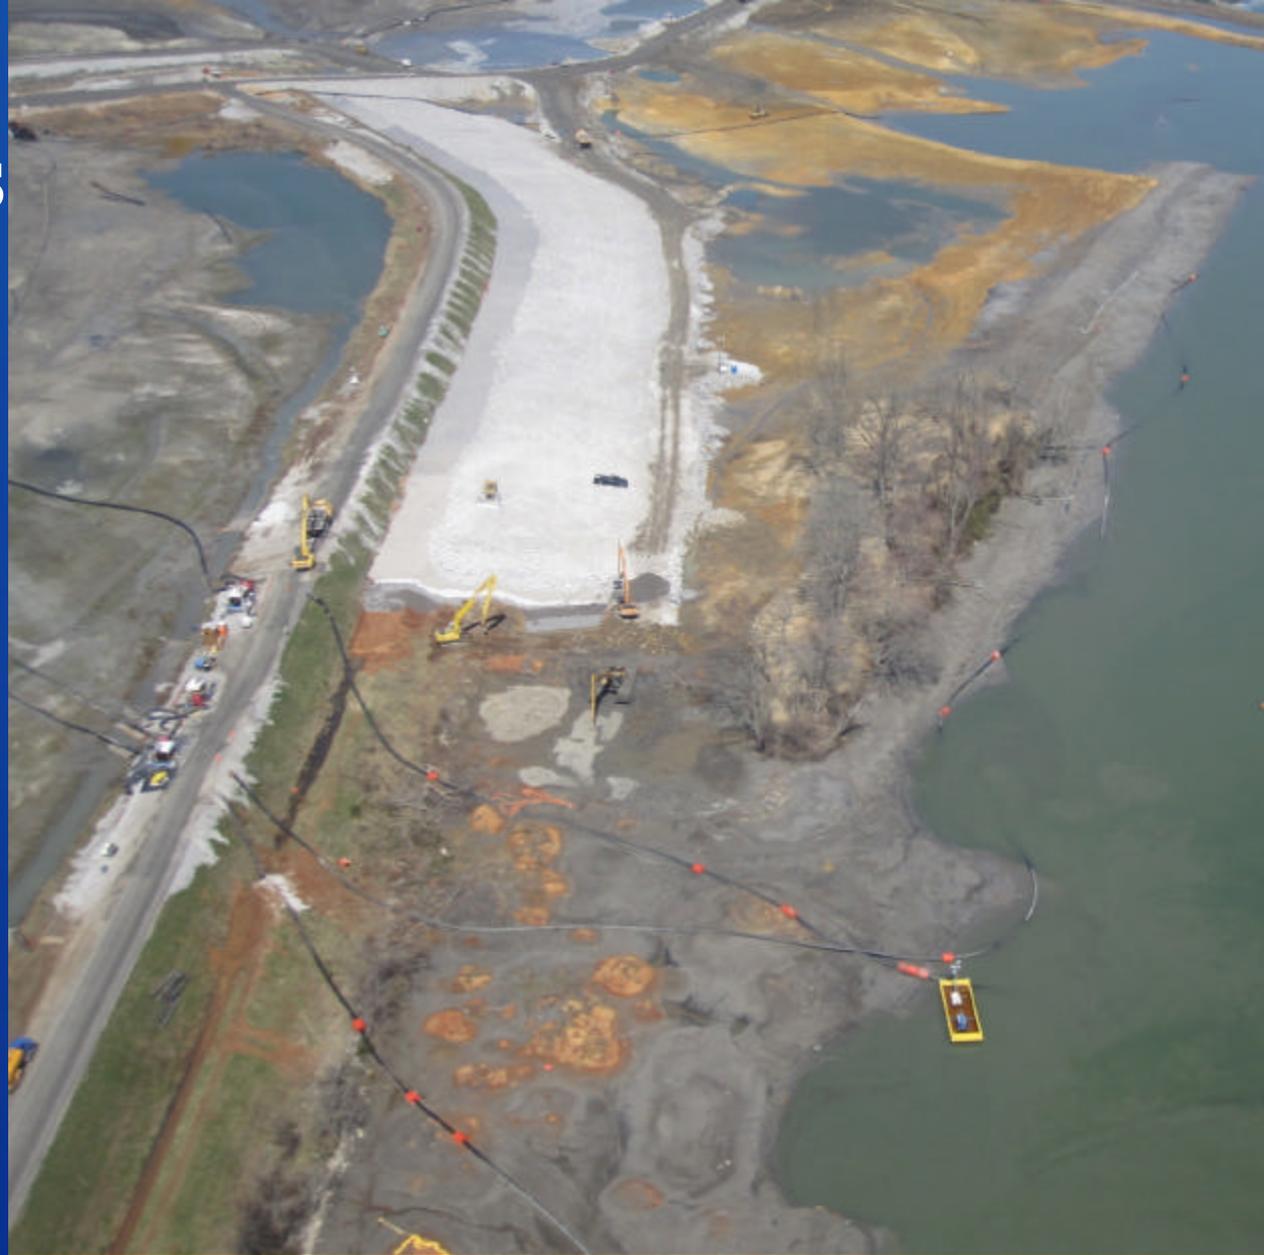
# Dike C Buttress

Seeps showed up at several of the tree holes.

Dike C slope stability Factors of Safety as low as 1.16

Later admitted that seismic failure is likely due to weak sand underneath the 10 feet of clay foundation.
