Restoring the Moonscapes of the Anaconda Uplands

Pedro Marques
Restoration Programs Manager
pmarques@bhwc.org

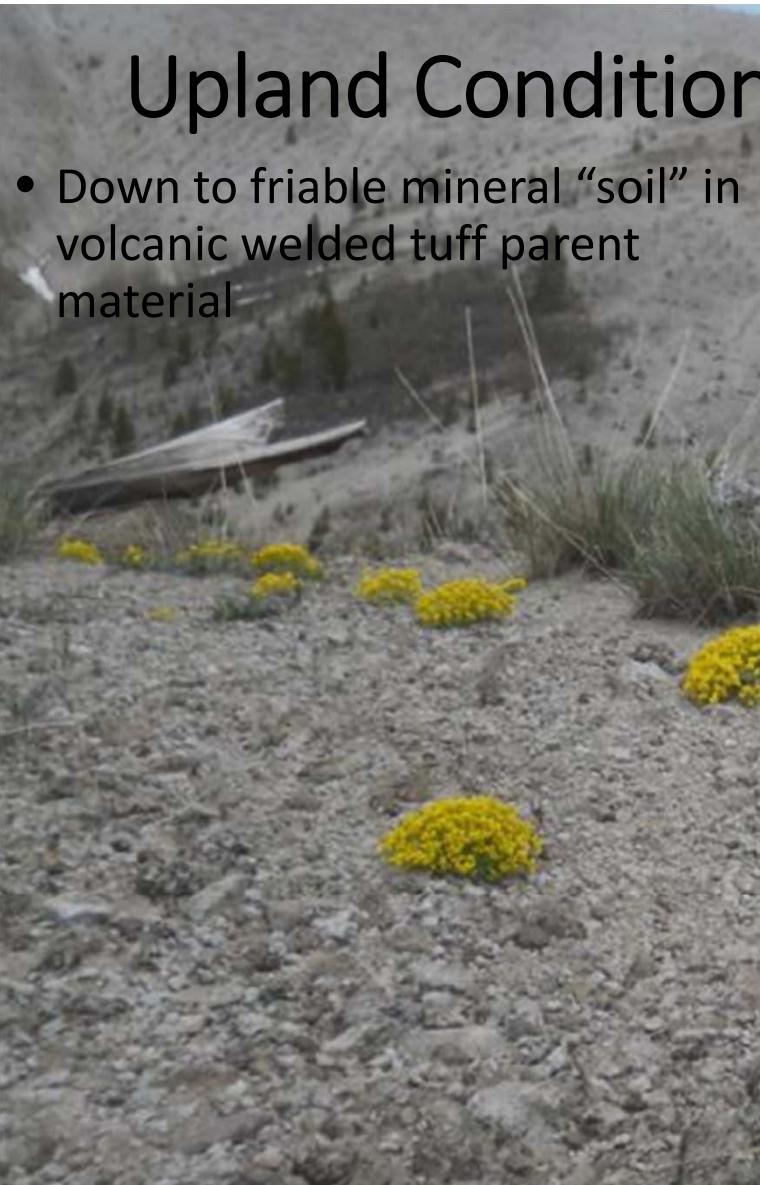
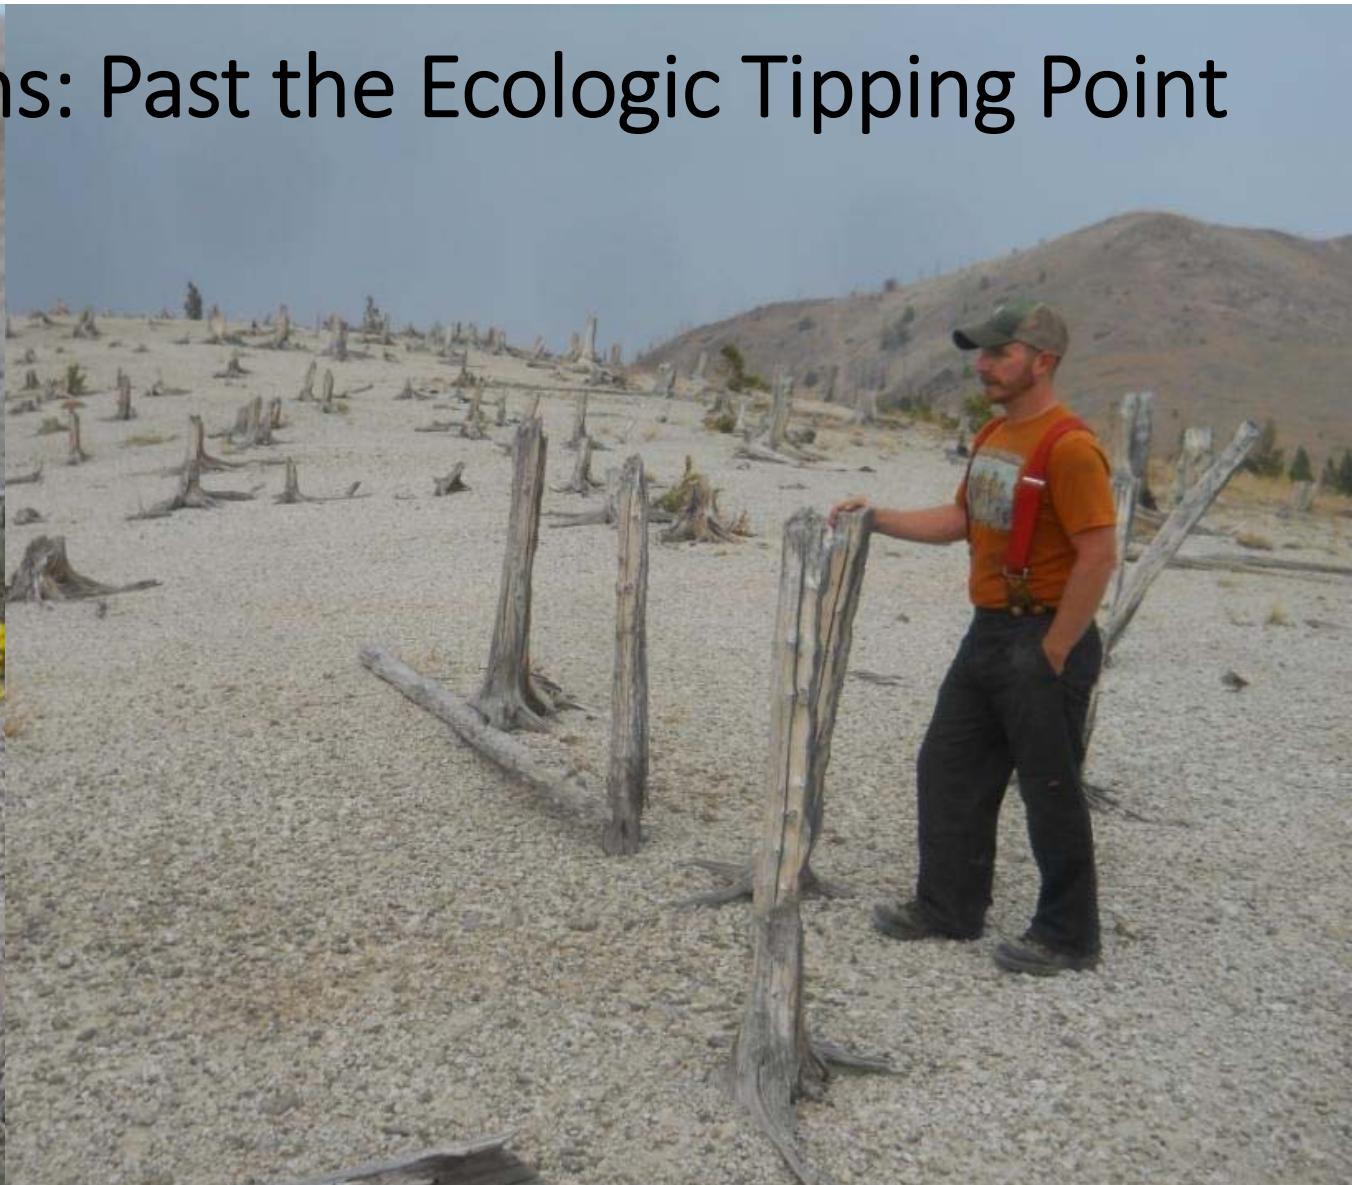
- Down to friable mineral “soil” in volcanic welded tuff parent material

- Down to friable mineral “soil” in volcanic welded tuff parent material
- Loss of 6"-18" of forest soil= most organics and water holding capacity
- Seed sources few and far between- high predation rates

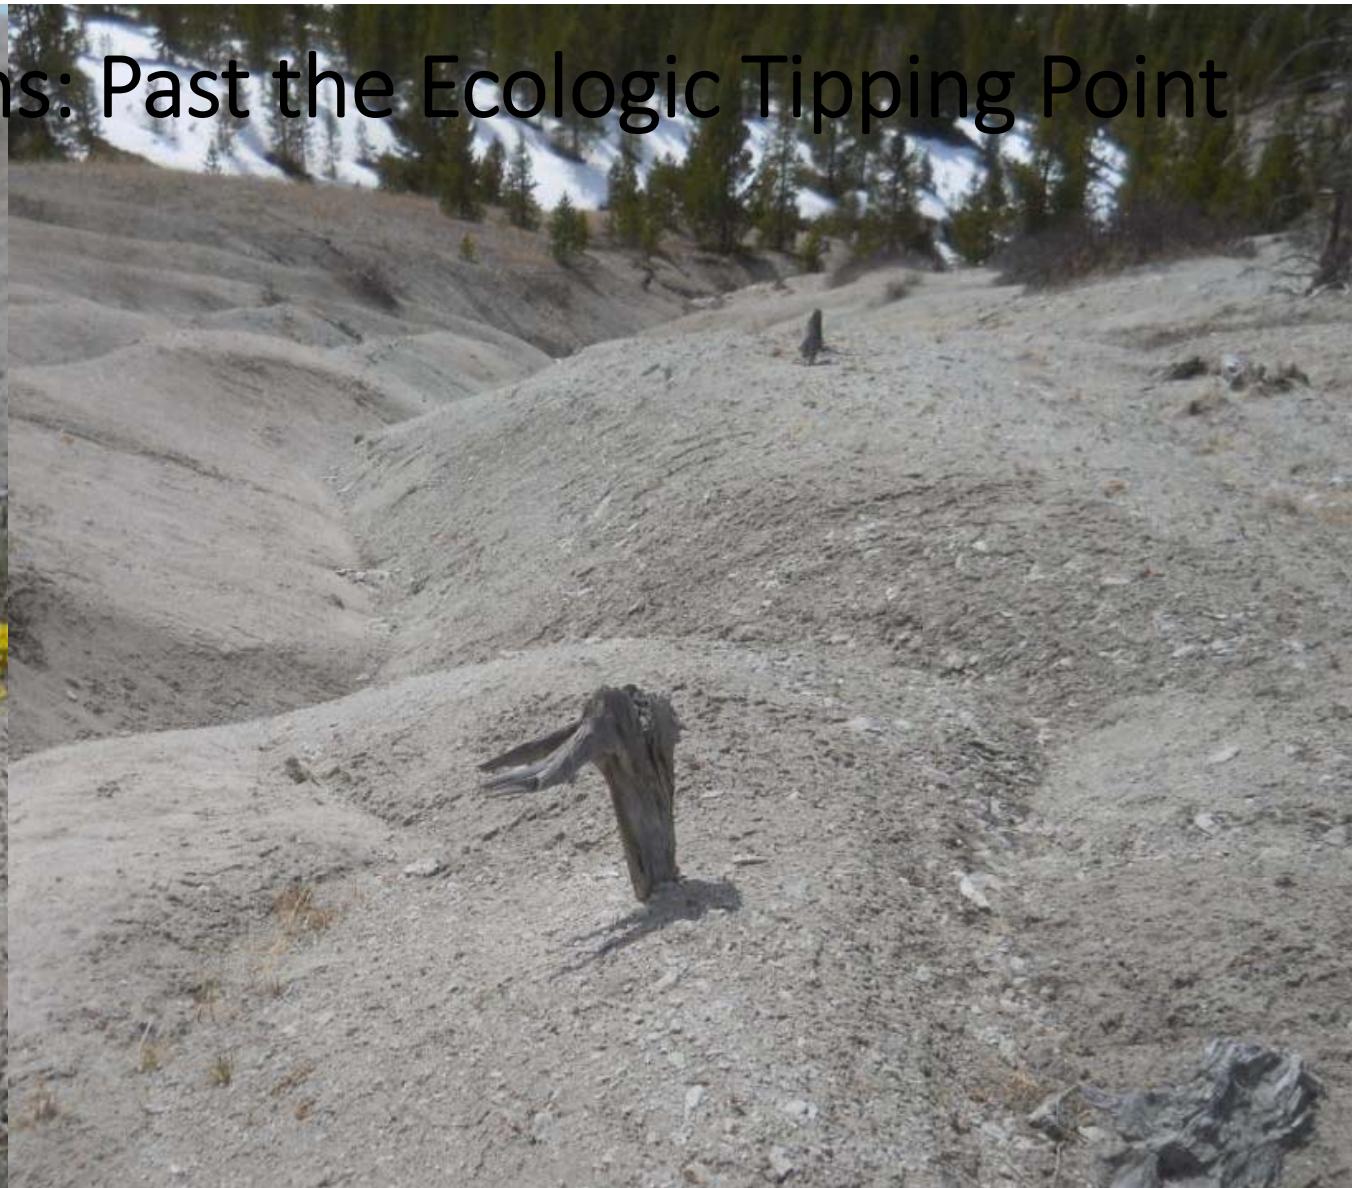
- Down to friable mineral “soil” in volcanic welded tuff parent material
- Loss of 6"-18" of forest soil= most organics and water holding capacity
- Seed sources few and far between- high predation rates
- Extreme summer, winter climate + wind erosion
- Loss of most natural grade controls and riparian buffer = sediment superhighways

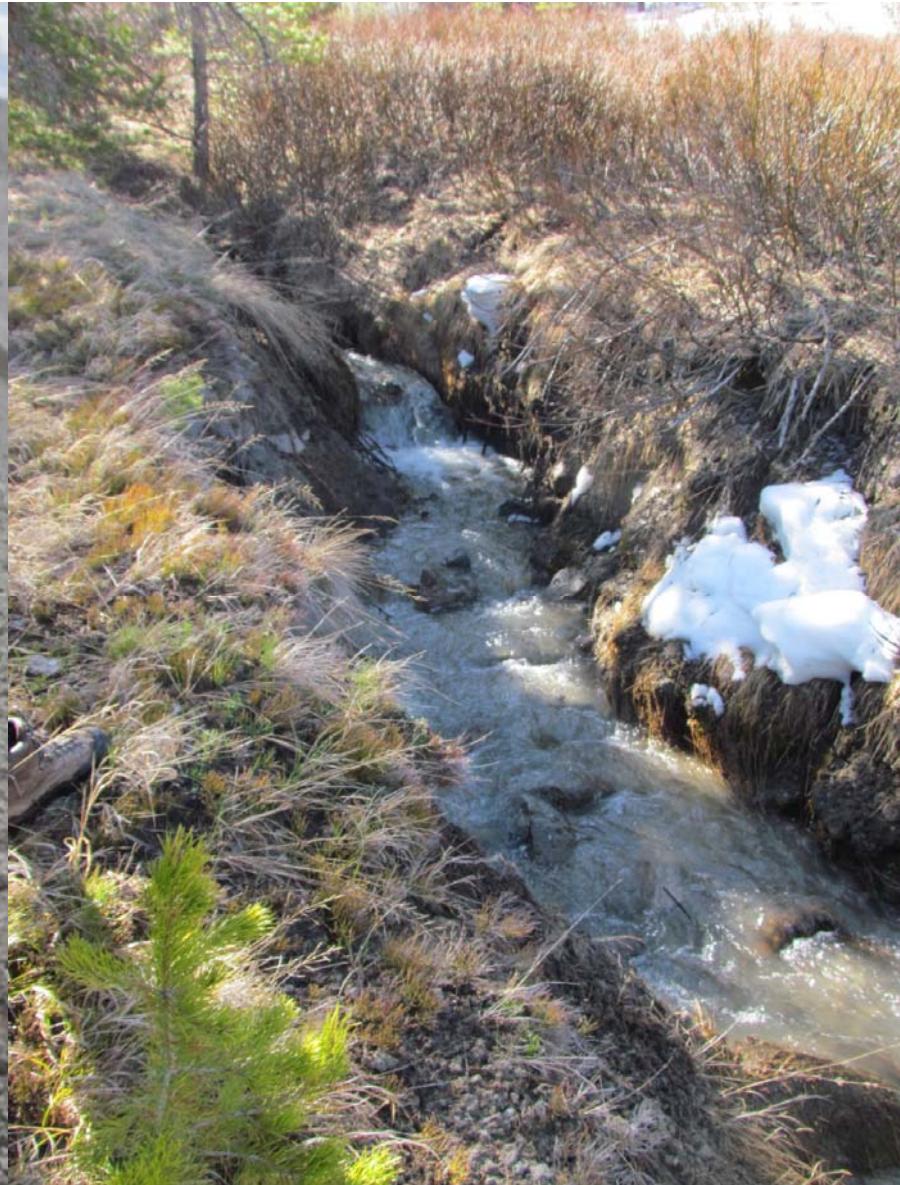
Riparian Conditions

- Incised streams associated with sediment plumes
- Loss of hydrologic connectivity and “Perched” riparian
- Beaver activity and habitat drastically reduced
- Herbivory
- Big Hole Landowners say California Creek “running white”
- Significant natural regeneration since 1980 from bottom up

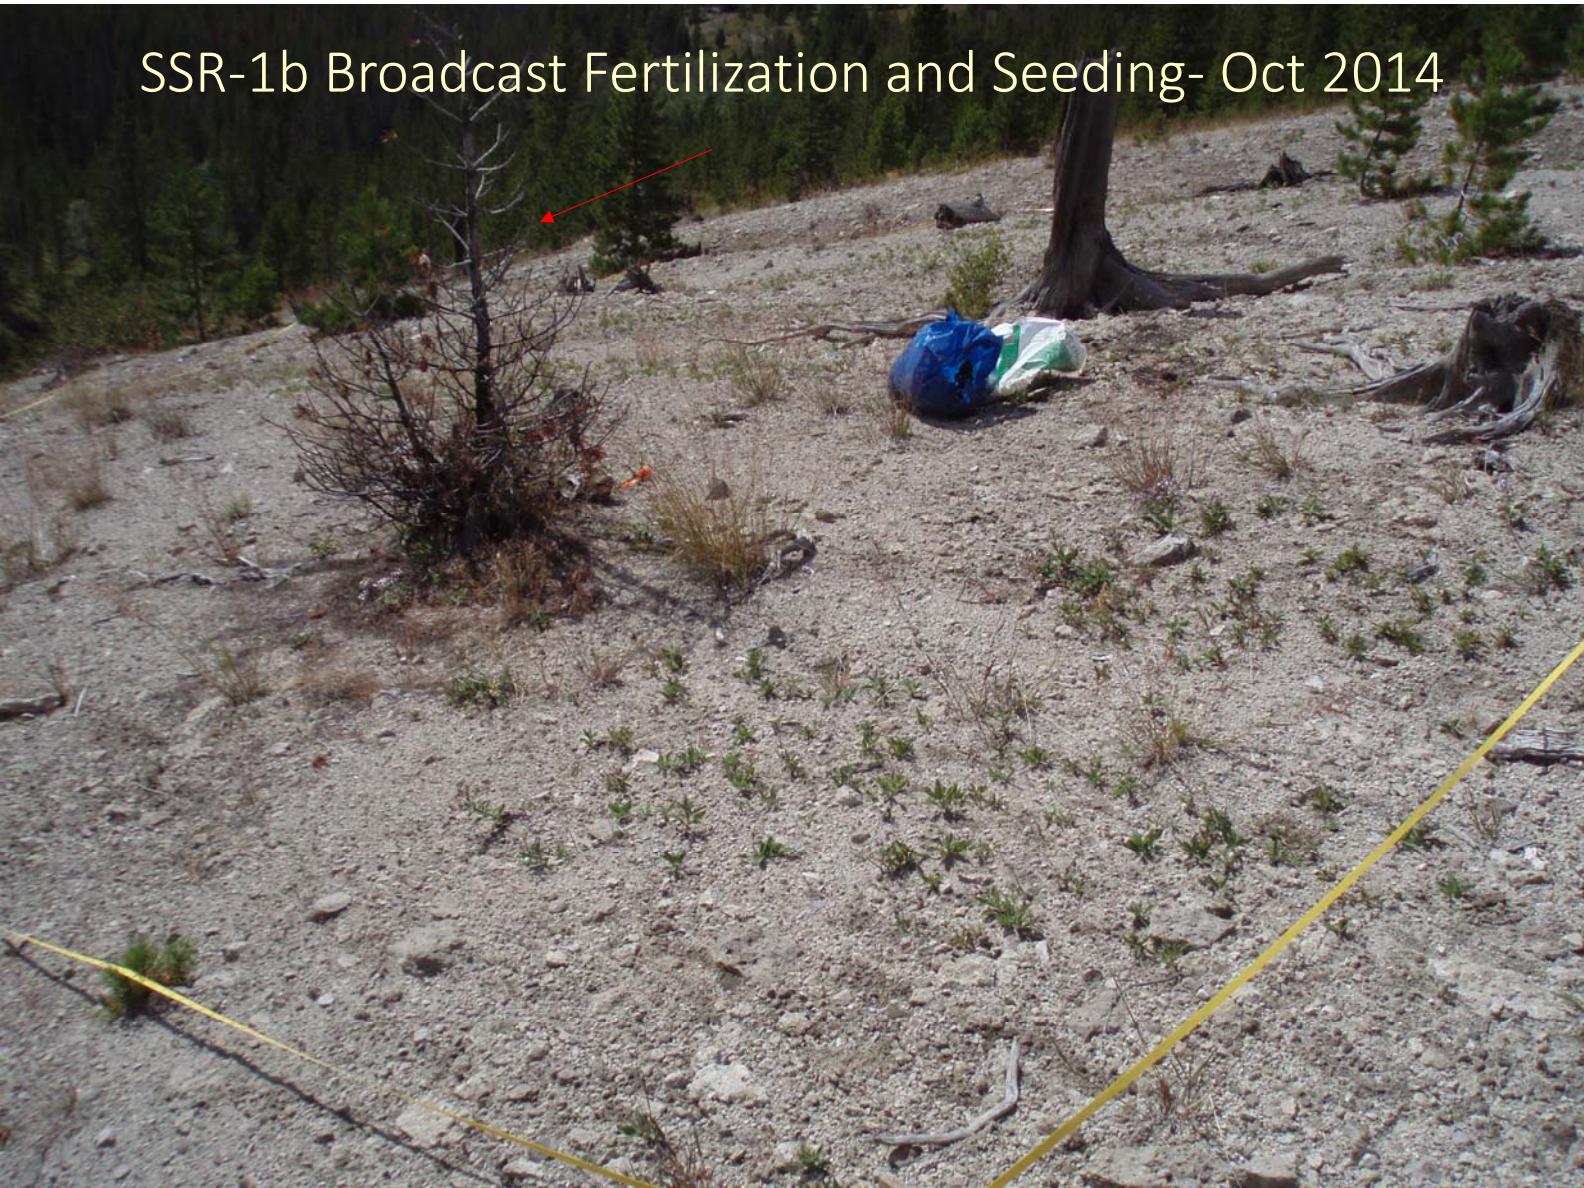
SSR-1b Broadcast Fertilization and Seeding- Oct 2014

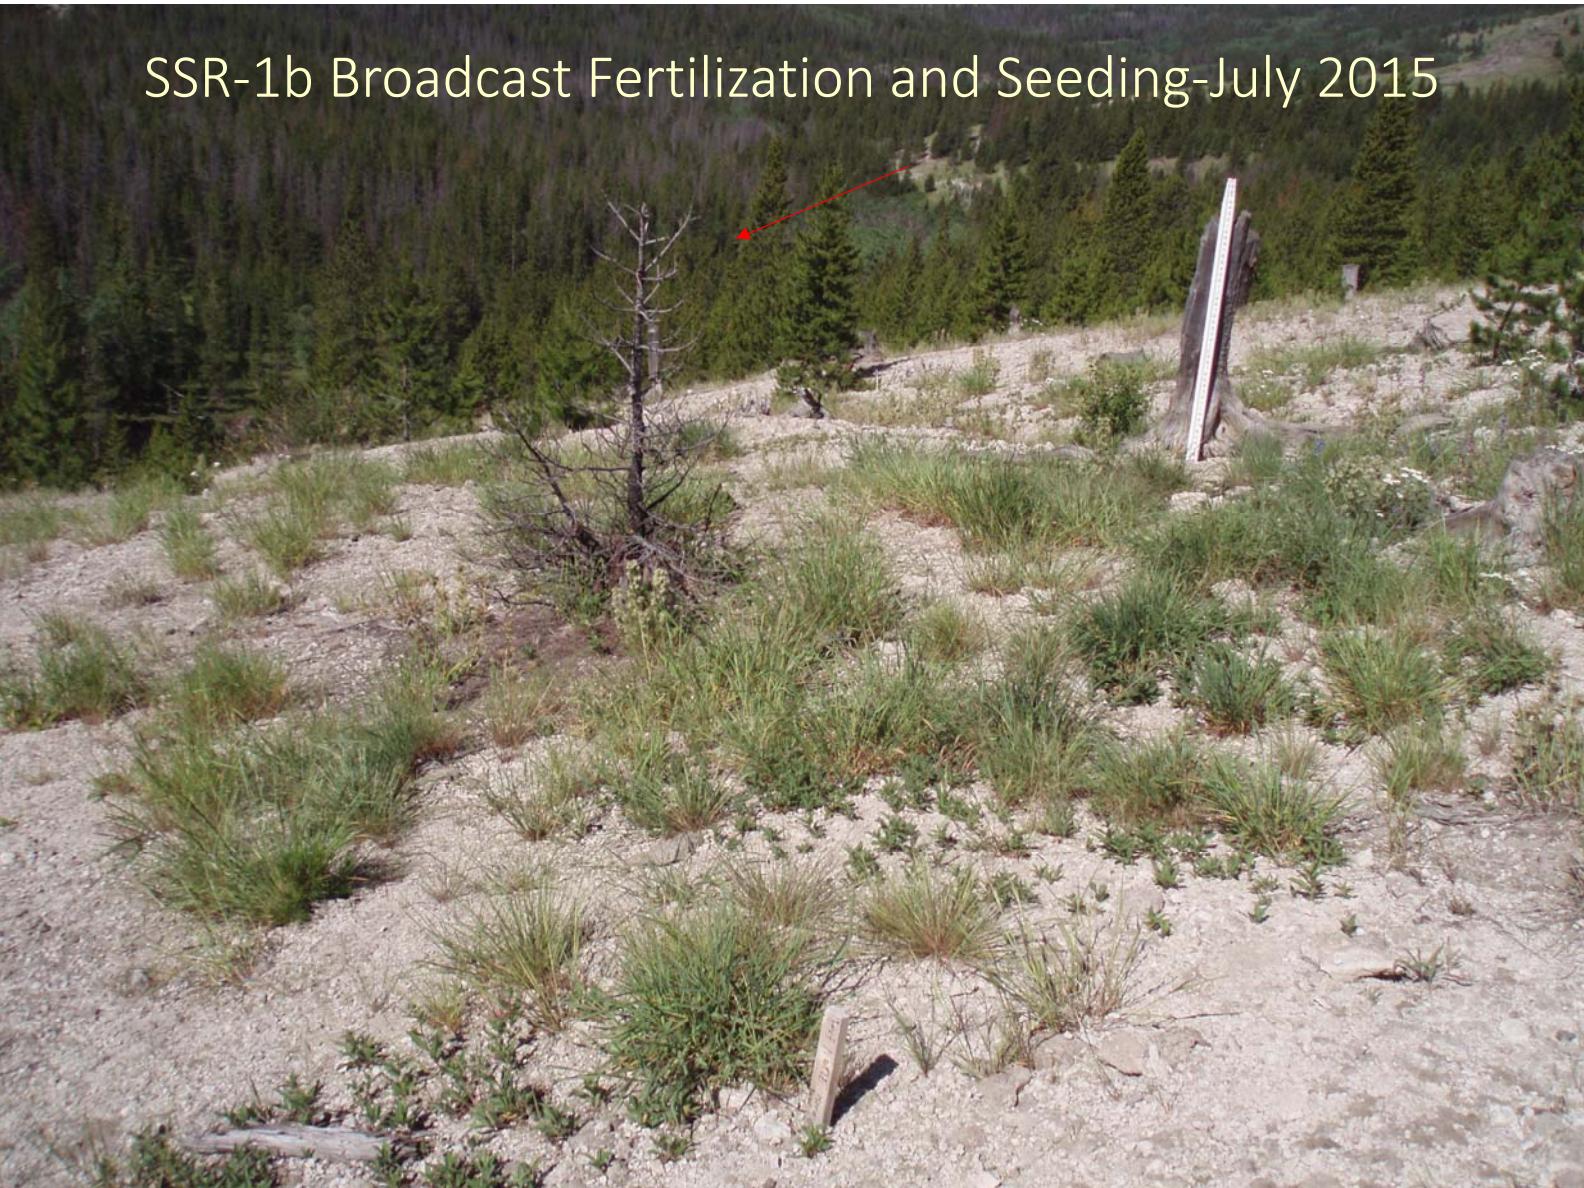
SSR-1b Broadcast Fertilization and Seeding-July 2015

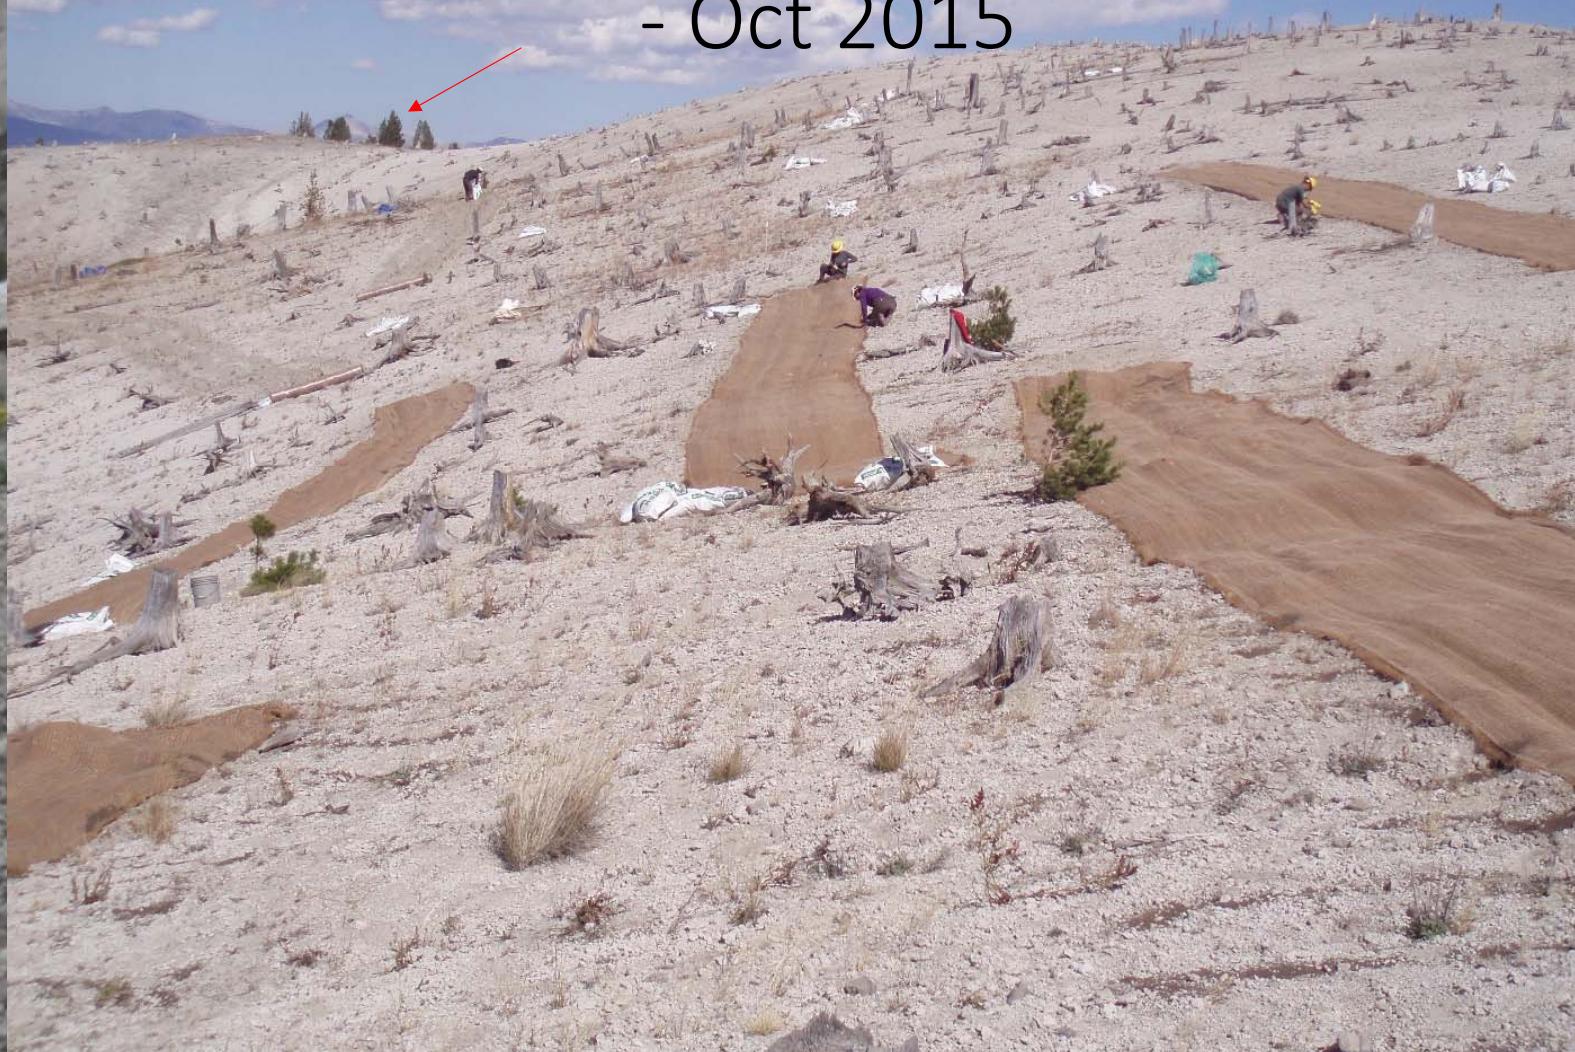
SSR-1c: 3 acre upland amendment fertilization
- Oct 2015

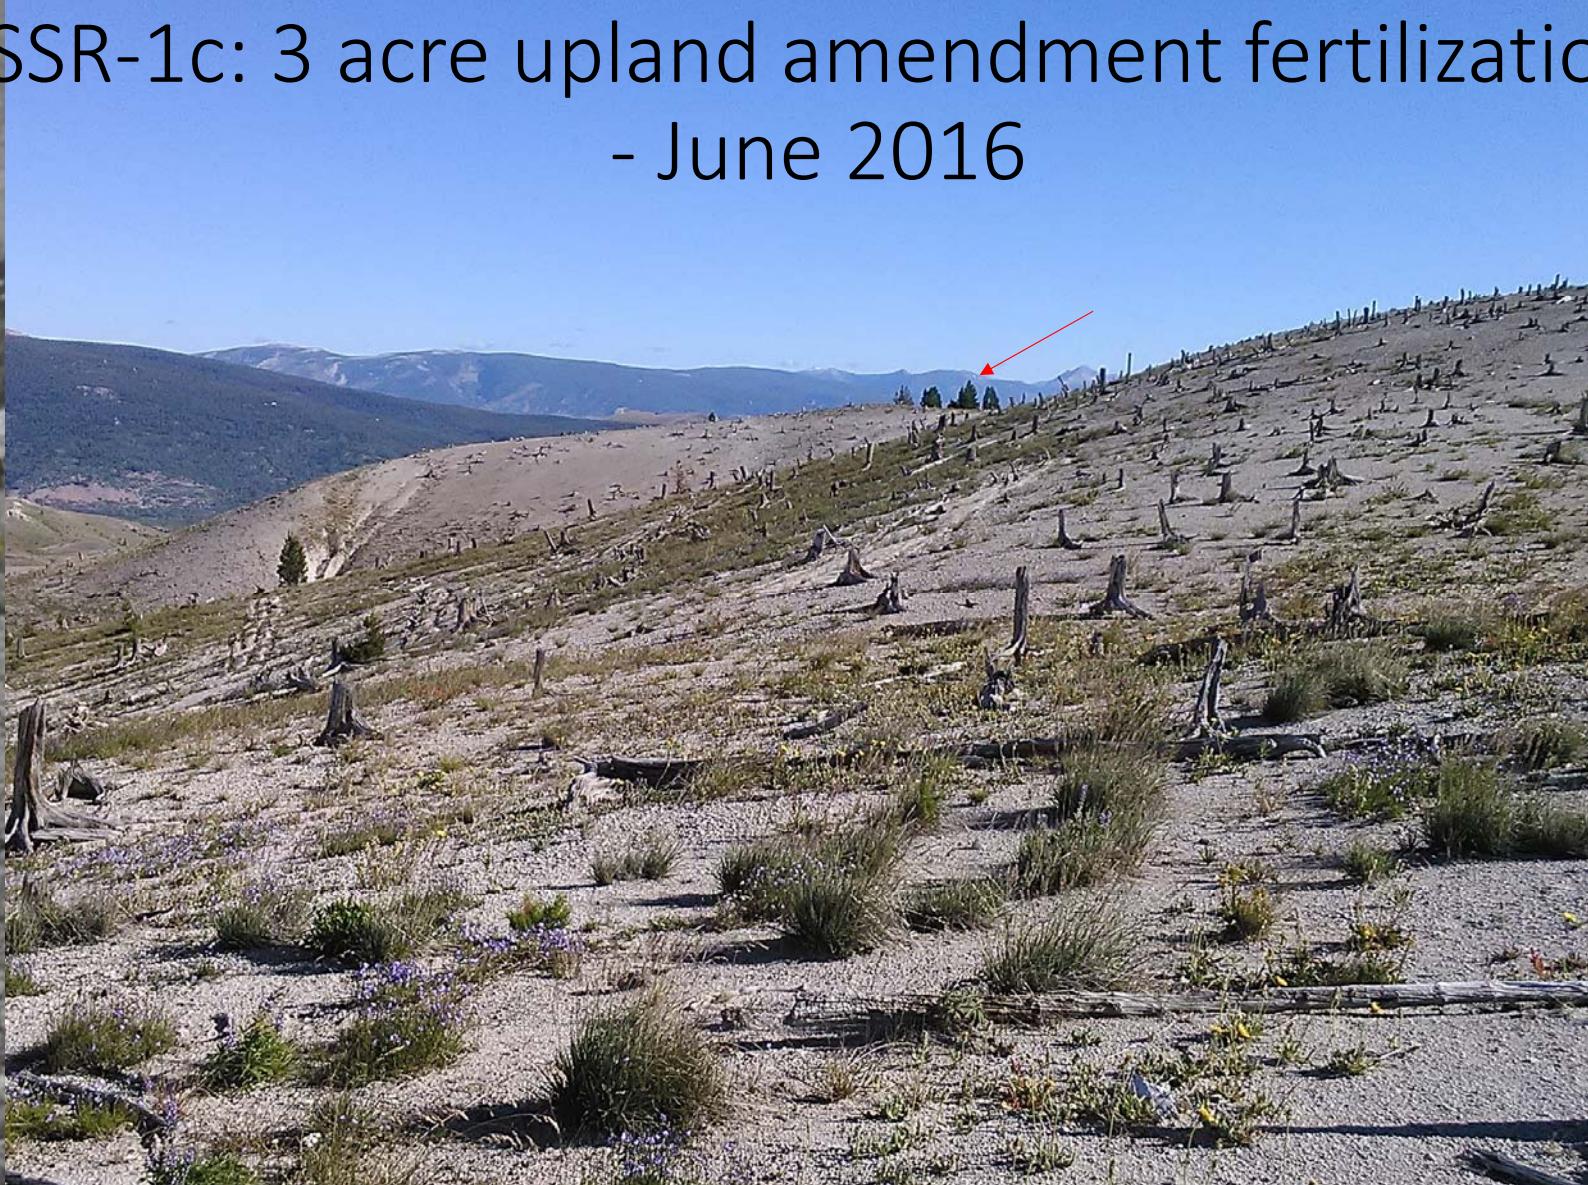
SSR-1c: 3 acre upland amendment fertilization
- June 2016

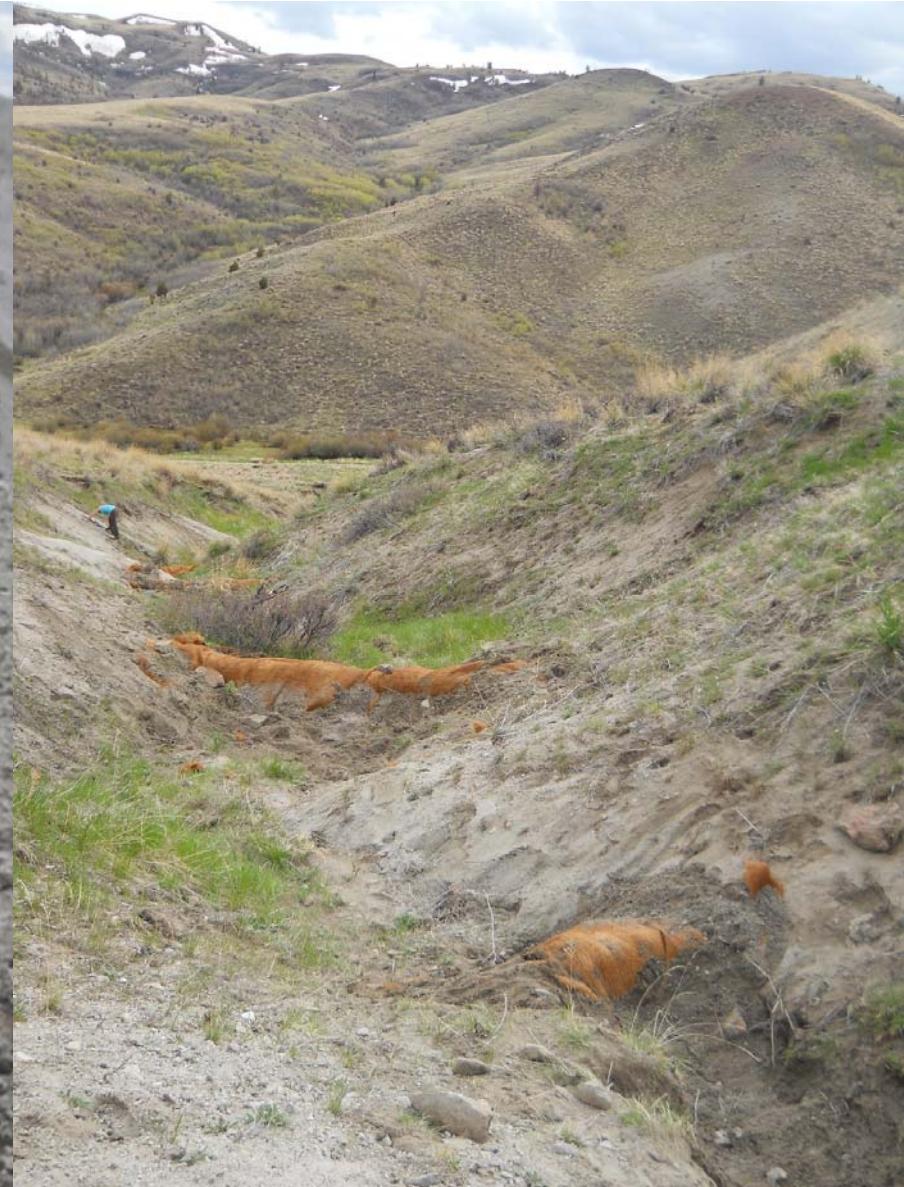
Filled structures:

- Widen gully bottom/floodplain
- Allow seed to settle and germinate in captured fines
- Can be built on again decreasing sidewall slope length
- Hold back moisture

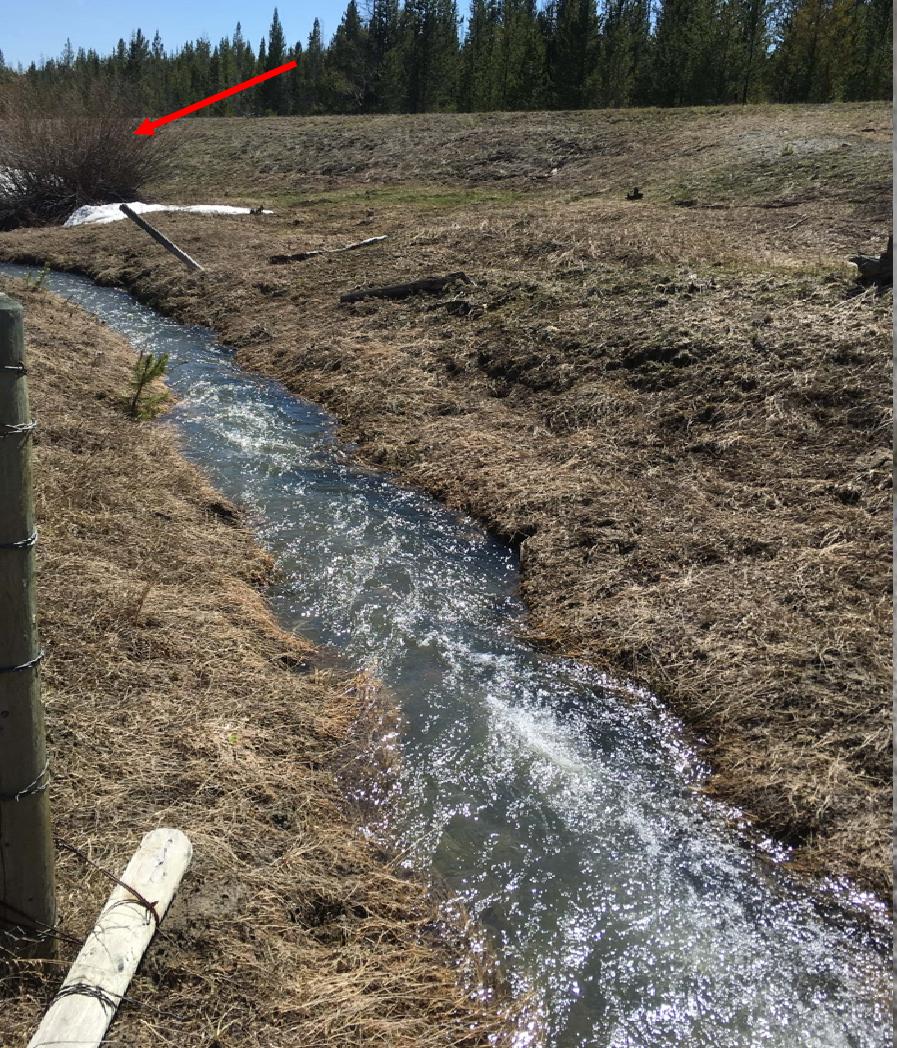
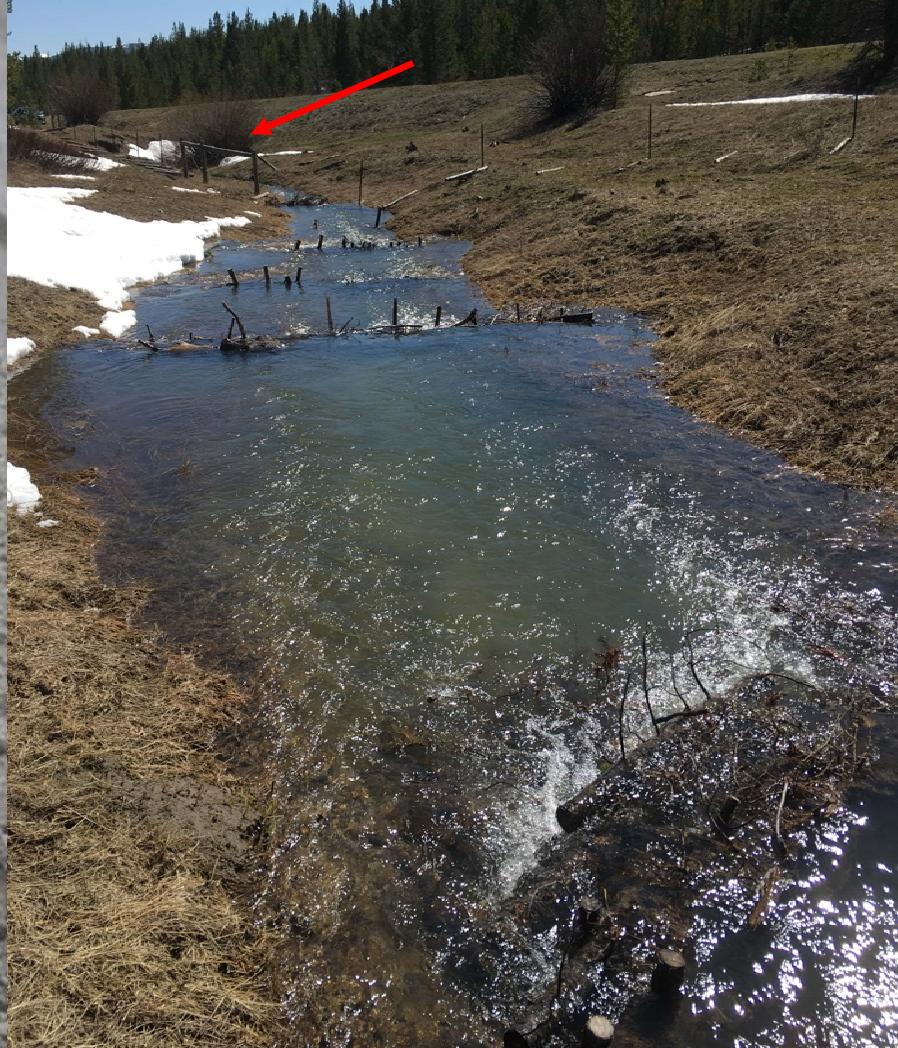
SSR 2-c: Beaver Mimicry

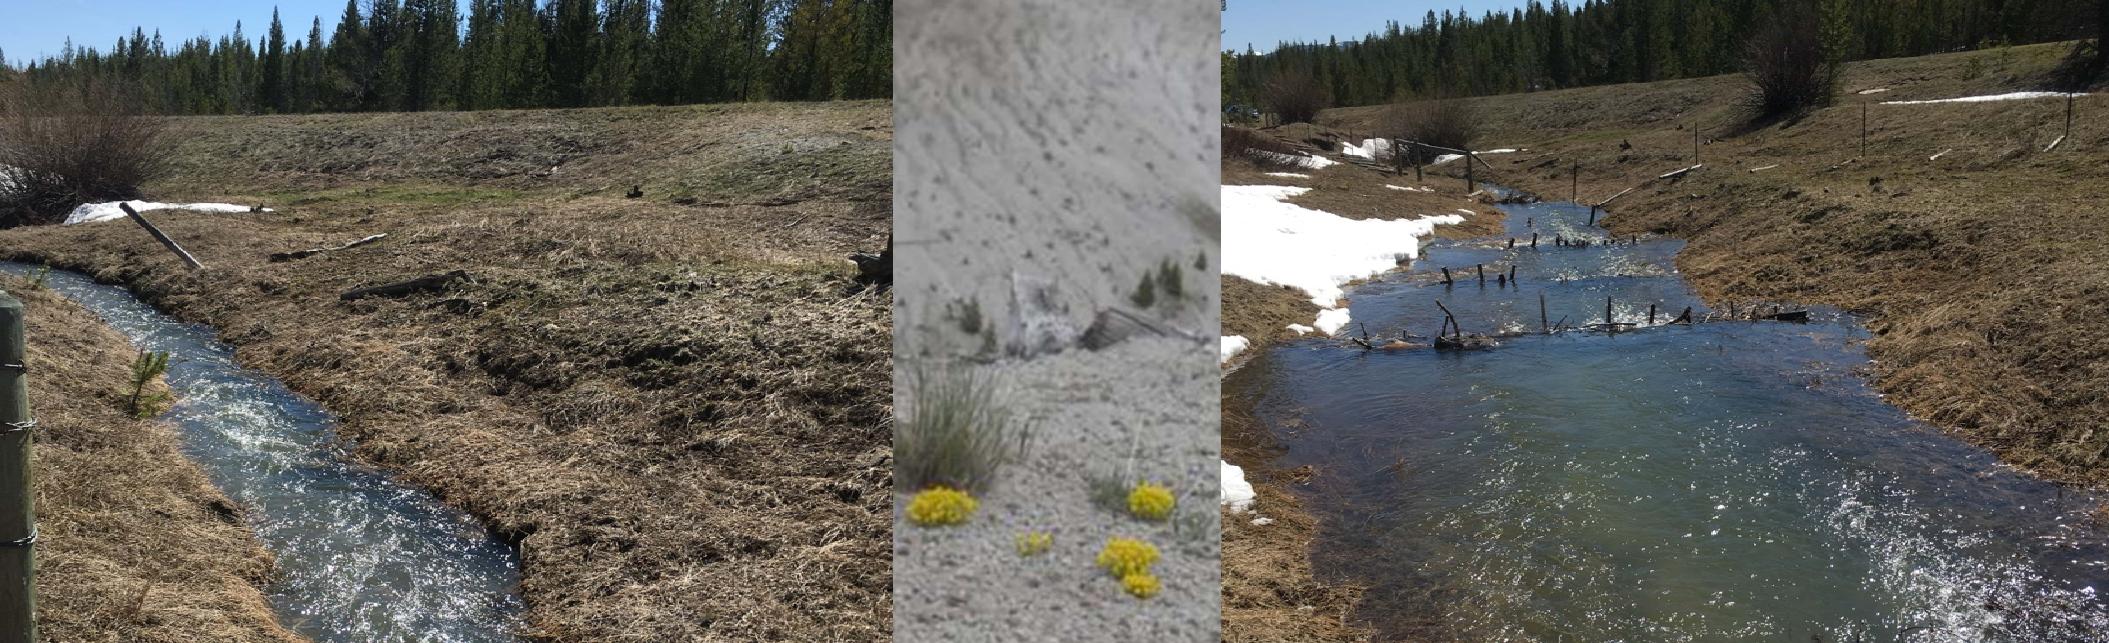
SSR 2-c: Beaver Mimicry

California Creek

- > 300 structures installed
- Avg. 0.2 T/ structure; 20.3 Tons sediment captured (oct. 2015)
- Restoring function for desired habitat

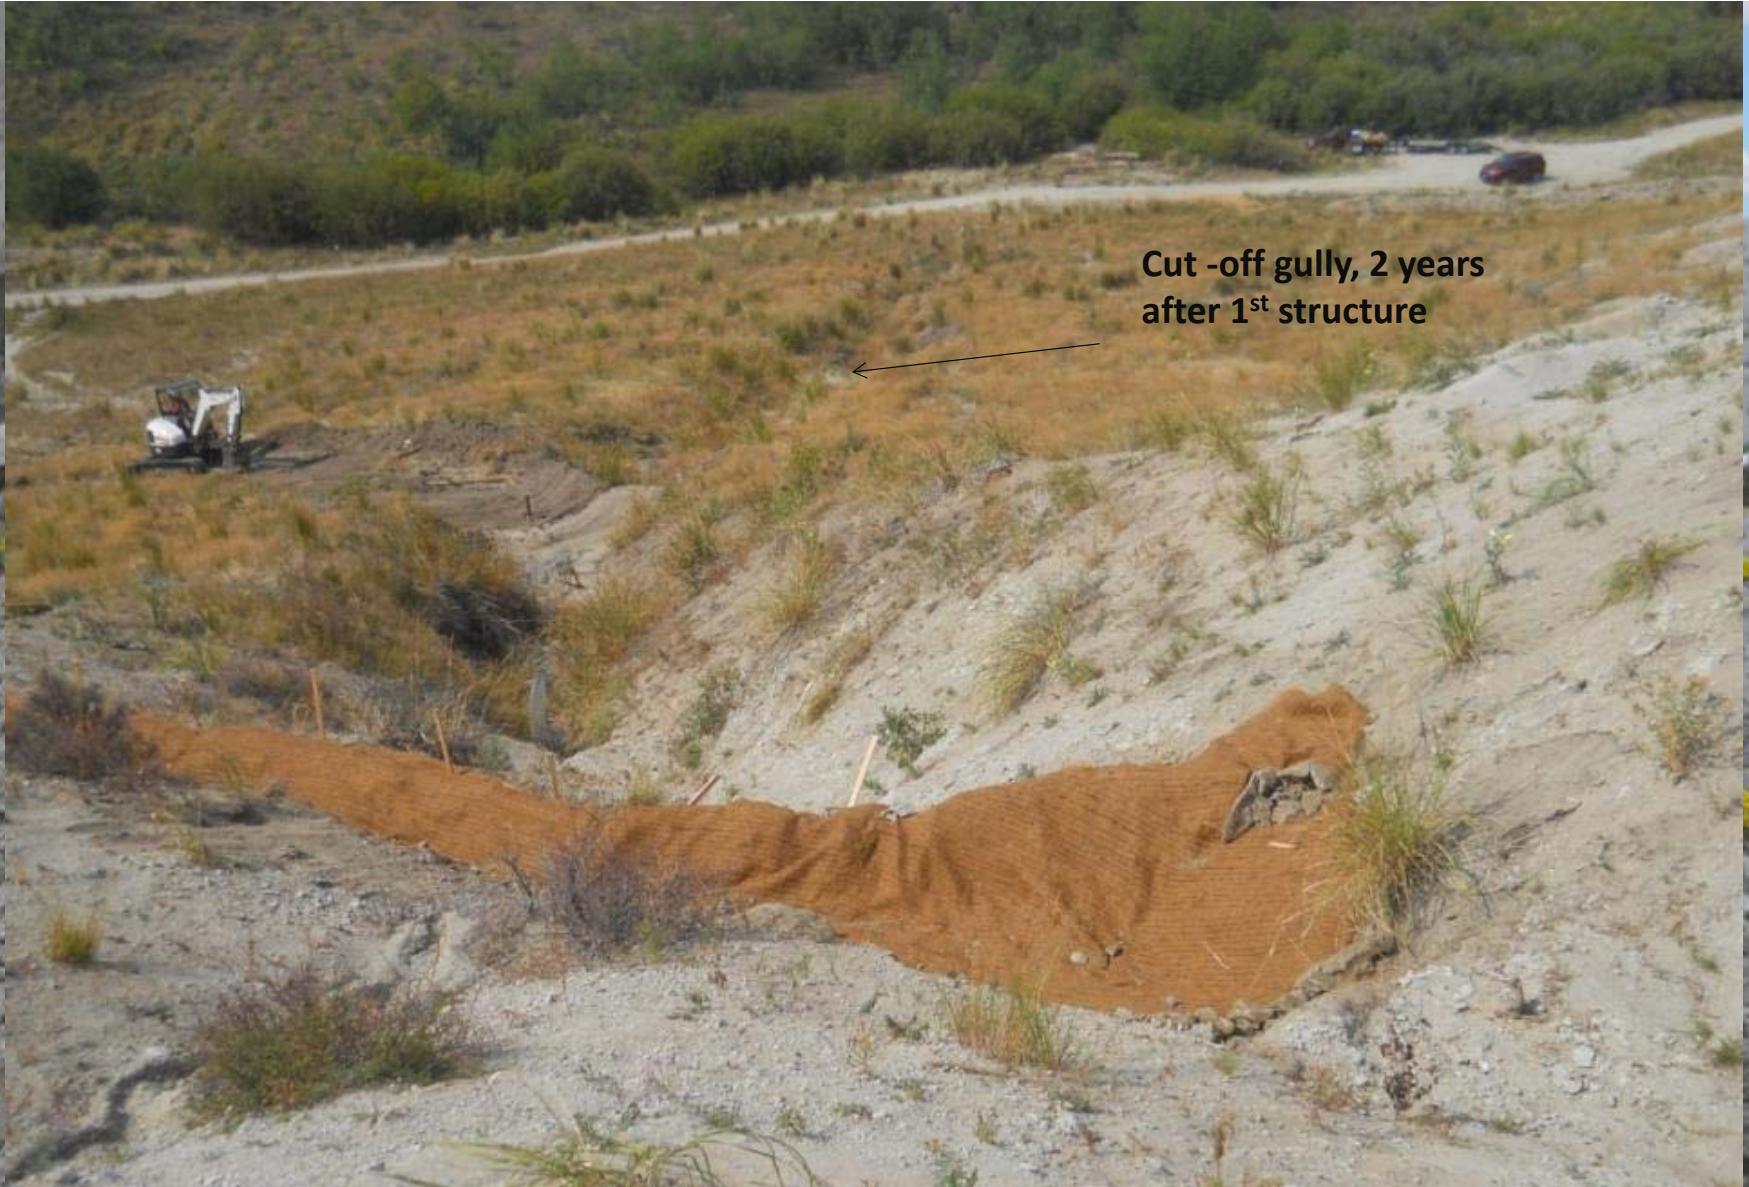
Cut -off gully, 2 years
after 1st structure
