UNDERGROUND MINE SURFACE SUBSIDENCE EVALUATION AND CLOSURE

Mine Design, Operations & Closure Conference 2013

**CDM
Smith**

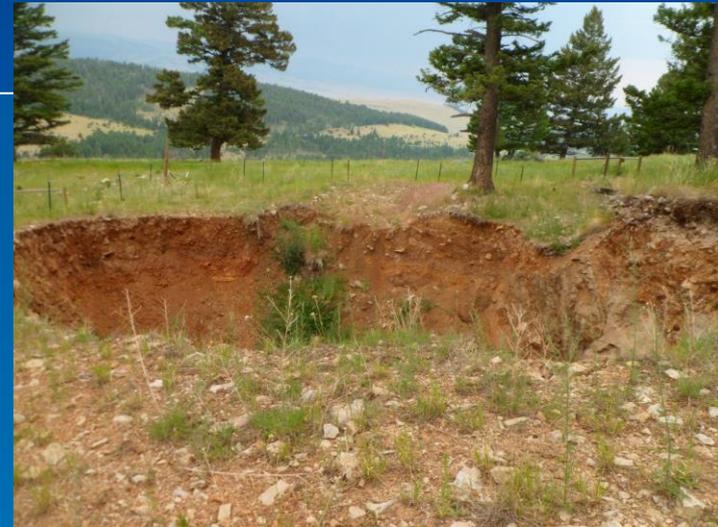
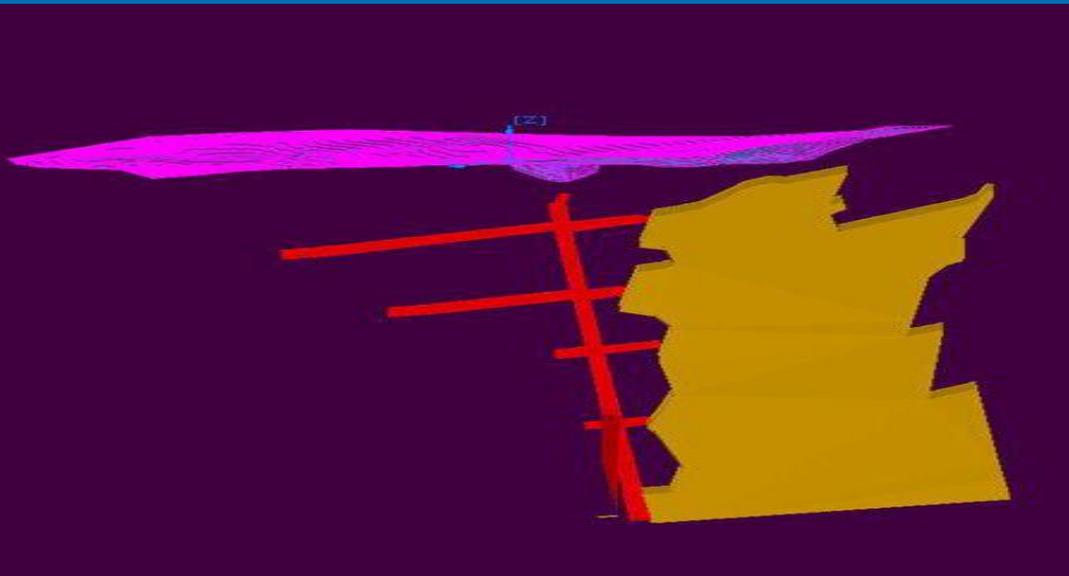
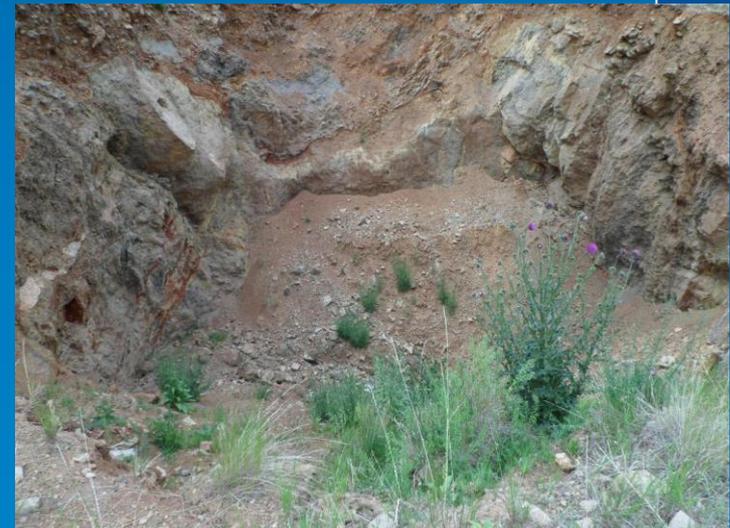
DC-24

- Subsidence found to be in the location of a vent raise shown on historic mine maps

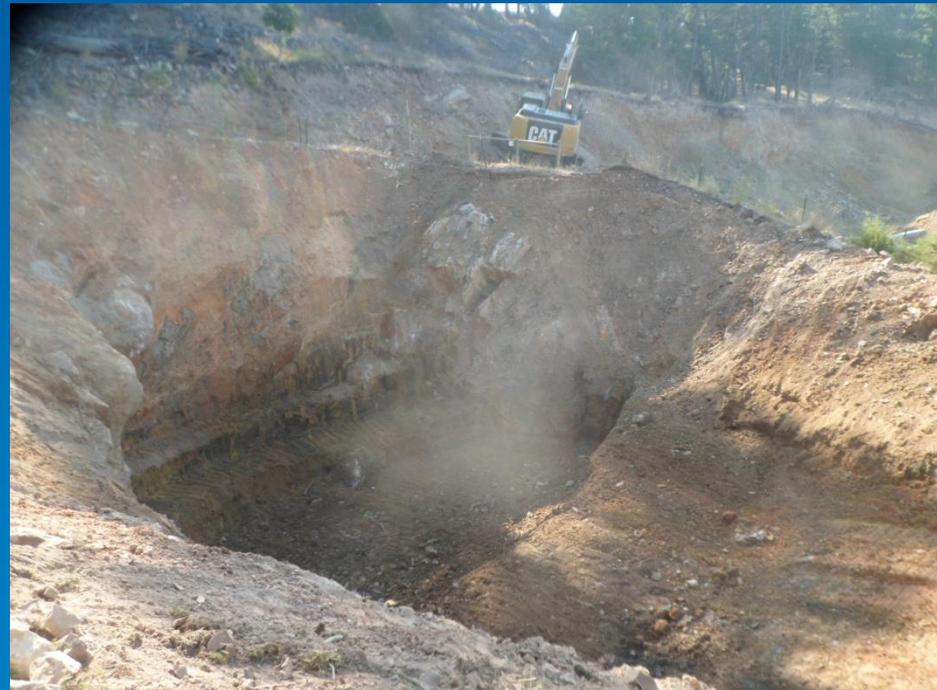
DC-24 Closure

- Remove loose materials –
 - Competent bedrock not found during excavation
 - Subsidence expanded during excavation
 - Plan modified to lengthen steel beams
 - Steel placed on undisturbed soil on footwall and hard clay layer on hanging wall

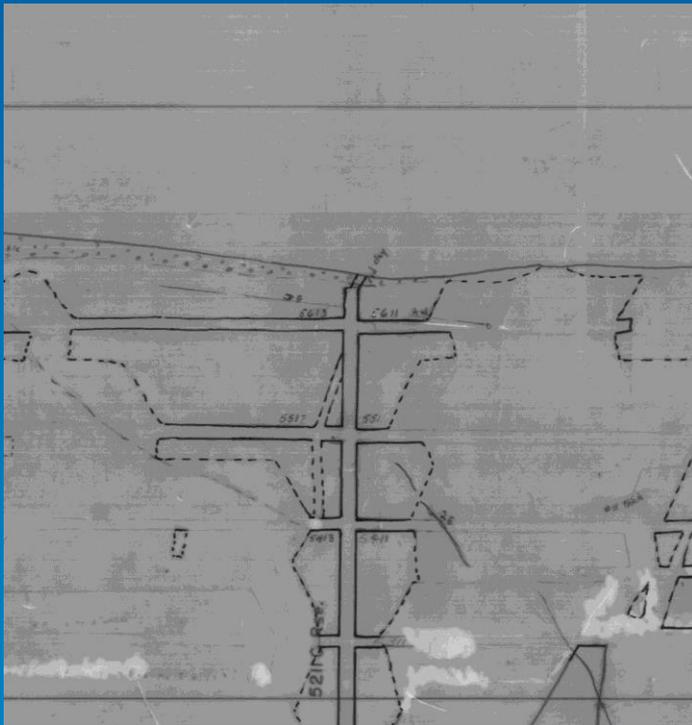
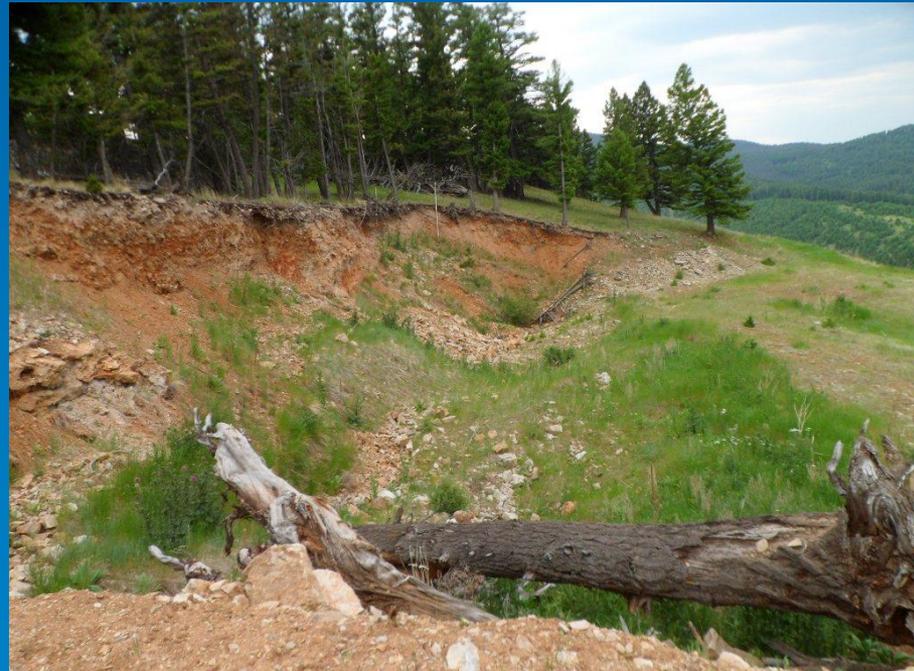
DC-25

- Thought to be caused by a previously collapsed stope that is continuing to subside

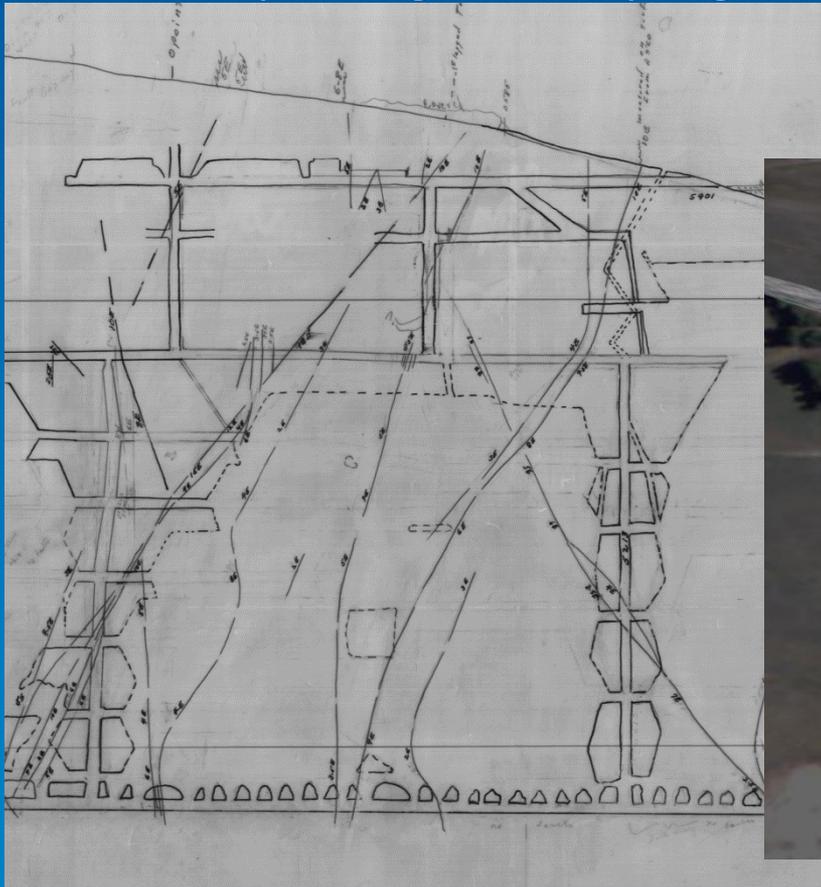
DC-16

- Small opening developing through entrance of closed portal

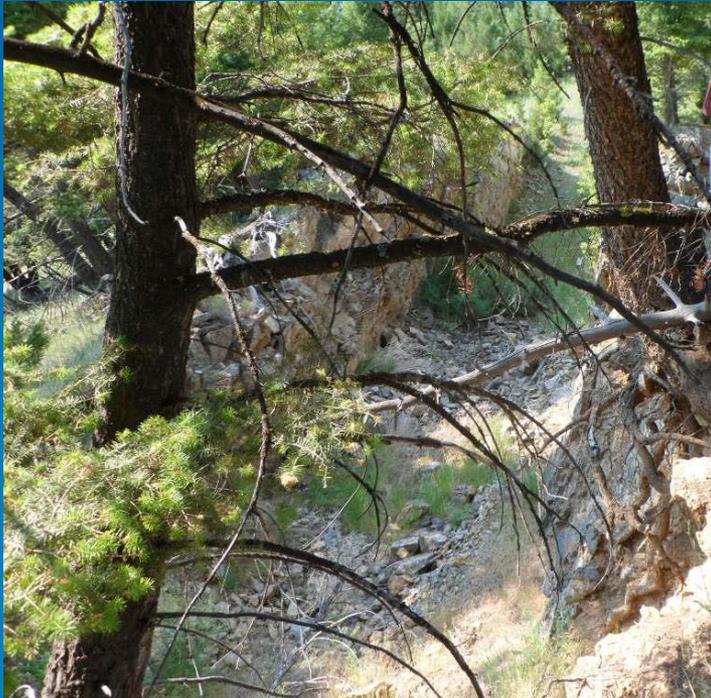
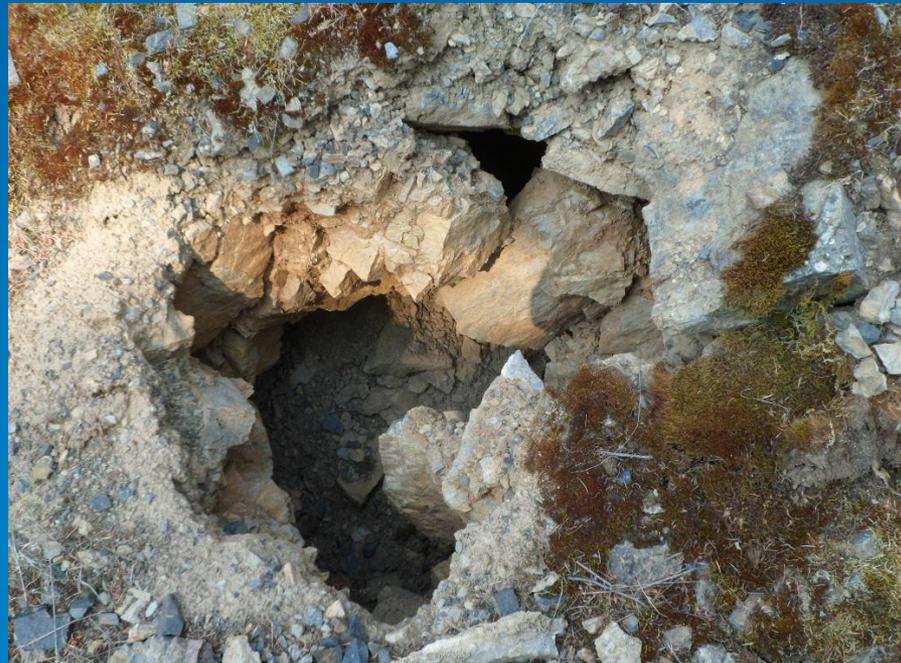
DC-16 Safety

- GPR survey indicated voids through closed portal entrance
- Competent ground identified to west of feature
- Work conducted from west side of feature

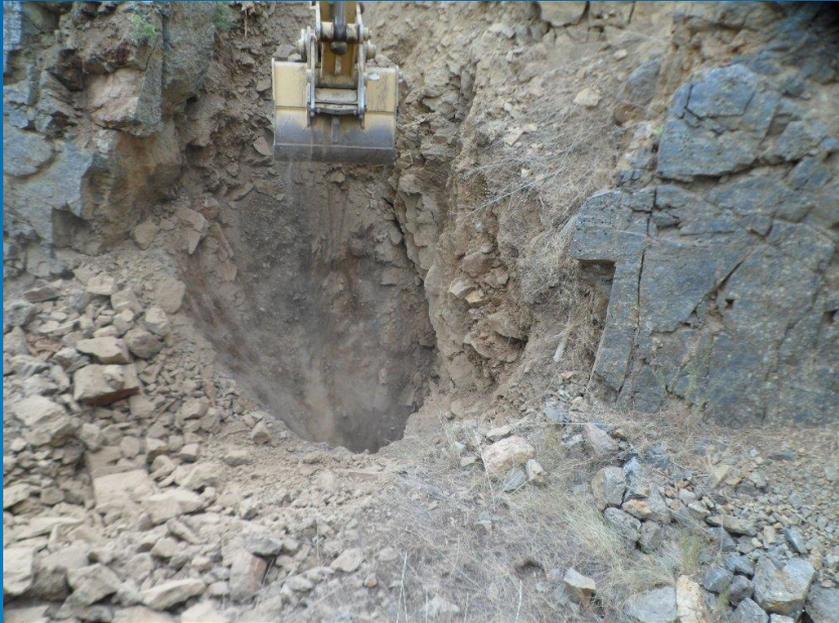
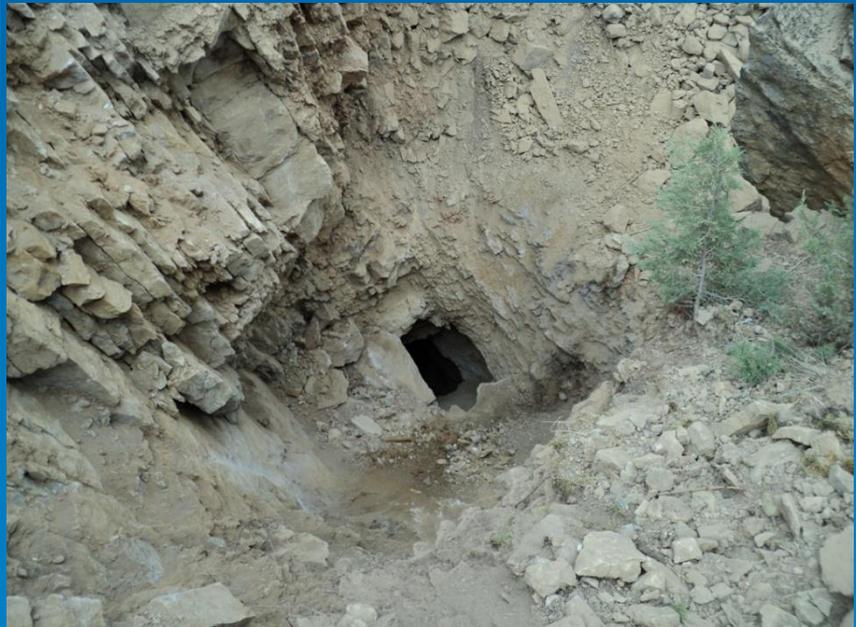
DC-16 Closure

- Removed unconsolidated material from feature
- Confirmed vertical vent raise going down to lower workings

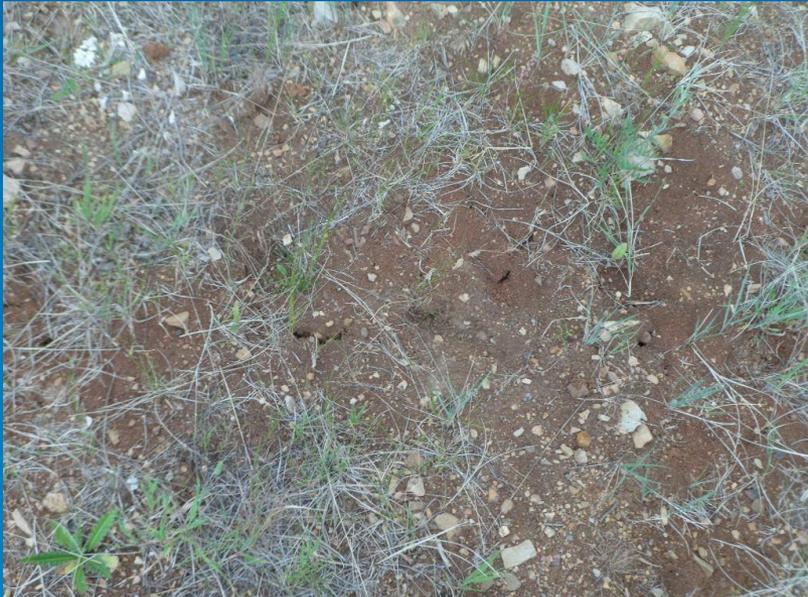
Ongoing Monitoring

- Set control points away from mine workings
- Set pins around subsidence area
- Yearly survey to monitor for signs of ground movement
- Visual inspections for indications of ground movement

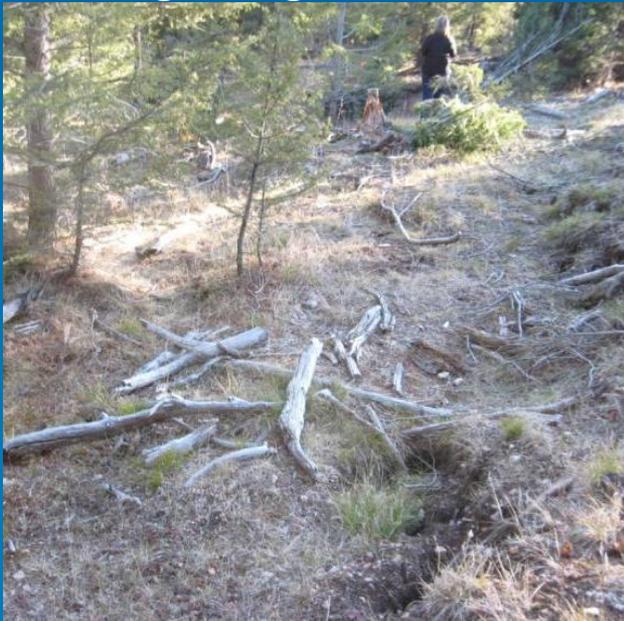
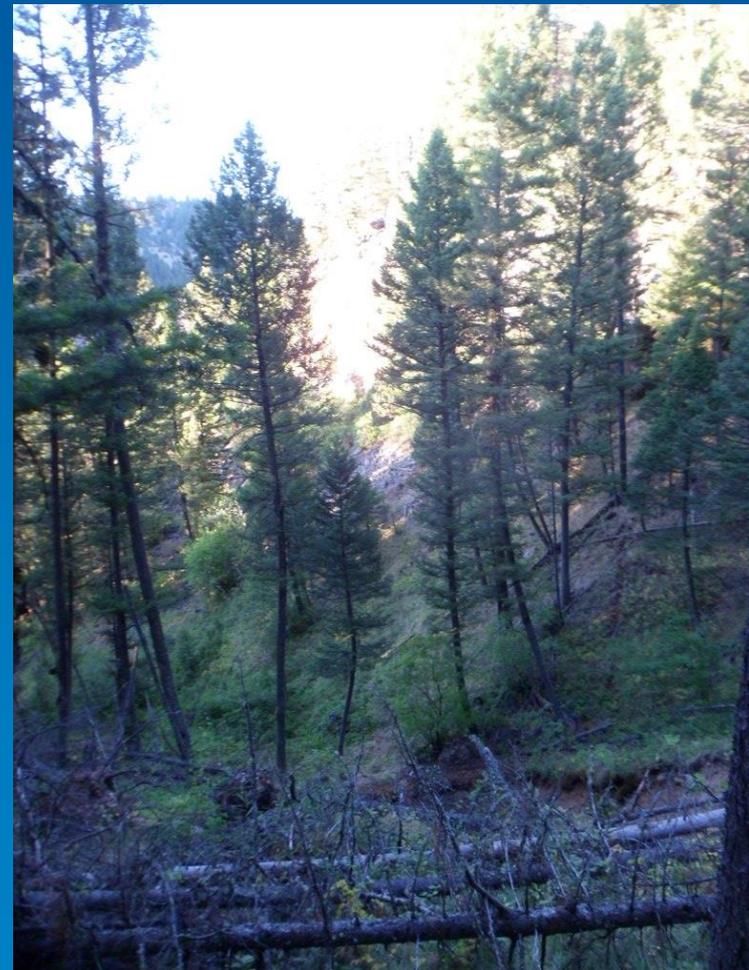
Predicting Subsidence

- Develop accurate 3-D model of mine workings
- Identify thin roof areas
- Identify areas where stormwater can flow into mine workings
- Visual signs of ground movement

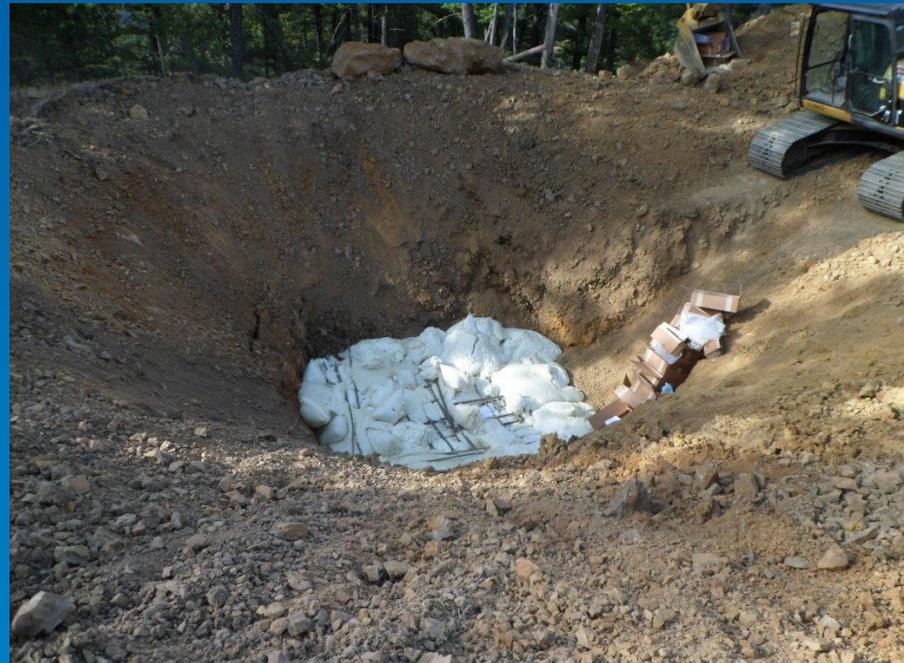
Developing Engineered Solutions

- Versatility is paramount (no one size fits all)
- Combination of various solutions may be necessary
- Solution must remain fluid through construction
- Design build approach is beneficial
- In cases with narrow vents, deep shafts, or areas where access is difficult, PUF is often an appropriate solution

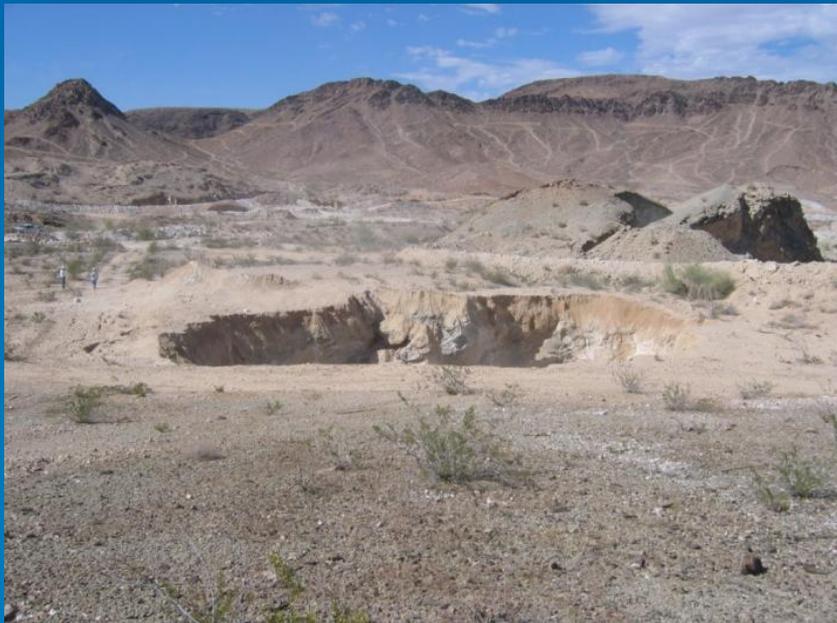
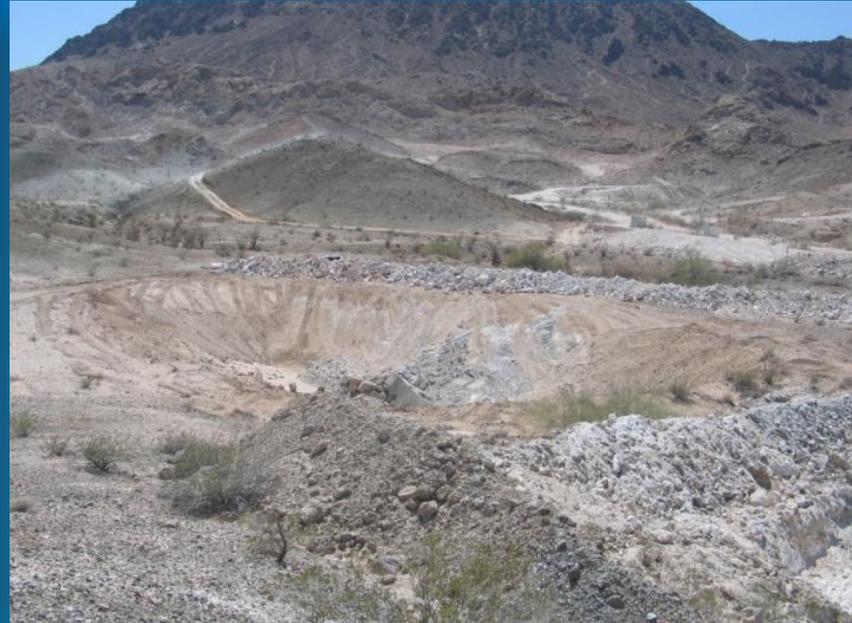
Developing Engineered Solutions

- Blasting can be an effective solution if workings can be understood and work can be completed safely
- Can cause additional issues

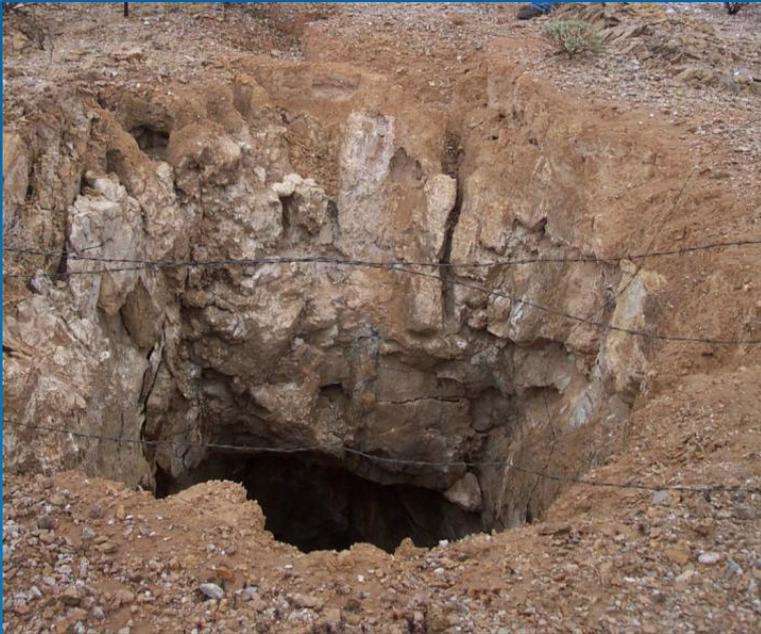
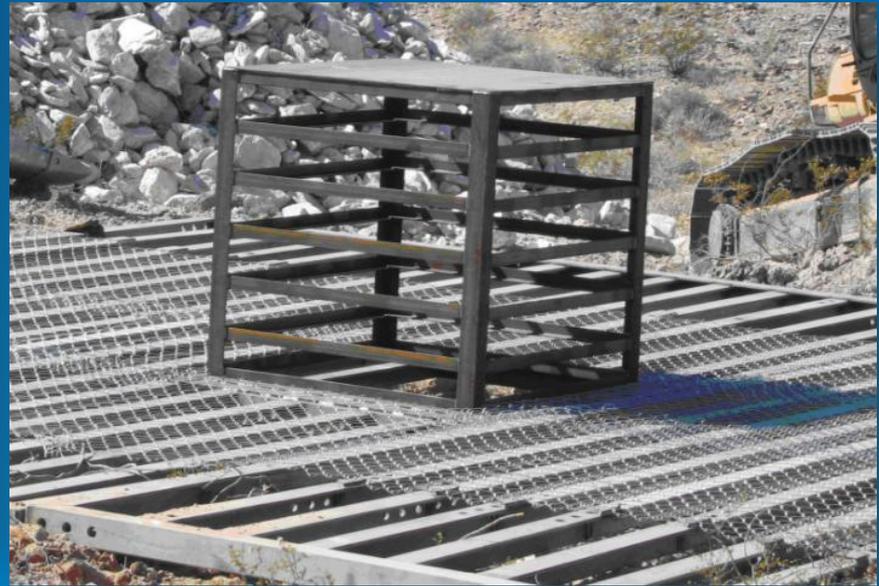
Developing Engineer Solutions

- Bat Gates, Fencing and Monolithic Concrete Slabs can be effective

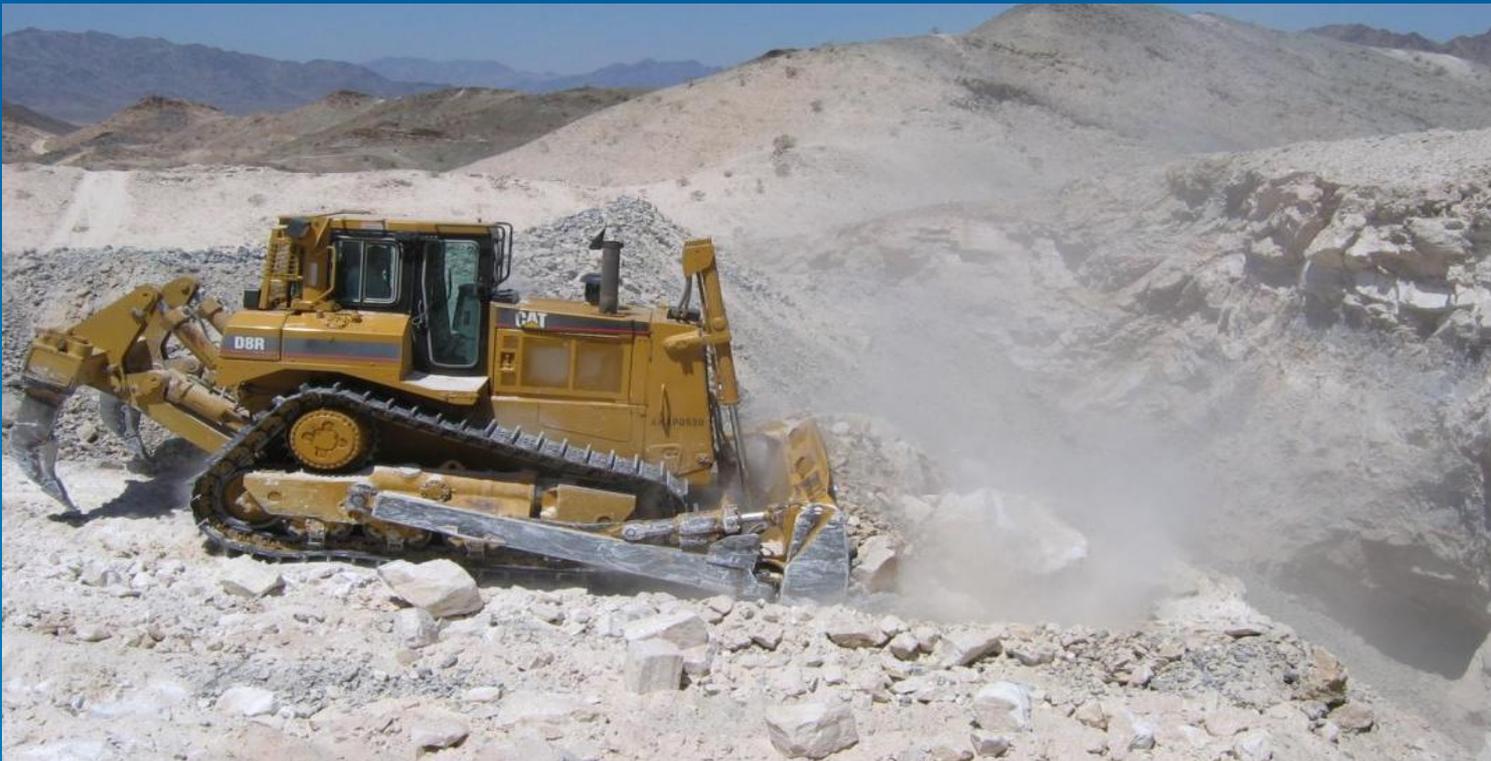
Developing Engineer Solutions

- Earthen backfill can be effective if subsurface volumes are understood and can be managed.
