Champion Mine CERCLA Removal Action

Dustin G. Wasley, PE, Principal
Cascade Earth Sciences – Spokane

Champion Mine Removal Action
May 5, 2010

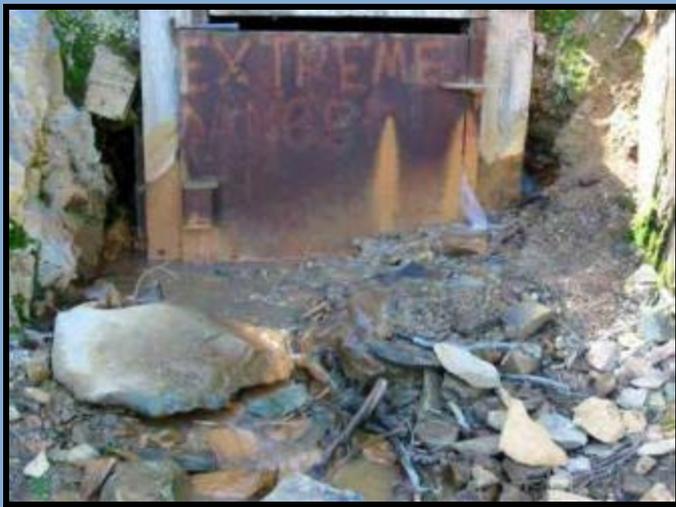
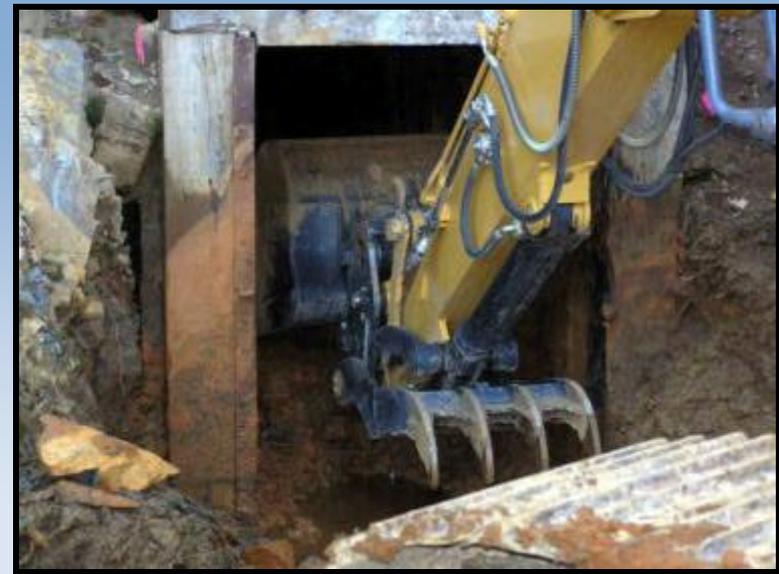
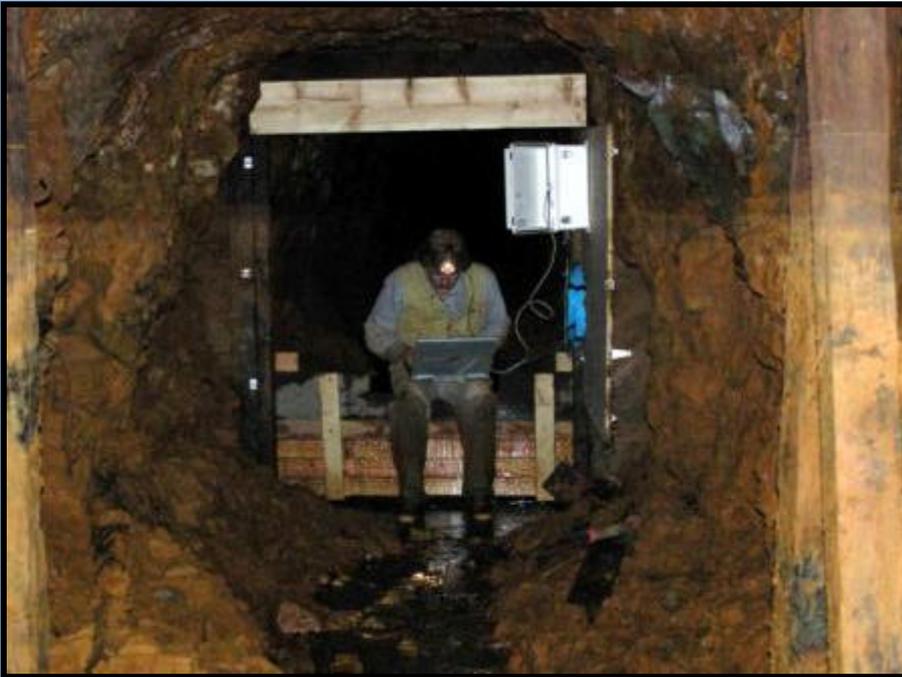
- Original Adit Door
- Opening & Draining
- Build A Dam
- Install DataLogger
- Monitor Q&Q

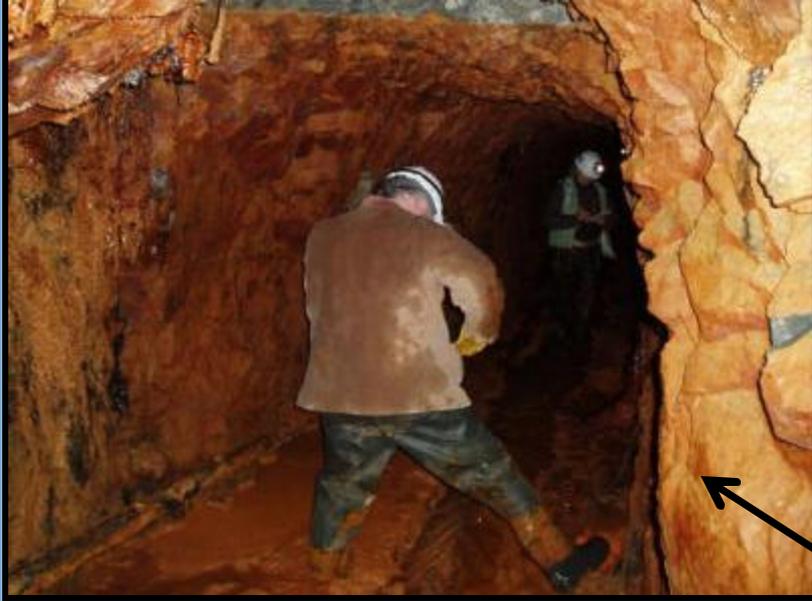
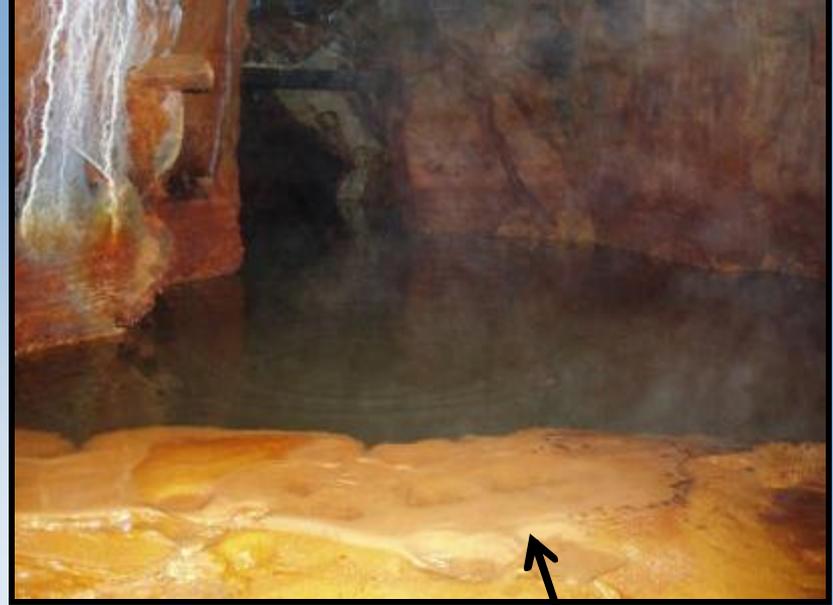
1,200 Level
Reservoir

Mapping

- Conclusions
 - The Majority of Flow from the Main Fault/Vein Near Faces
 - Acid (pH = 2.8-3.8 su) Discharging from Several Small Stopes at the Midpoint
 - Alkaline Seeps Neutralize Flow Before the Portal
- **Bottom Line - Segregation Not Worth Cost & Maintenance!**

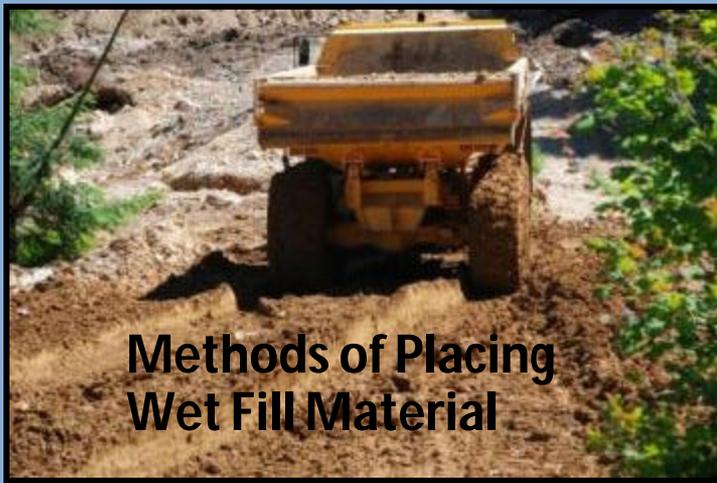
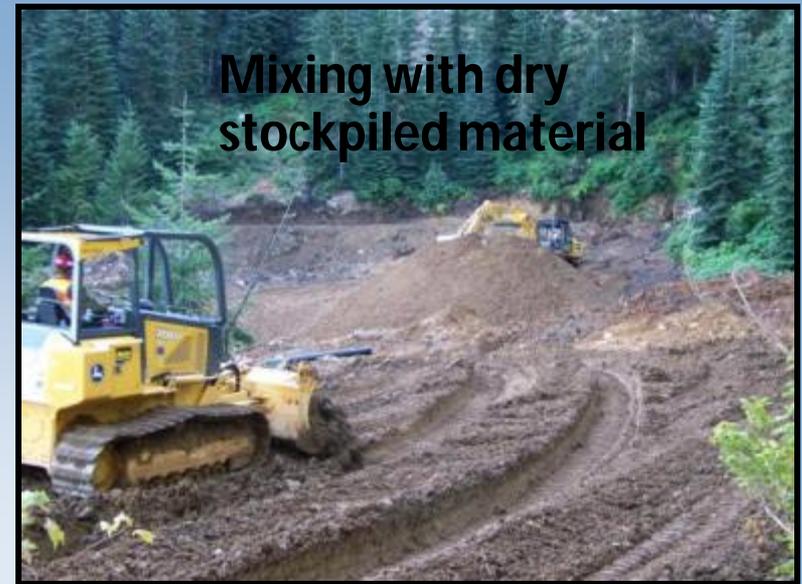
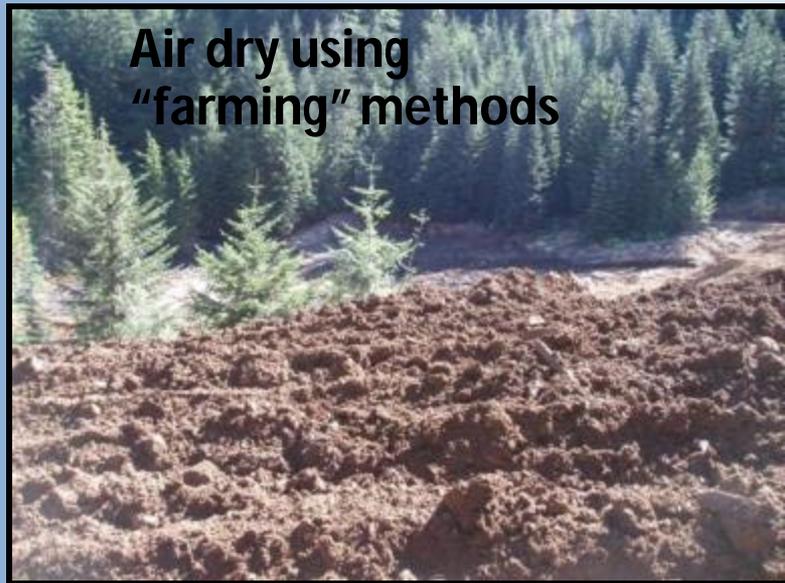
Dealing with the Wet Material

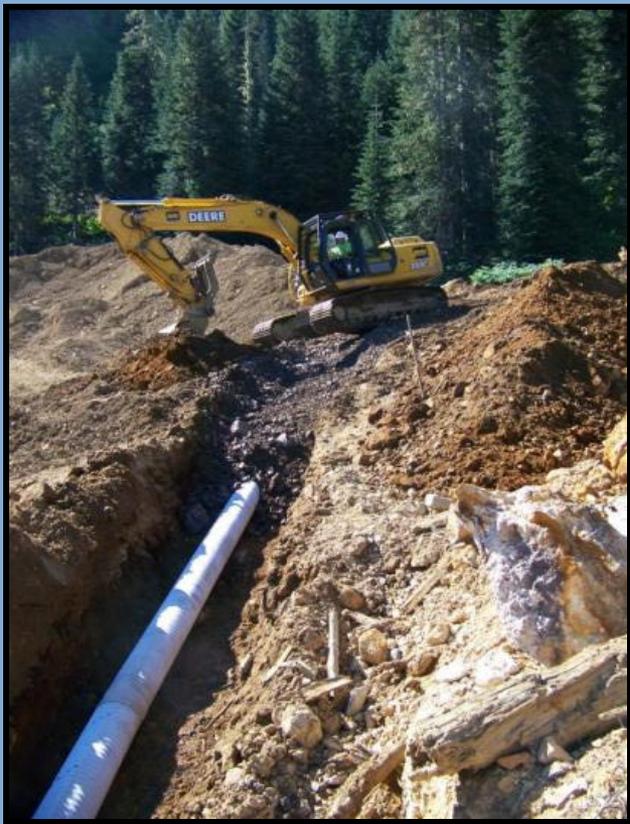
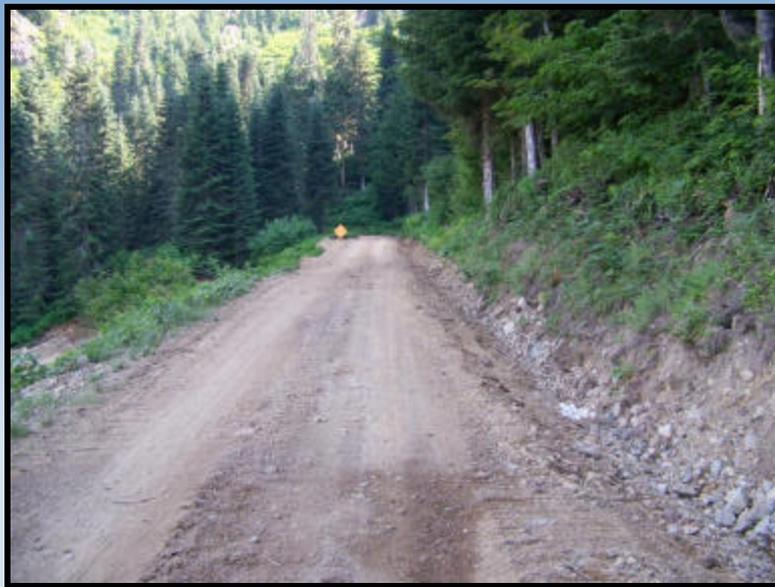
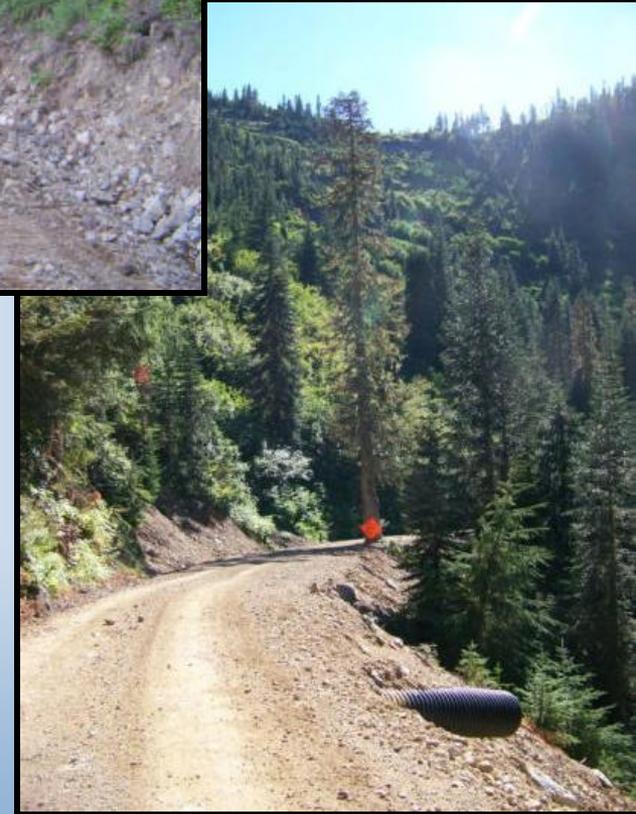
Repository 2 – Keeping It Dry

1. Repository Underdrain to Wetland
2. Regrade Road above Repository
3. Remove/Redirect Ditch Relief Culverts
