# Silver Bow Creek – Balancing Competing Priorities and Lessons Learned

2013 Mine Design, Operations and Closure  
Conference

# SA4 PROJECT OVERVIEW

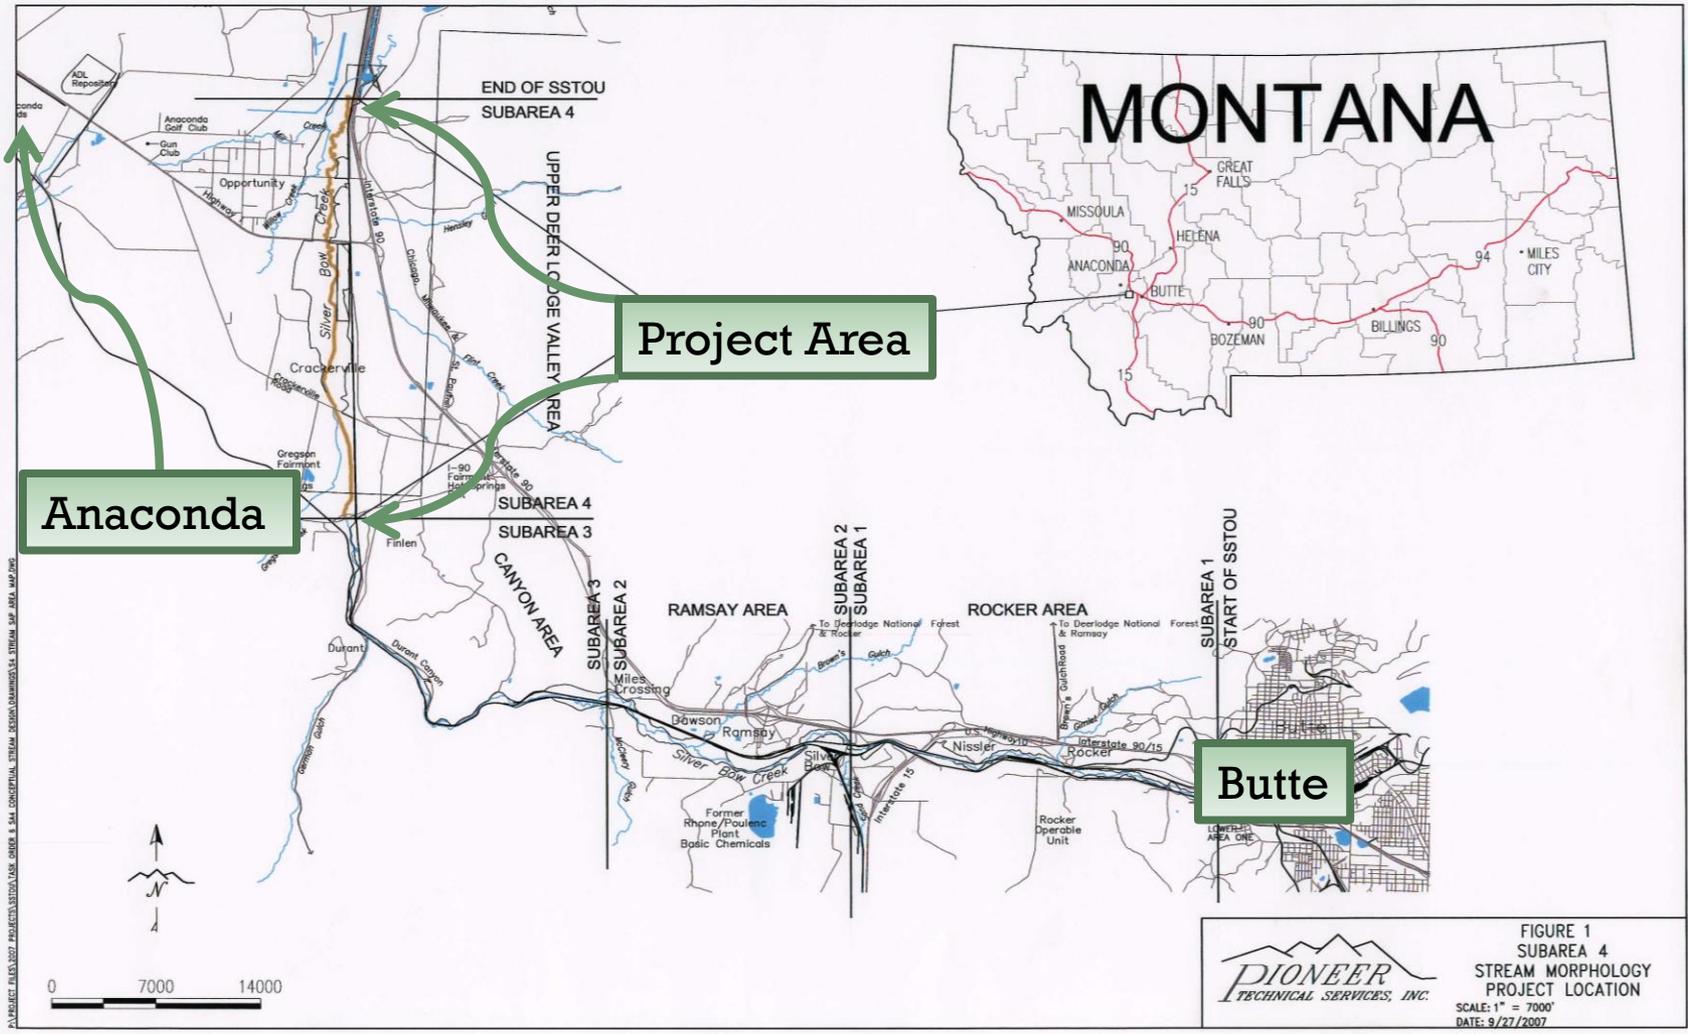
# PROJECT OVERVIEW MAP

**FIGURE 1**  
**SUBAREA 4**  
**STREAM MORPHOLOGY**  
**PROJECT LOCATION**  
 SCALE: 1" = 7000'  
 DATE: 9/27/2007

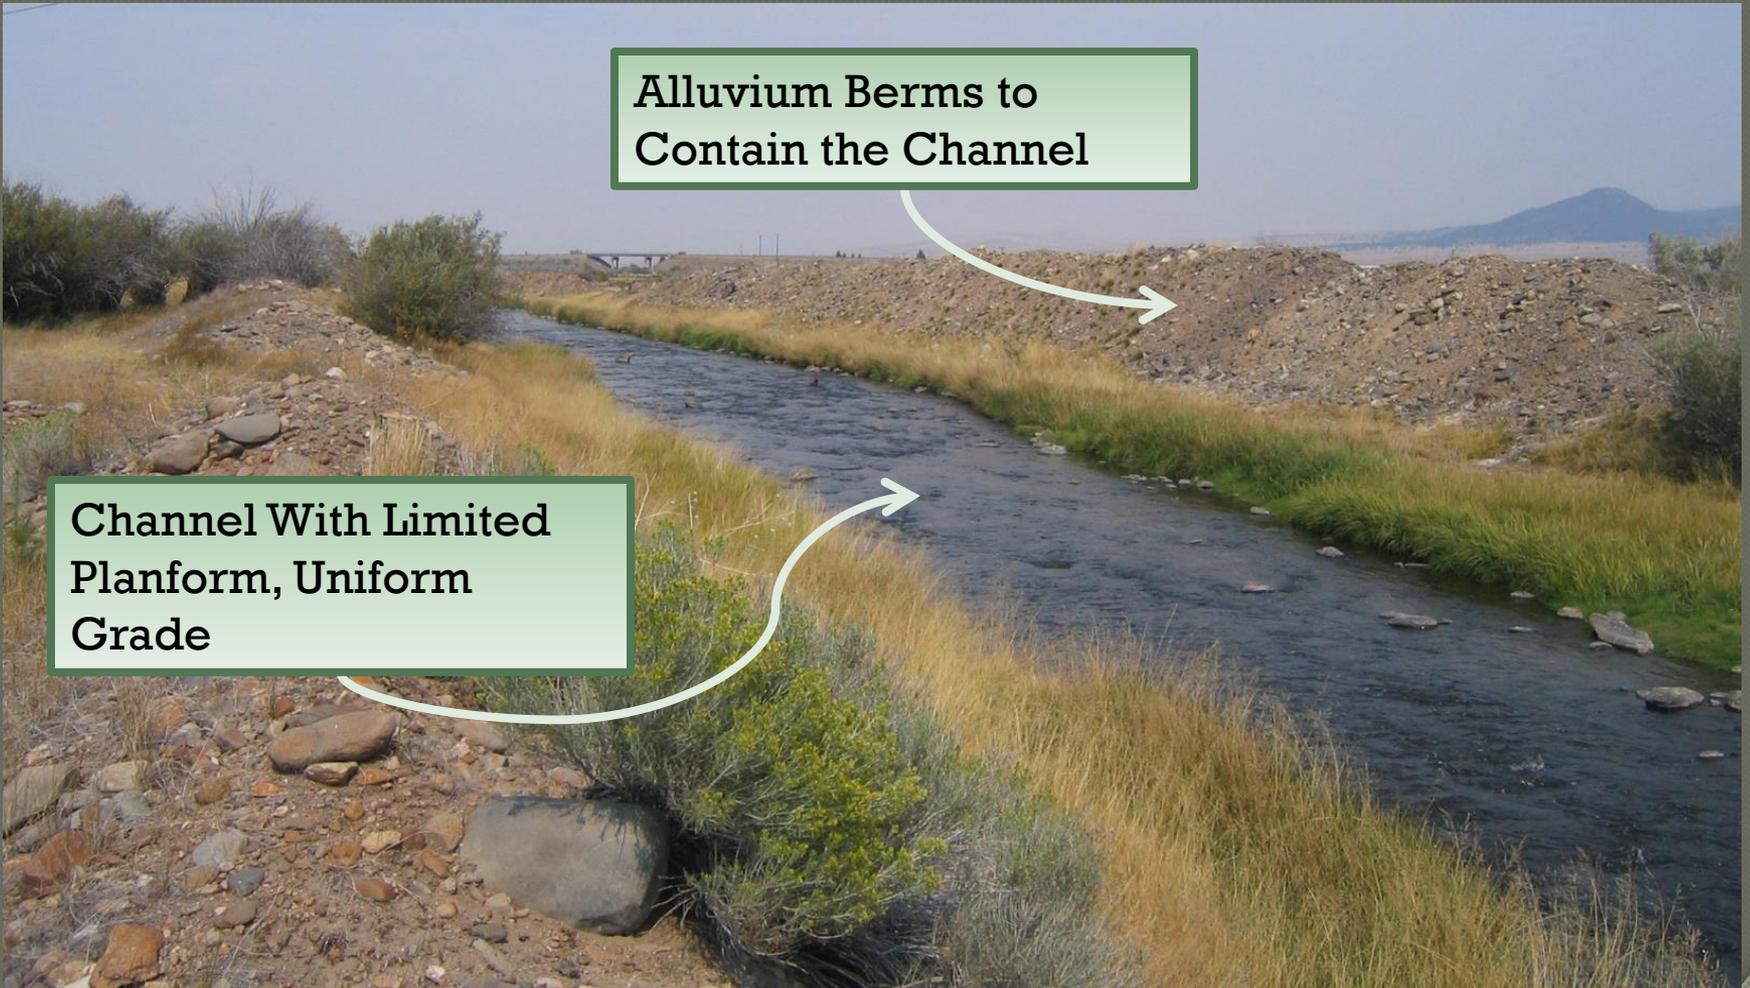
# CHANNELIZED REACH

Alluvium Berms to  
Contain the Channel

Channel With Limited  
Planform, Uniform  
Grade

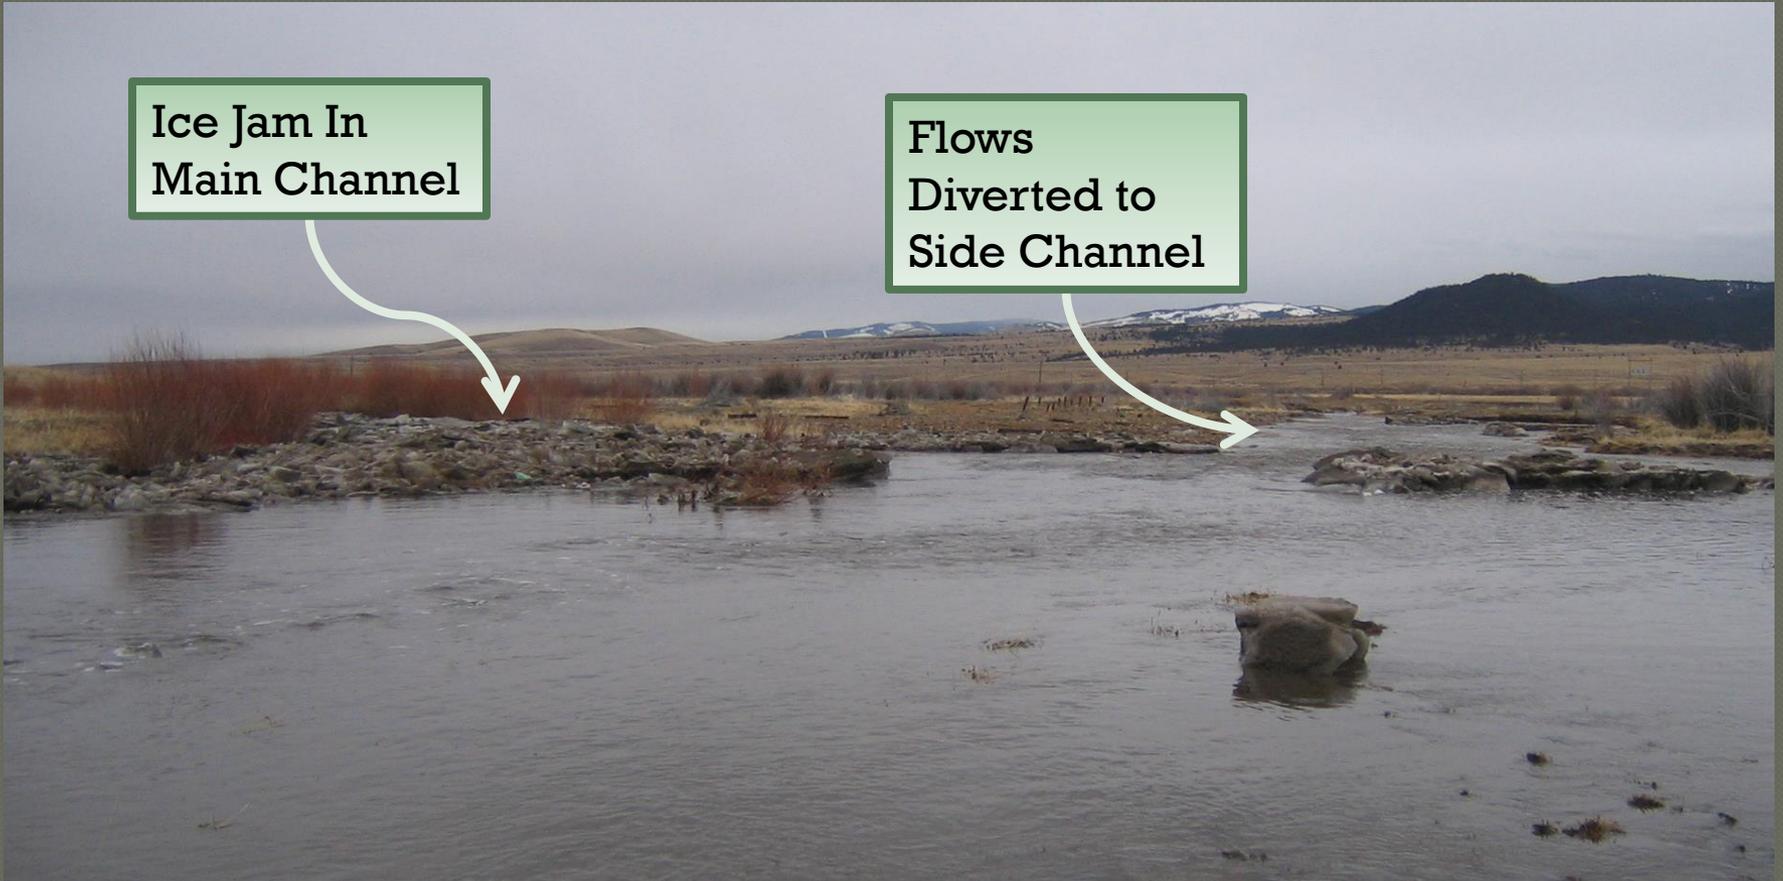
# ICE JAMS

Ice Jam In  
Main Channel

Flows  
Diverted to  
Side Channel

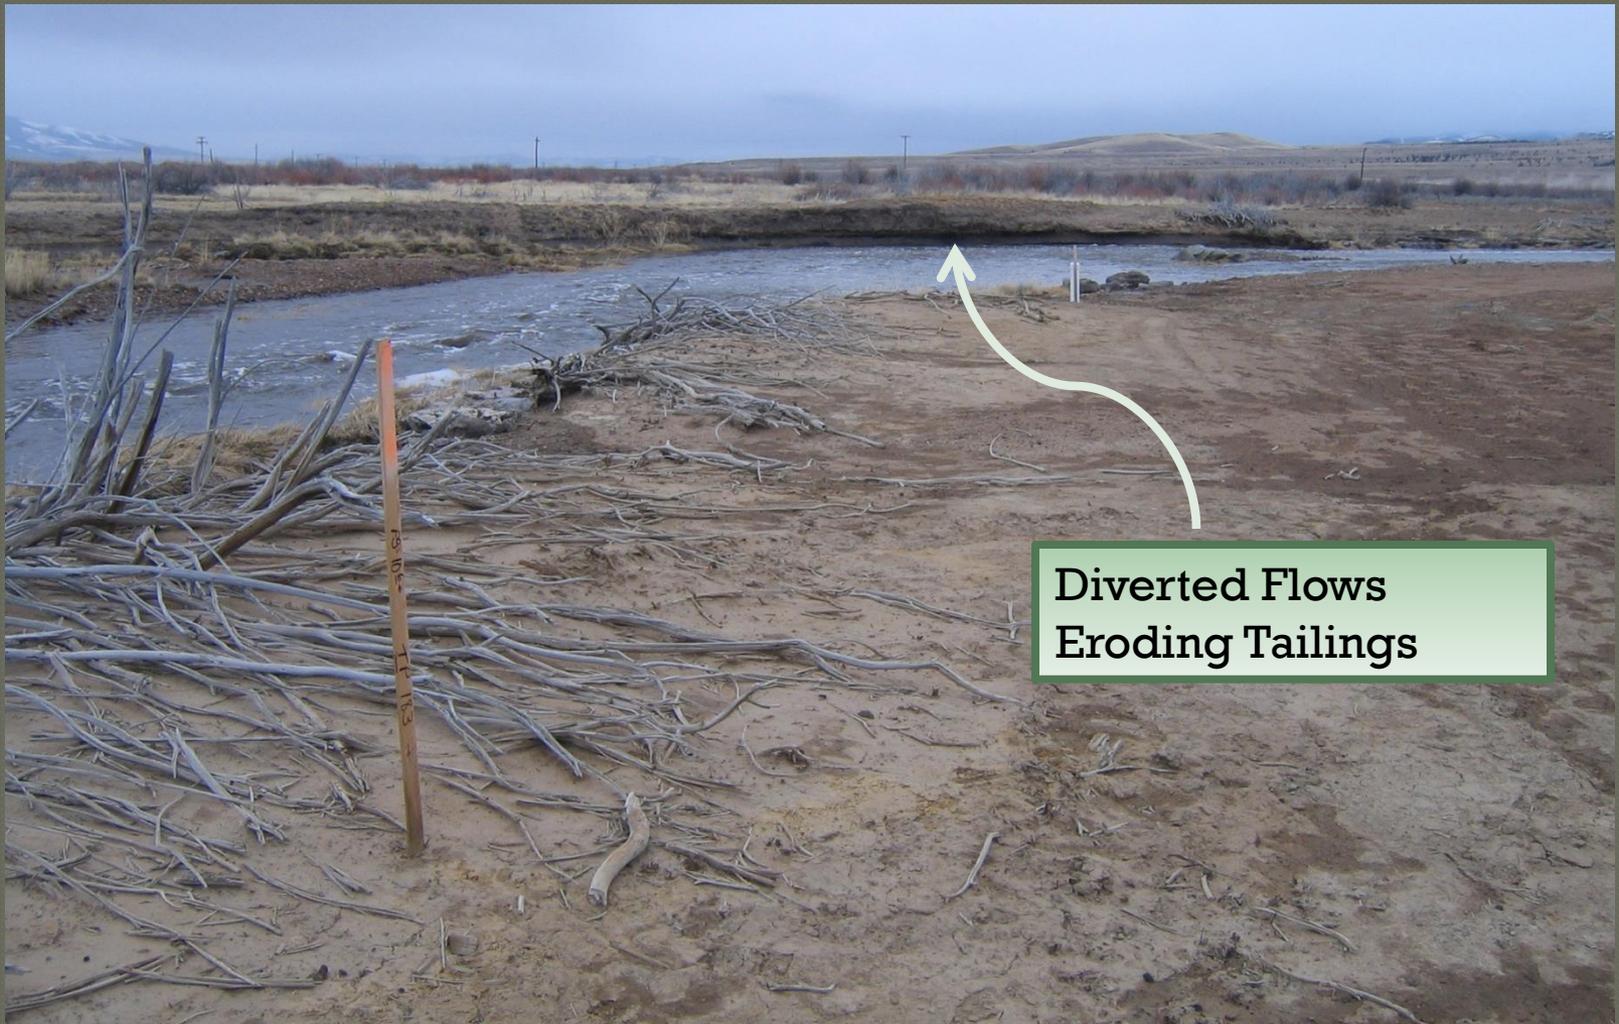
# SIDE CHANNEL EROSION

Diverted Flows  
Eroding Tailings

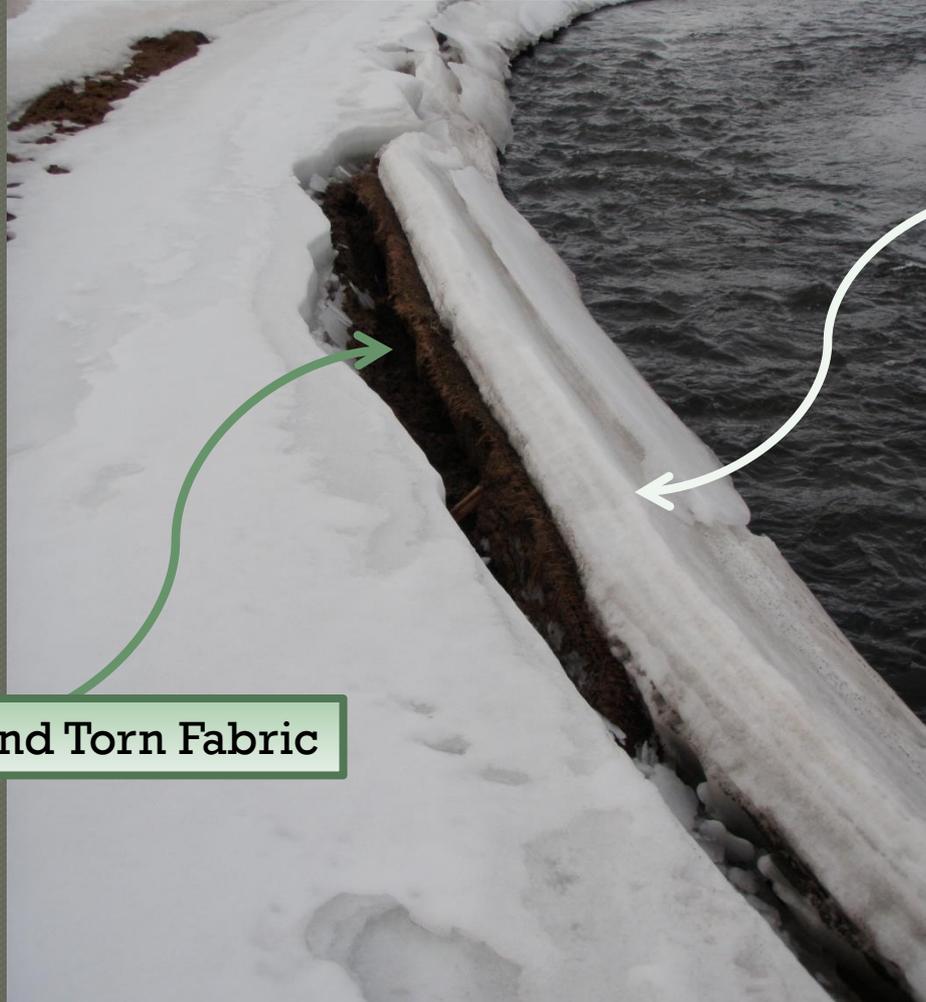
# ICE DAMAGE

Ice Shelf

Cracking and Torn Fabric

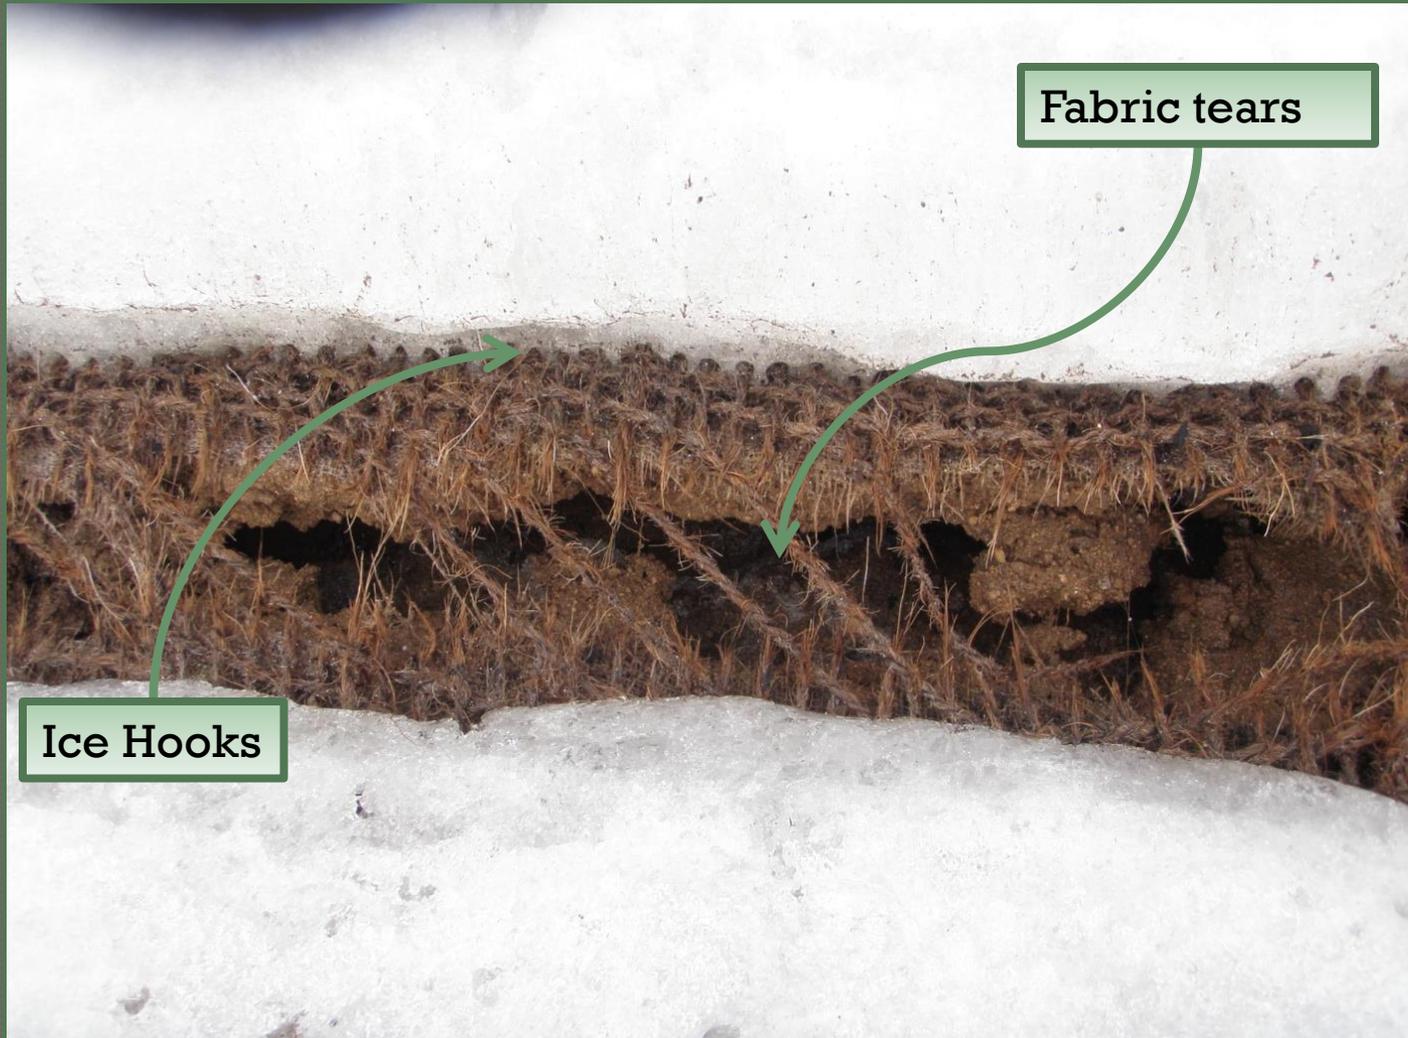
# ICE DAMAGE

Fabric tears

Ice Hooks

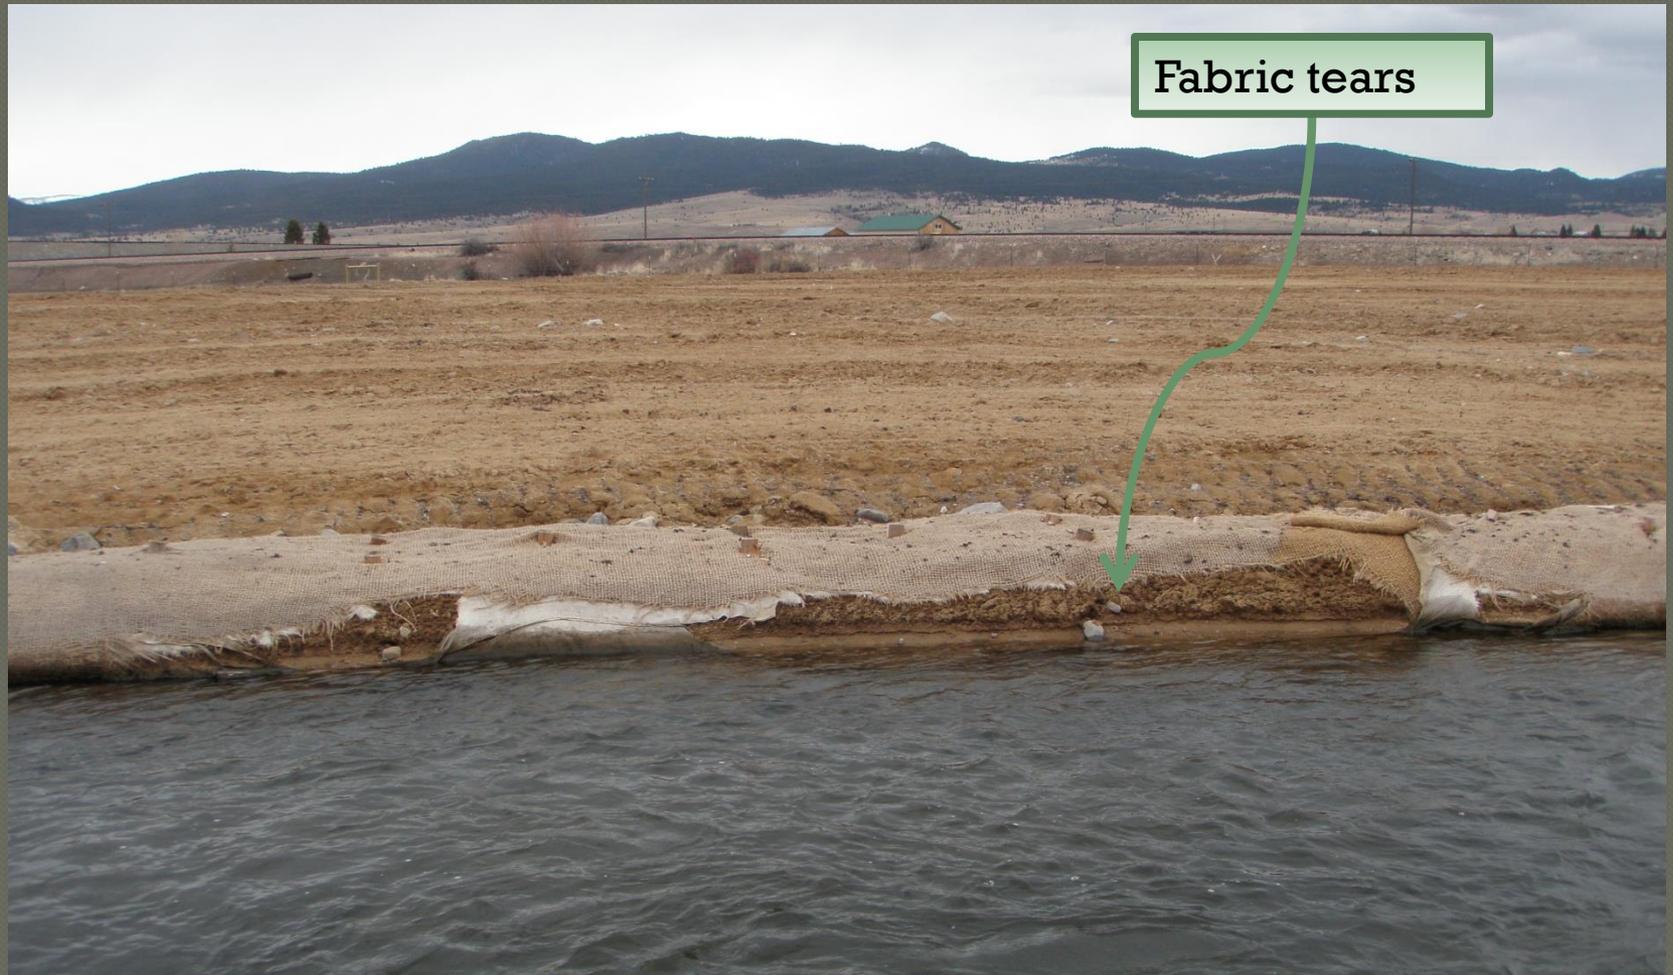
# ICE DAMAGE

Fabric tears

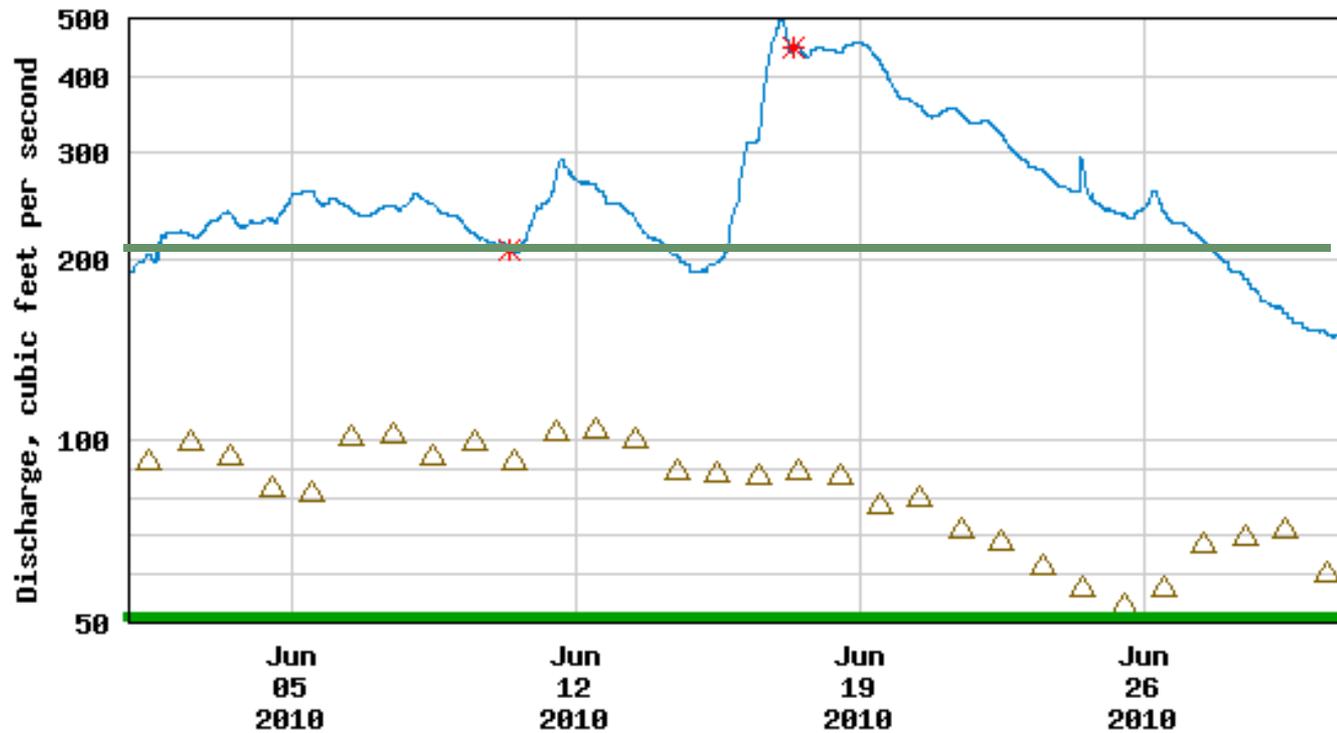
# 2010 FLOOD FLOWS

USGS 12323600 Silver Bow Creek at Opportunity MT

- △ Median daily statistic (23 years)
- \* Measured discharge
- Discharge
- █ Period of approved data

<b>Years of Record</b>	<b>23</b>
Normal Range of Bankfull Days/Year	7-14
Bankfull Days Before 2010	115
Bankfull Days/Year Before 2010	5.5
Bankfull Days in 2010	24
Bankfull Days in 2011	47
Bankfull Days After 2011	186
Bankfull Days/Year After 2010	6.3
Bankfull Days/Year After 2011	8.1

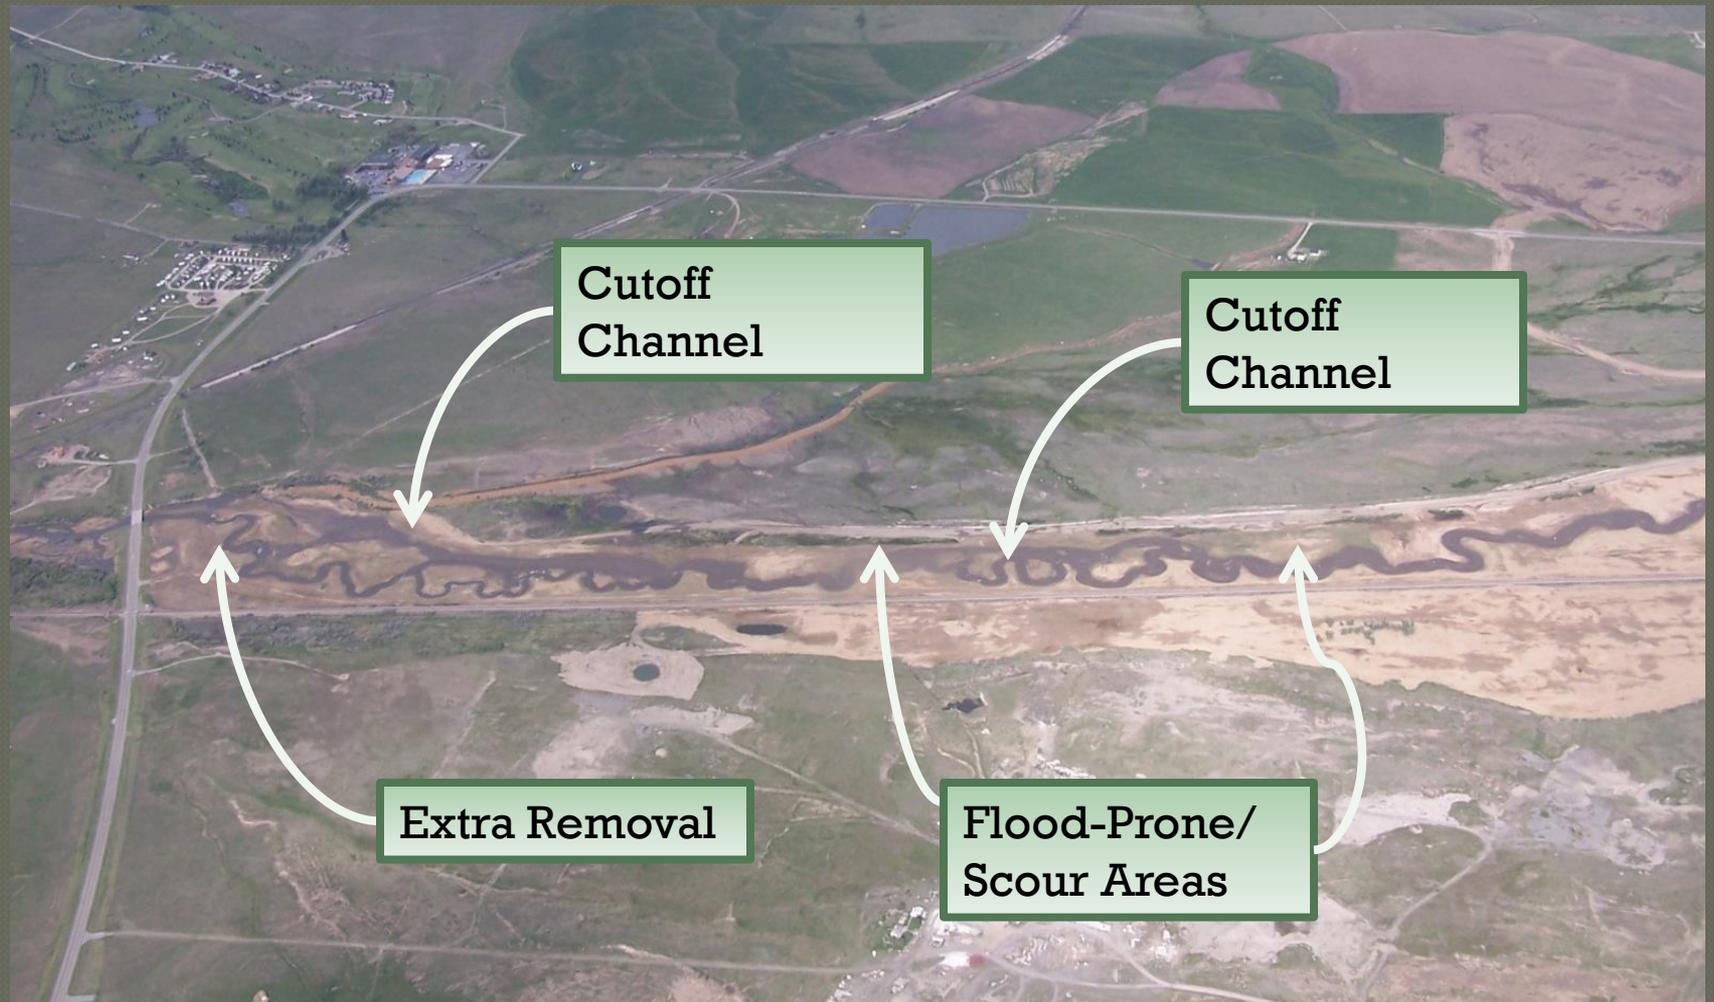
# AERIAL FLOOD PHOTO

Cutoff  
Channel

Extra Removal

Flood-Prone/  
Scour Areas

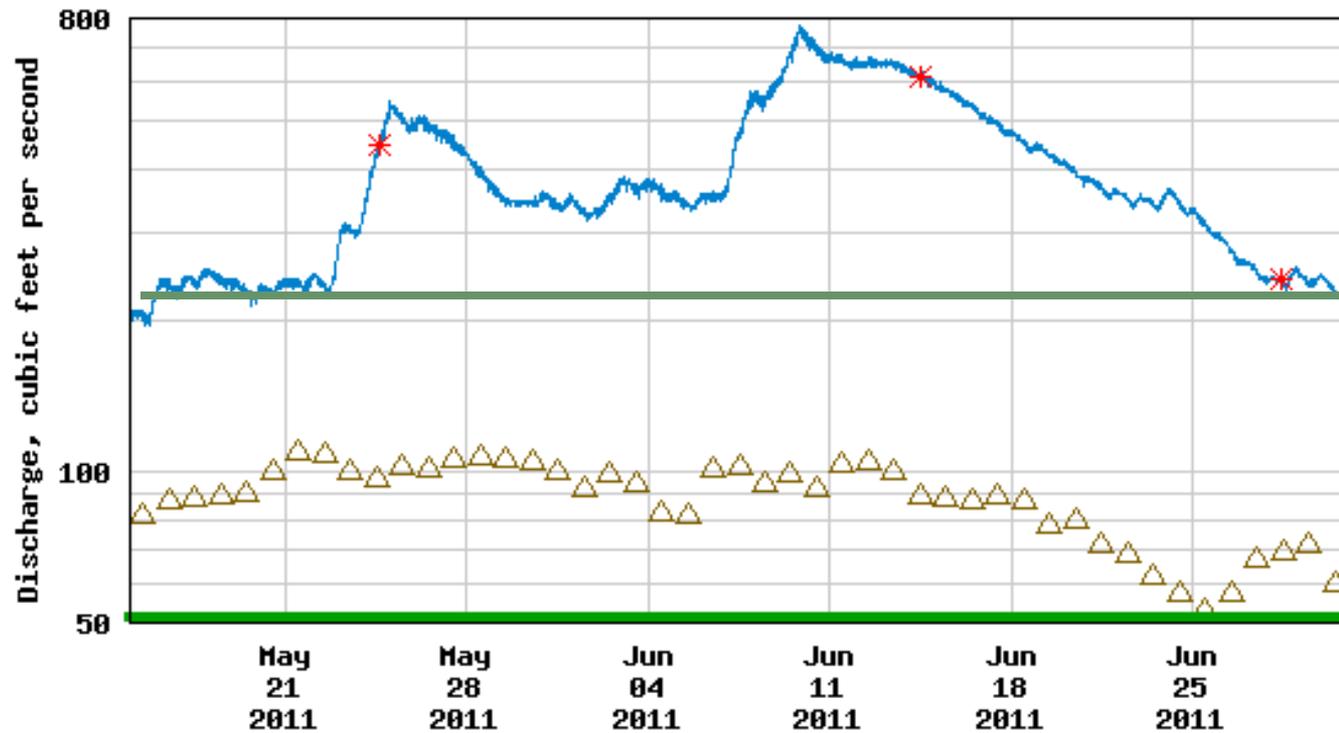
# 2011 FLOOD FLOWS

USGS 12323600 Silver Bow Creek at Opportunity MT

△ Median daily statistic (23 years) \* Measured discharge  
— Discharge — Period of approved data

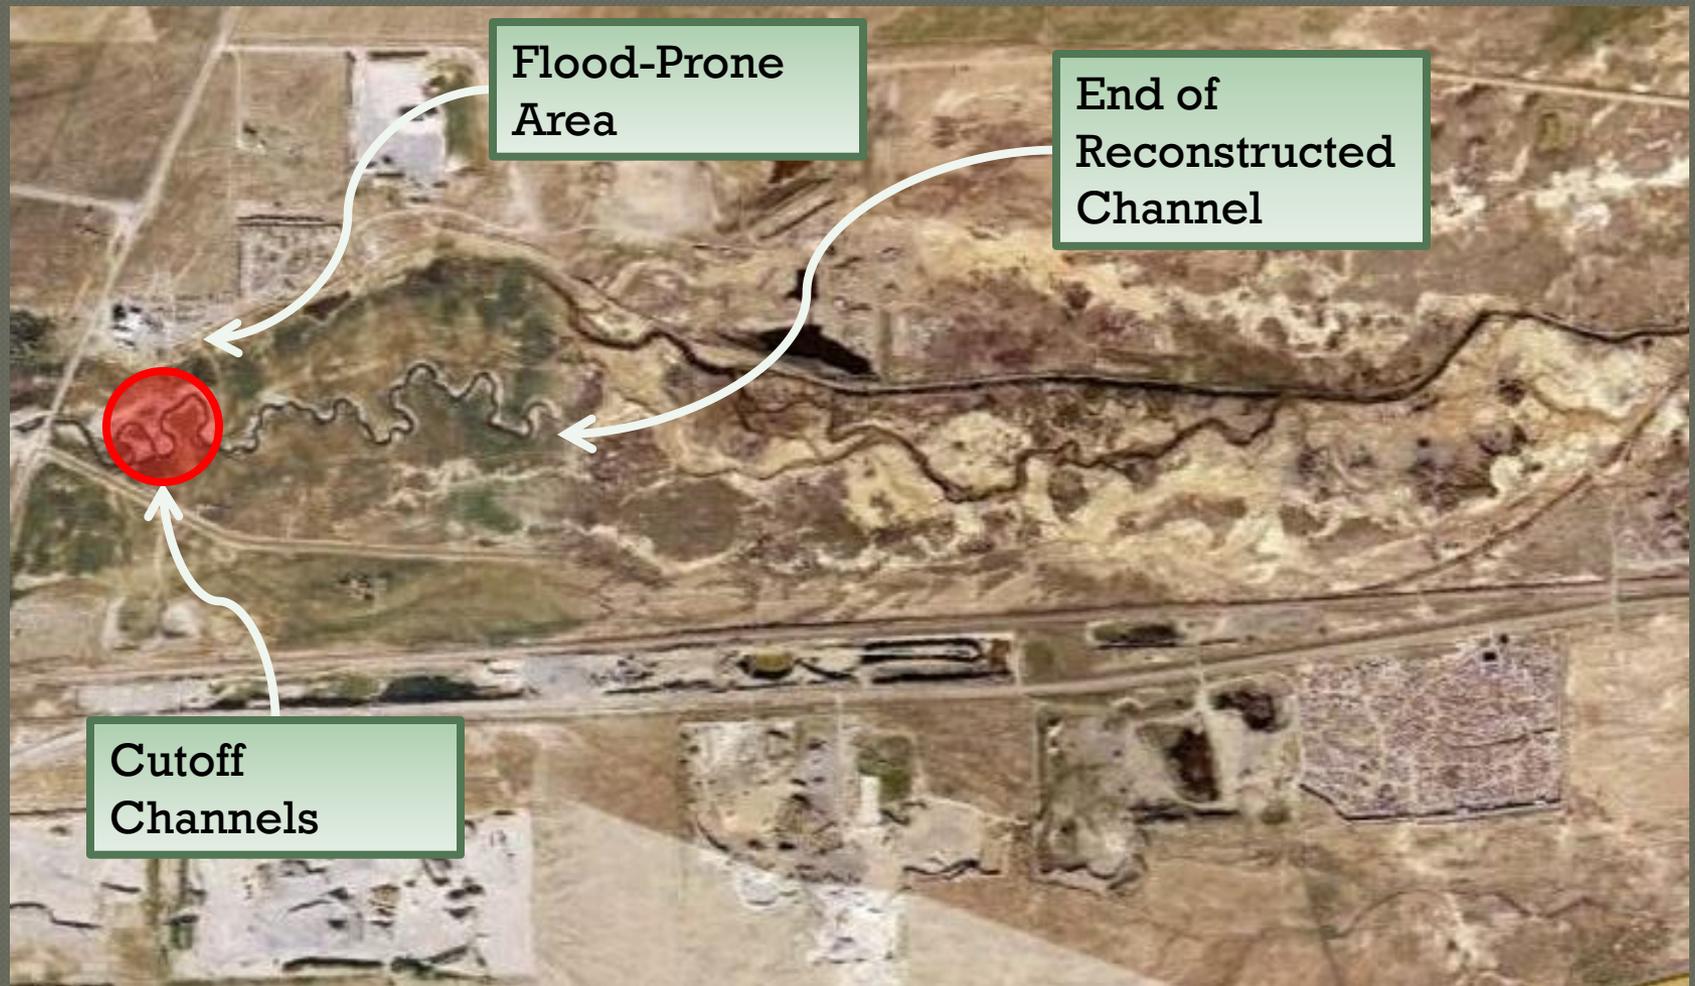
# POST FLOOD PHOTO

Flood-Prone  
Area

End of  
Reconstructed  
Channel

Cutoff  
Channels

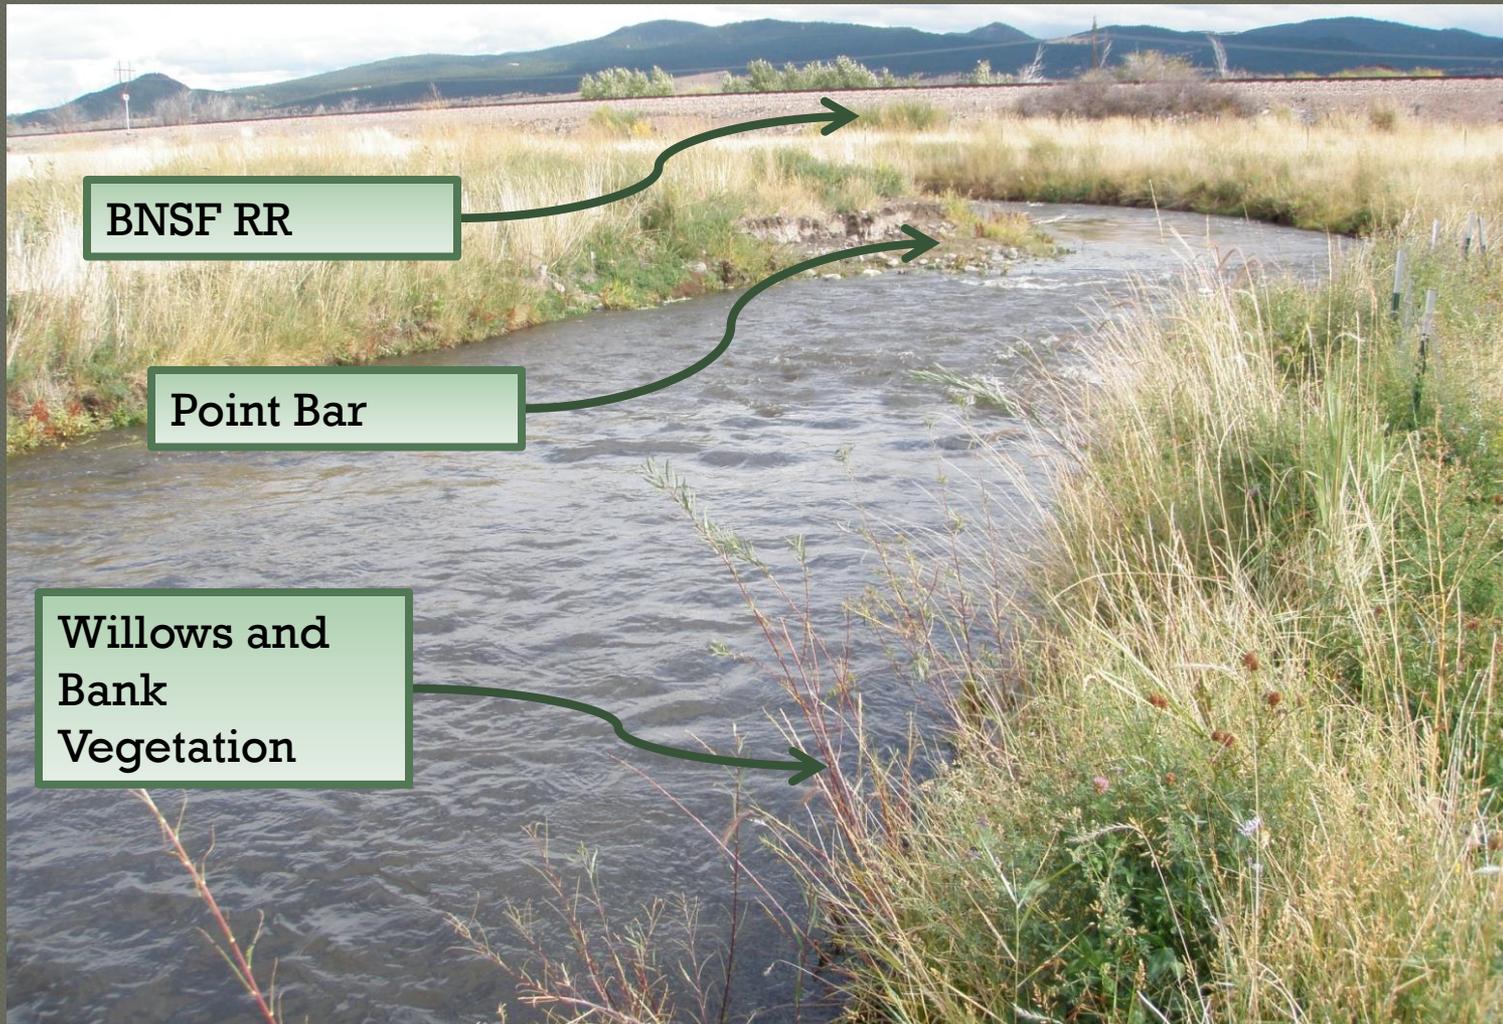
# POST FLOOD PHOTO

BNSF RR

Point Bar

Willows and  
Bank  
Vegetation

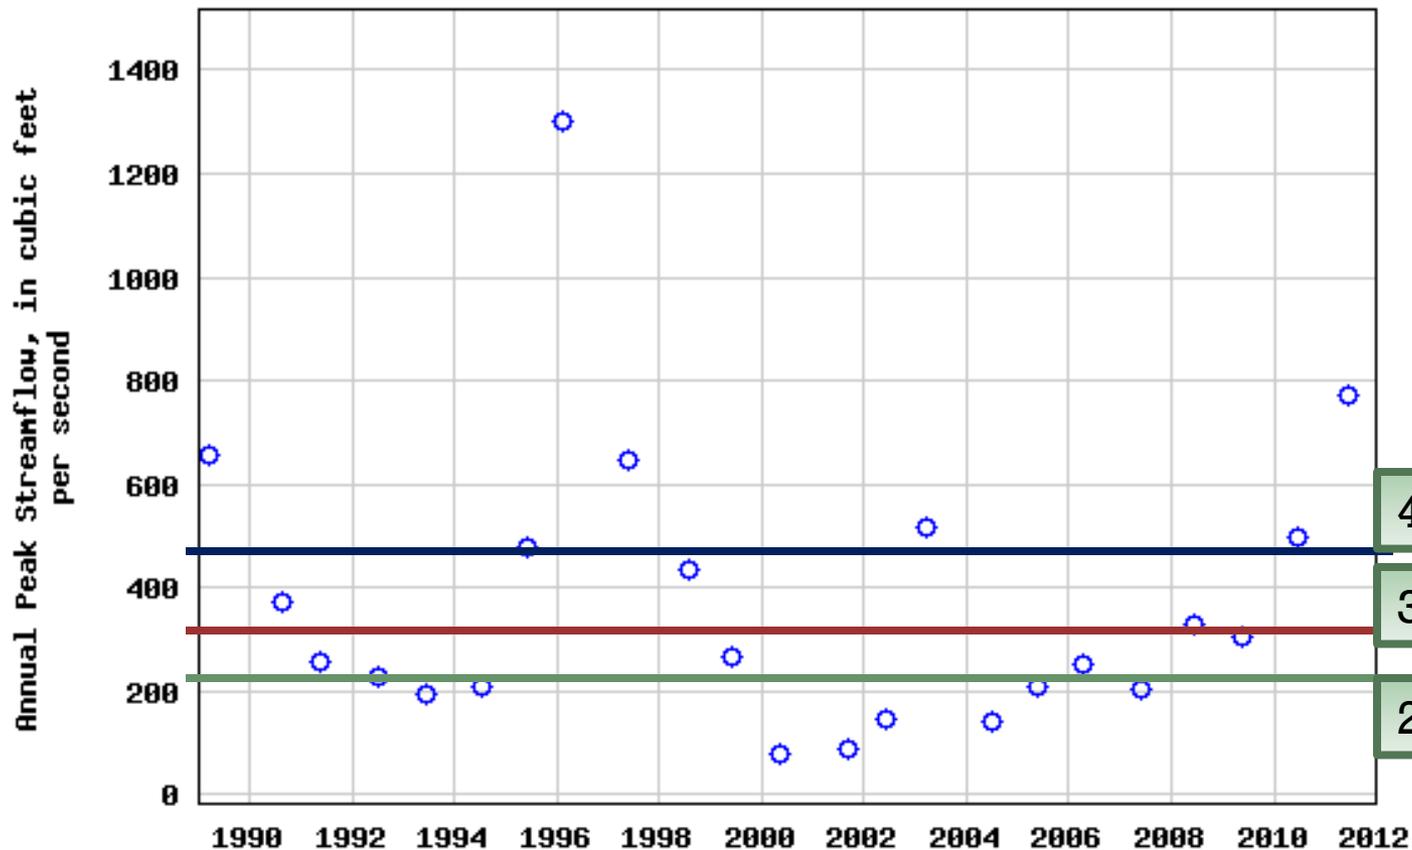
# REVISED CHANNEL CAPACITY

USGS 12323600 Silver Bow Creek at Opportunity MT

450

300

210

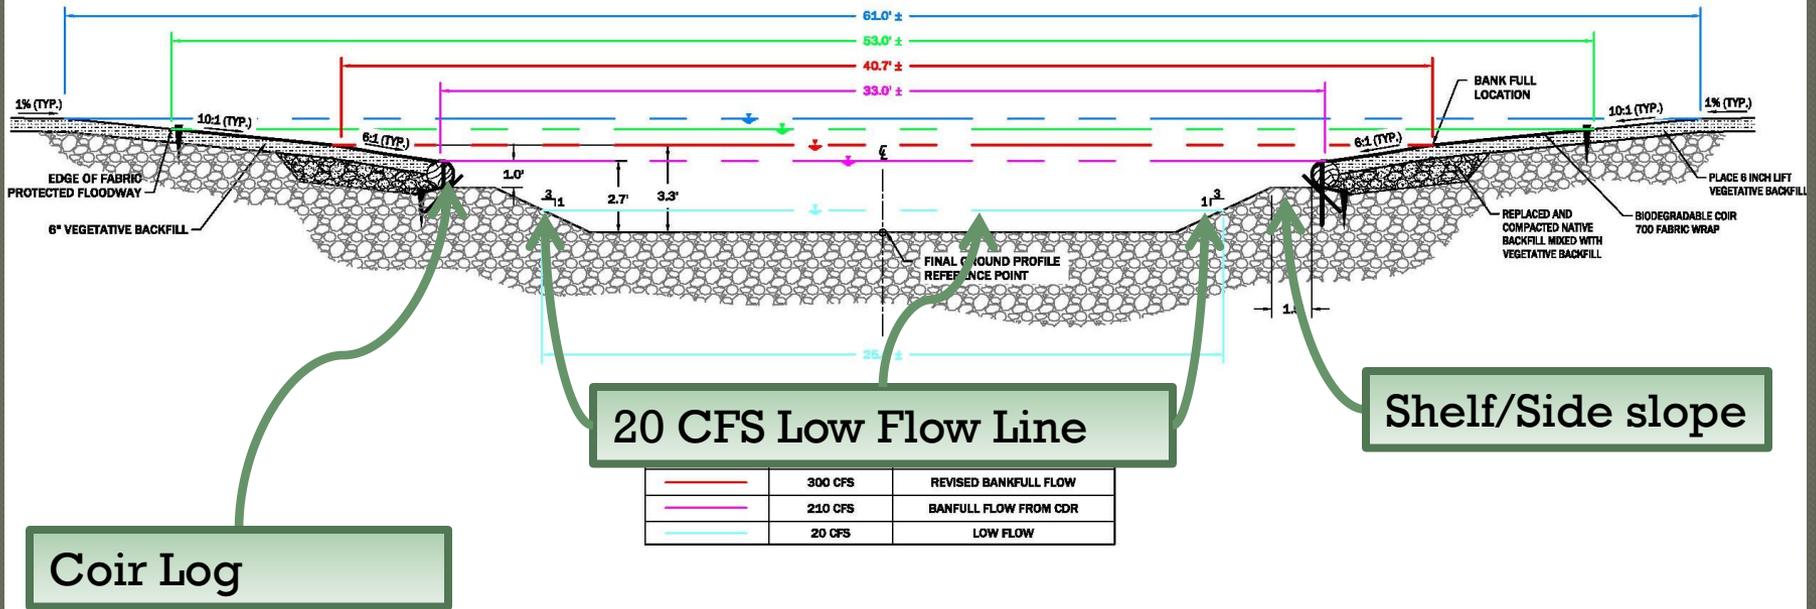
# REVISED CHANNEL

CONCEPTUAL DEFORMABLE CHANNEL WIDE RIFFLE SECTION (TYPICAL)

- Larger Channel
- Coir Fabric/Coir Rolls
- Shallower Bank Slopes
- Floodplain Swales or Side Channels
- QA/QC
- Compaction in Fill Areas
- Minimum Channel Dimensions

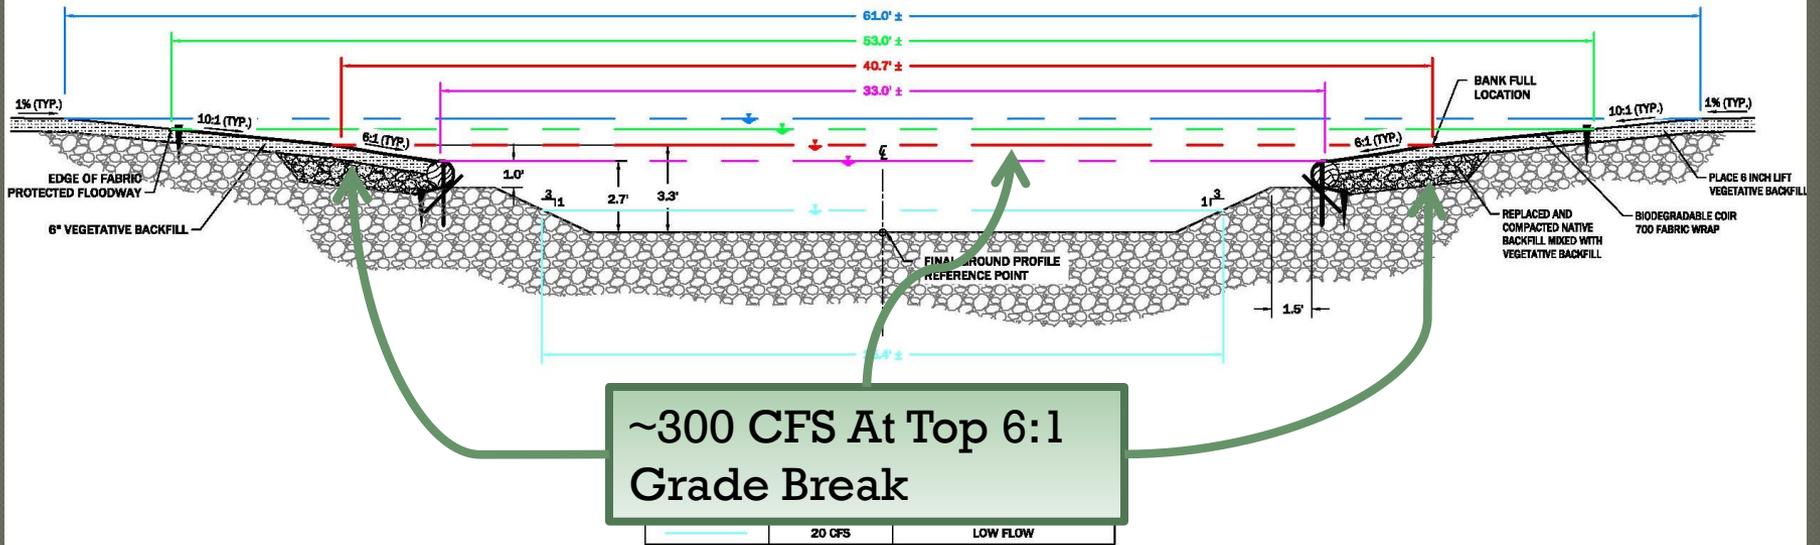
# REVISED CHANNEL

CONCEPTUAL DEFORMABLE CHANNEL WIDE RIFFLE SECTION (TYPICAL)

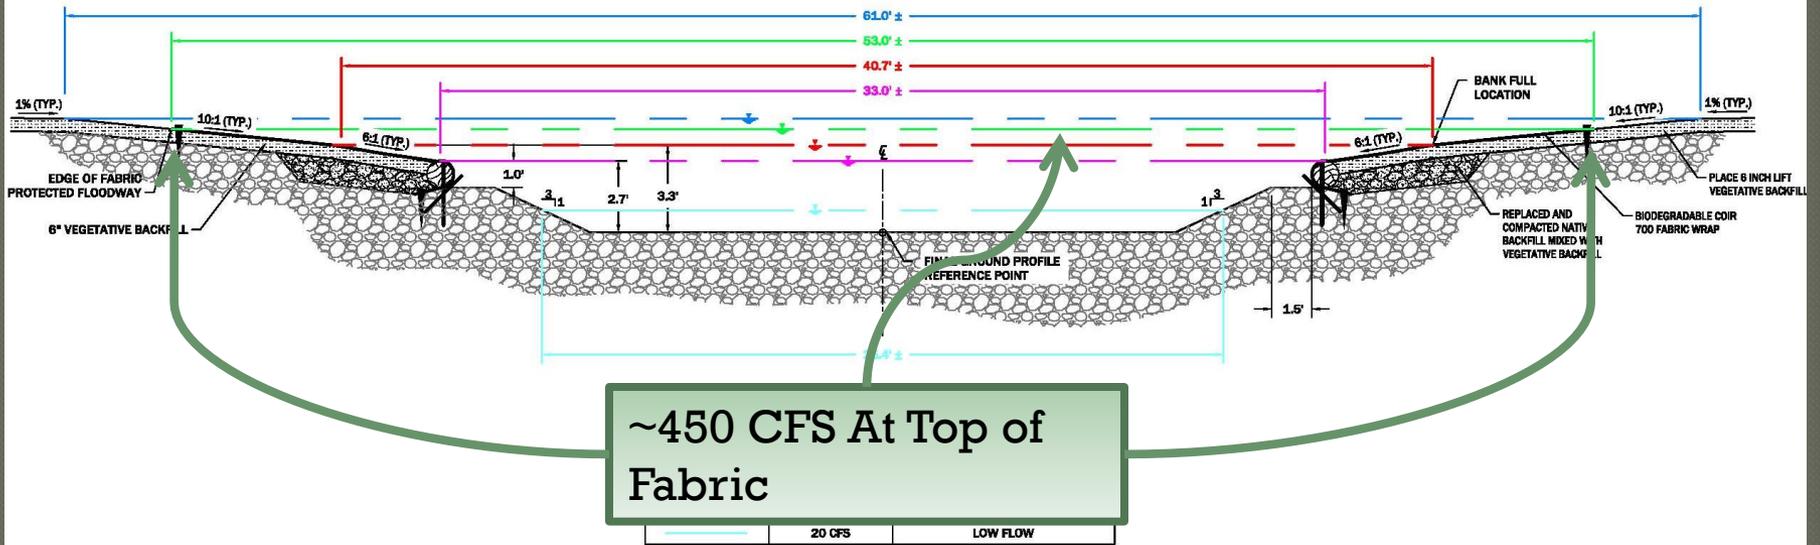
# REVISED CHANNEL

CONCEPTUAL DEFORMABLE CHANNEL WIDE RIFFLE SECTION (TYPICAL)
