# Silver Bow Creek – Balancing Competing Priorities and Lessons Learned

2013 Mine Design, Operations and Closure  
Conference

# SA4 PROJECT OVERVIEW

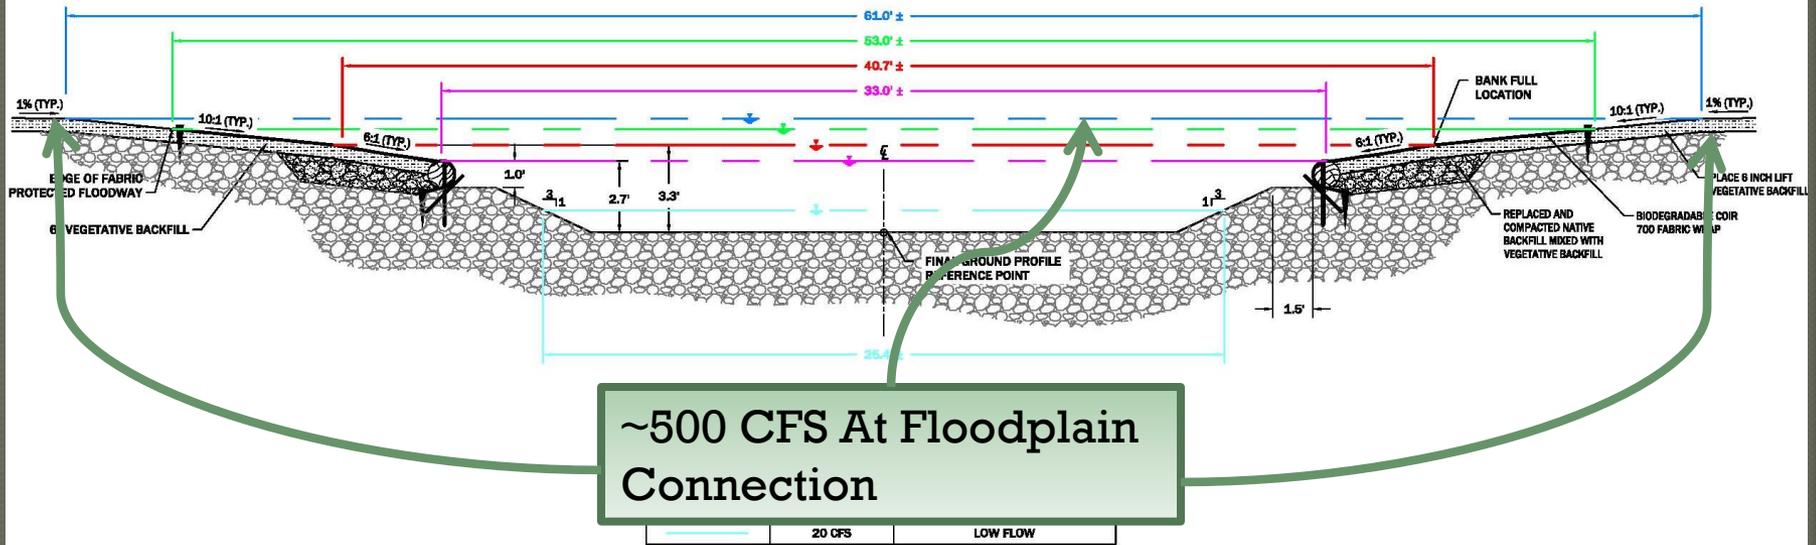
# REVISED CHANNEL

CONCEPTUAL DEFORMABLE CHANNEL WIDE RIFFLE SECTION (TYPICAL) 1

$\frac{3}{16}" = 1'-0"$

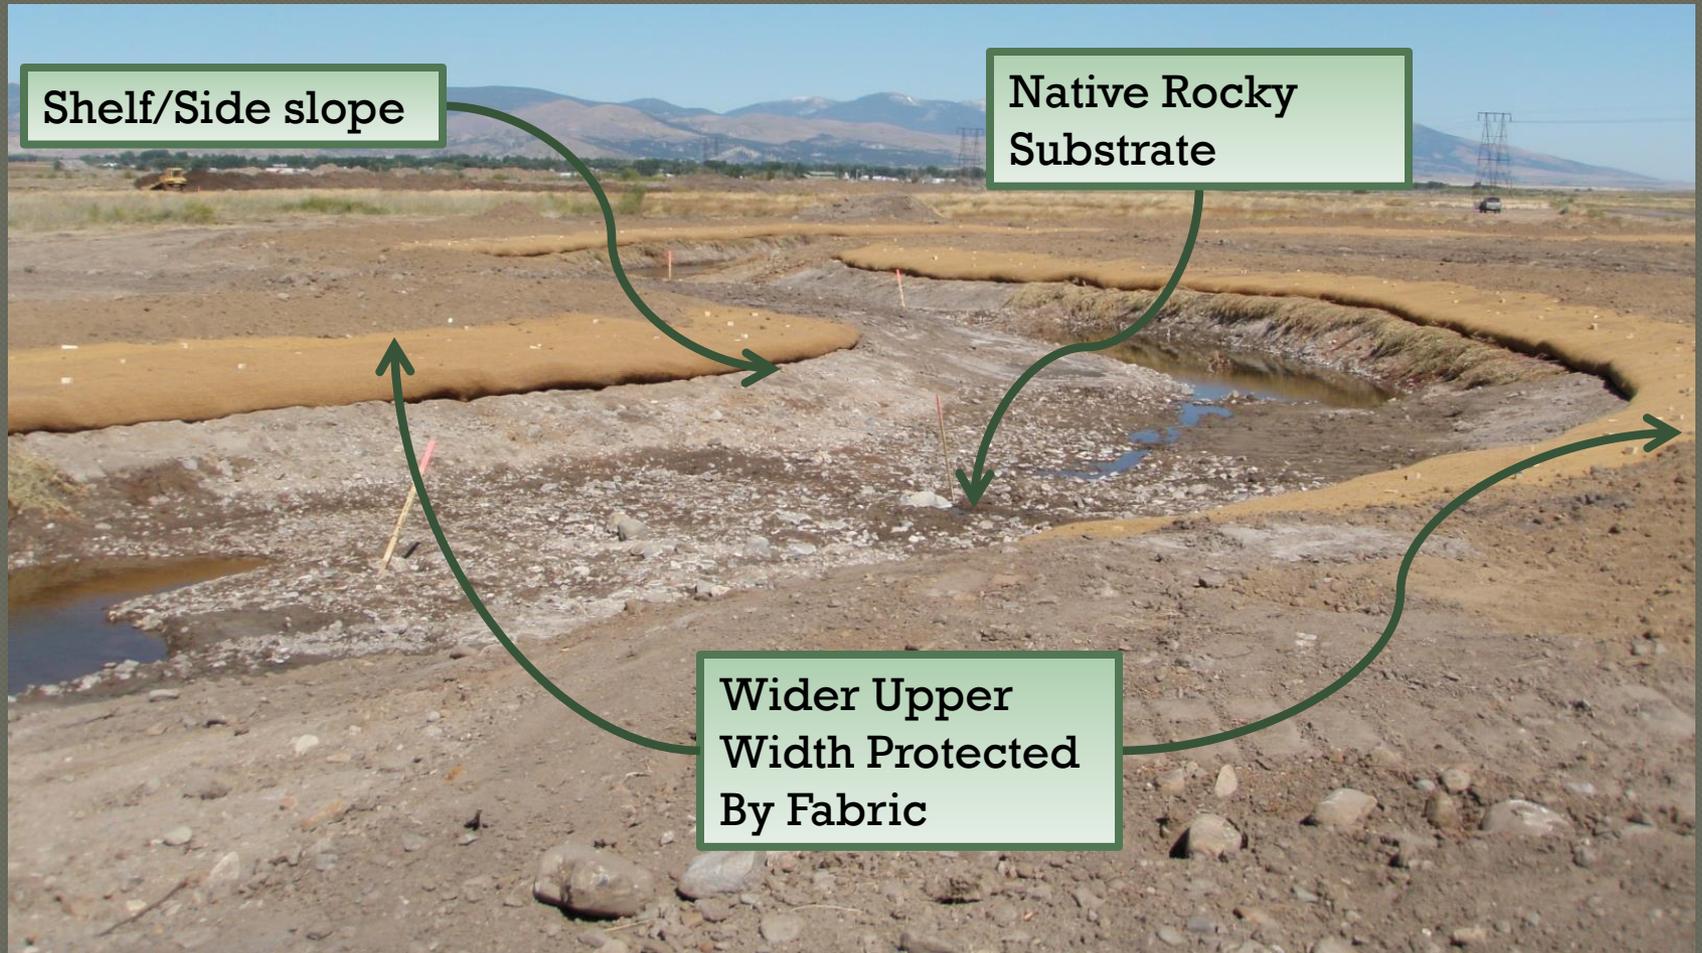
# REVISED CHANNEL

Shelf/Side slope

Native Rocky  
Substrate

- Larger Channel Capacity
- Enhanced Initial Stability
- Still Have Some Risk
- Side Channels/Terraces
- QA/QC Is Key
- Ice Jams Remain A Wildcard
- Expect and Budget for Some O&M/Repair
